# Building and Timber Pest Inspection Report VR

Inspection Date: Fri, 13 Feb 2026

Property Address: 16 Kurrajong St, Durack QLD 4077,  
Australia

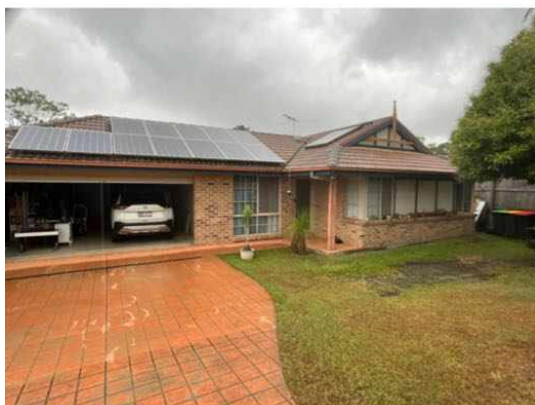
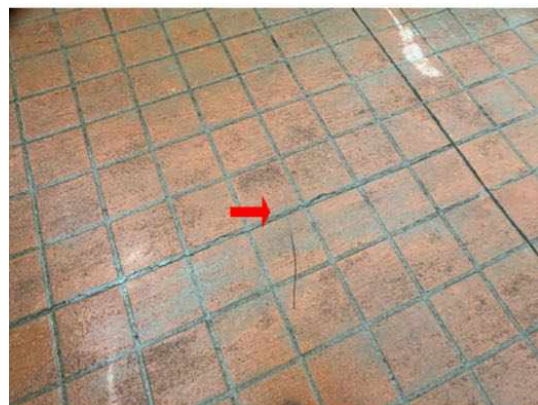
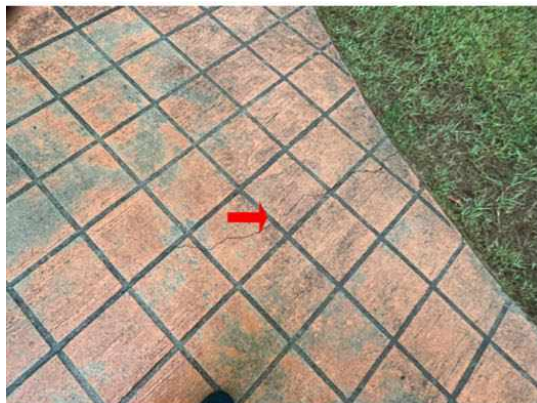
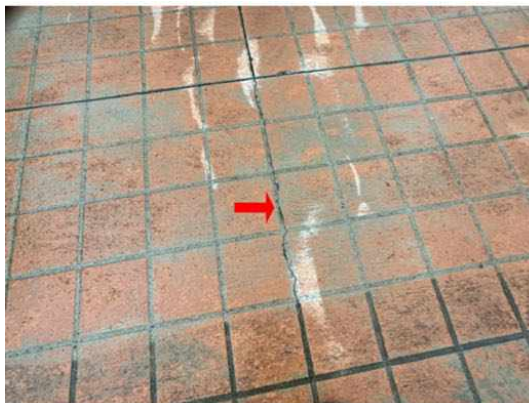
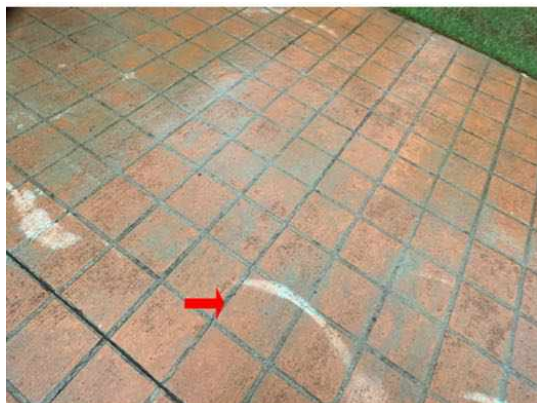
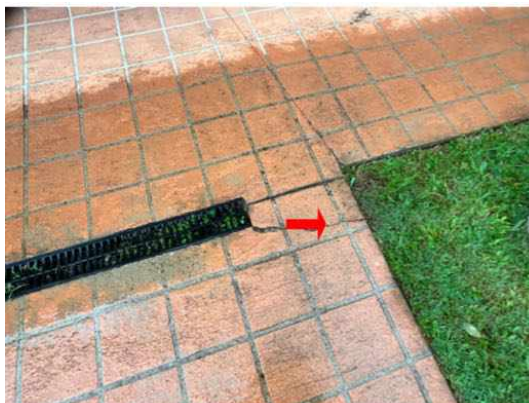
Building: Main Building  
Location: Driveway  
Finding: Crack in concrete slab - Category 1  
Information: A crack coded as Category 1 was identified in the slab. A Category 1 crack is described as a fine but noticeable crack, with the slab at an otherwise reasonable level.

To be considered Category 1, the approximate width of the crack is less than 1.0mm, or a less than 10mm change in offset when a 3m straight edge is placed over the defect.

Category 1 cracks should be monitored for a period of 12 months. At the end of the monitoring period, identified cracks that are rated greater than Category 2 are considered defects, and require rectification.

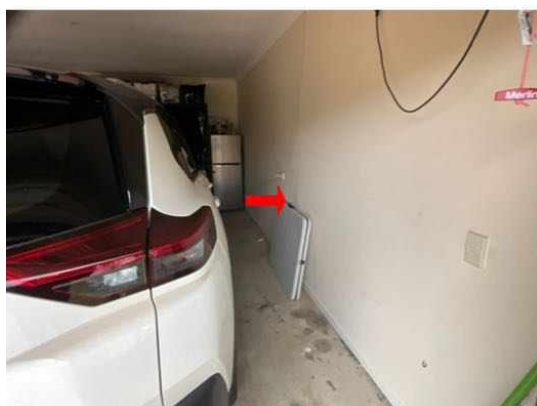
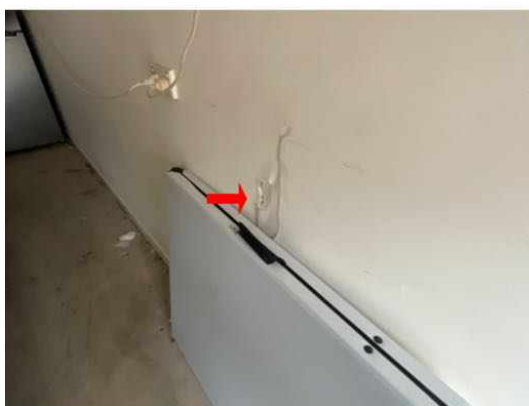
### Finding 3.02

Building: Main Building  
 Location: Garage  
 Finding: Damage to Plasterboard Wall – Garage  
 Information: Damage to Plasterboard Wall – Garage

Impact damage was observed to the plasterboard wall lining, including puncturing/tearing of the plaster surface and deformation to the wall finish. The damage appears consistent with physical impact (likely vehicle door or stored items). The wall lining is no longer in sound condition and cosmetic integrity has been compromised.

Damaged plasterboard can deteriorate further over time, may expose internal wall cavities, and presents an unsightly finish. If left unattended, this may allow moisture ingress or pest access and reduce overall presentation and durability of the garage area.

Engage a licensed plasterer or qualified handyman to patch or replace the damaged plasterboard section, reinstate internal wall lining, and repaint to match surrounding finishes.

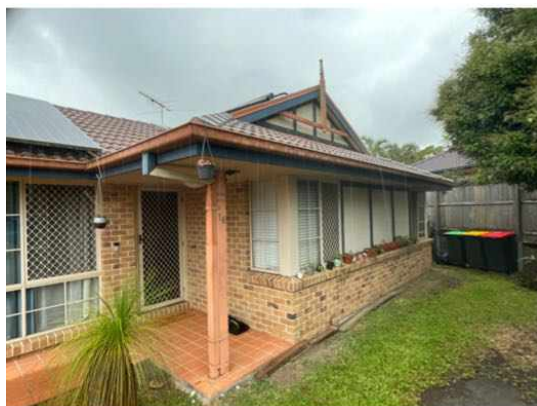
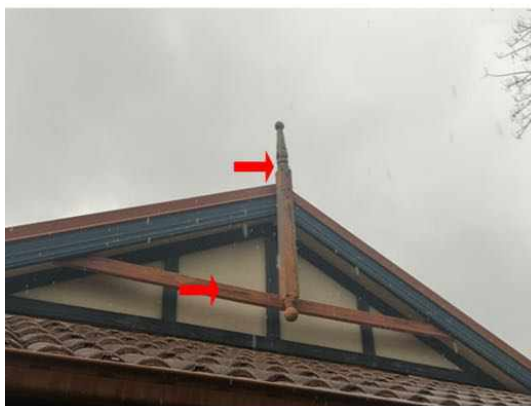
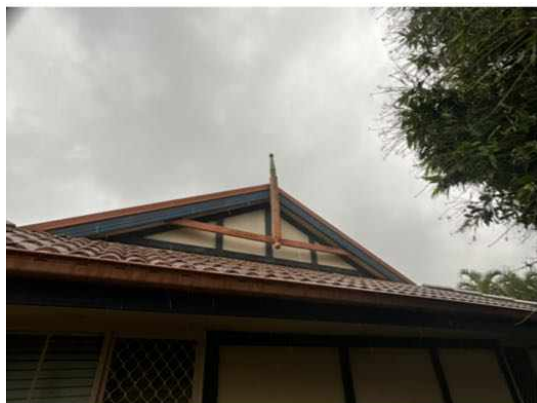
### Finding 3.03

Building: Main Building  
 Location: Front Elevation  
 Finding: Gable Roof – Fascia & Timber Trims Weathering  
 Information: Gable Roof – Fascia & Timber Trims Weathering

Timber fascia and decorative gable trim components show signs of weathering and coating deterioration. Minor surface degradation and ageing of timber elements were observed.

deterioration, moisture ingress and reduced lifespan of external trim elements.

A licensed painter or carpenter should assess, prepare and repaint all affected timber elements. Replace any sections showing advanced deterioration.

Maintenance recommended within 6–12 months.

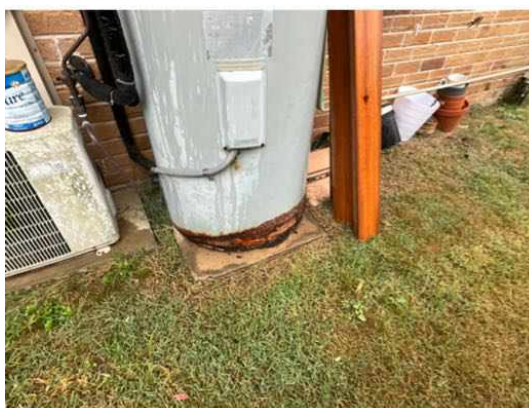
### Finding 3.04

Building: Main Building  
 Location: Exterior walls - right side  
 Finding: Corrosion to Hot Water Service Tank – Rear External Wall  
 Information: Corrosion to Hot Water Service Tank – Rear External Wall

Significant corrosion and rust deterioration were observed to the lower section (base ring) of the hot water service storage tank. Rust staining and active corrosion are evident around the bottom perimeter of the unit, indicating advanced metal degradation. This condition is consistent with prolonged moisture exposure and age-related failure of the tank lining/coating.

Corrosion at the base of a hot water service is a common precursor to sudden tank failure and leakage. If left unaddressed, this may result in water damage to surrounding structures, loss of hot water supply, and potential flooding of the area. The structural integrity of the tank is considered compromised.

Engage a licensed plumber to assess the unit and arrange replacement of the hot water service as required. Given the extent of corrosion observed, replacement is strongly recommended rather than repair.

High priority – recommend replacement within 30 days or sooner if signs of leakage occur.

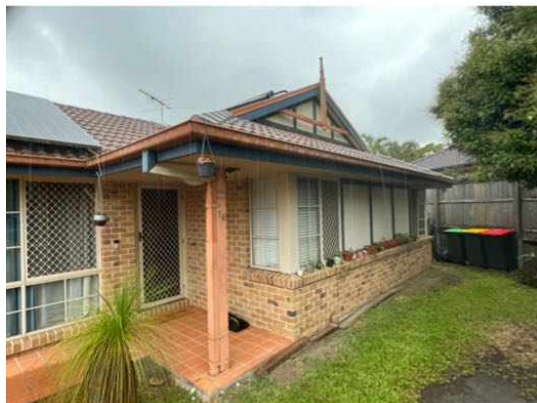
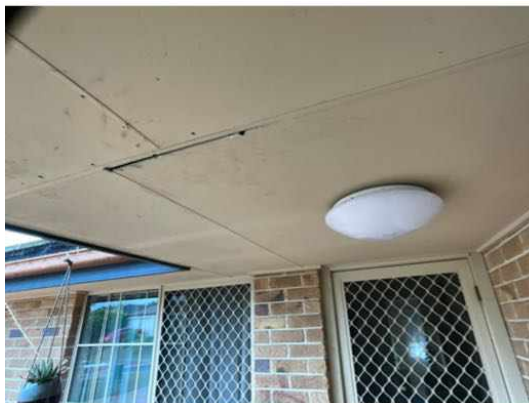
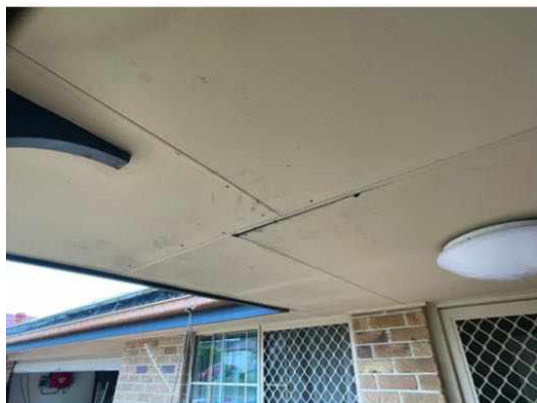
**Finding 3.05**

Building: Main Building  
Location: Front Elevation  
Finding: Separated / Misaligned Eave Sheets – Front Entry Porch  
Information: Separated / Misaligned Eave Sheets – Front Entry Porch

The eave lining sheets at the front door area were observed to be misaligned and separating at sheet junctions, with visible gaps between panels. Fixings appear inadequate or have loosened over time, allowing movement of the sheets. Minor staining and surface marks were also noted, consistent with moisture exposure and age-related deterioration.

Open joints in eave linings may allow moisture ingress, insects, vermin, and wind-driven rain into the roof void. Continued movement may lead to further sheet displacement or collapse, and increases the risk of hidden timber moisture damage and mould development within the ceiling cavity.

Engage a qualified carpenter or handyman to refix or replace affected eave sheets, install additional fixings as required, realign joints, and reseal. Any damaged sections should be replaced. Following rectification, repaint to provide weather protection.

Medium priority – recommend repairs within 30–60 days, or sooner if movement worsens or water ingress is observed.

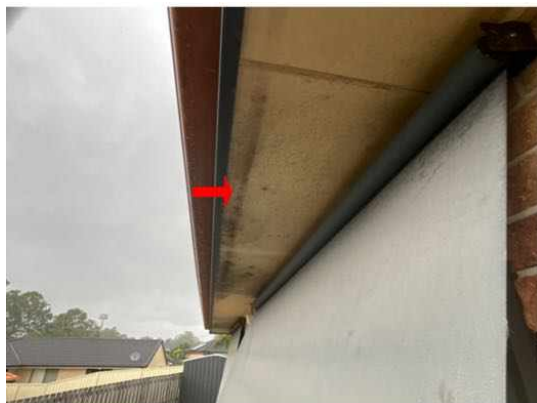
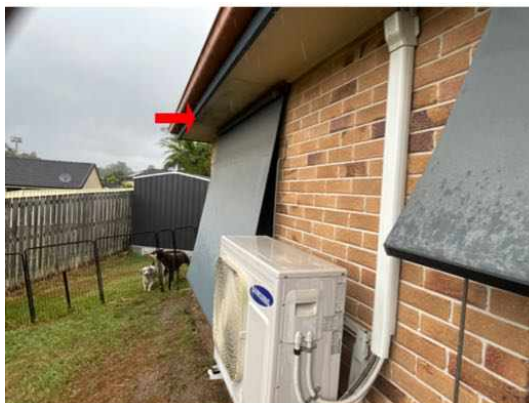
### Finding 3.06

Building:	Main Building
Location:	Rear Elevation
Finding:	Eaves – Mould Growth and Moisture Staining (Defect)
Information:	Eaves – Mould Growth and Moisture Staining (Defect)

Visible mould growth, staining, and surface discolouration were observed to the underside of the eaves, as shown in the photographs. The affected areas display characteristics consistent with prolonged moisture exposure.

The mould growth and staining are indicative of moisture ingress, likely associated with roof leaks, defective flashing, blocked gutters, or inadequate water runoff management. At the time of inspection, no invasive investigation was undertaken to confirm concealed timber damage or structural deterioration.

This condition is classified as a DEFECT (Minor to Moderate).

If left unaddressed, ongoing moisture exposure may lead to deterioration of eaves linings, concealed timber decay, and potential spread of mould. Continued moisture ingress may escalate this condition to a more serious defect over time.

Further investigation by a suitably qualified roofing contractor is recommended to identify and rectify the source of moisture ingress. Affected eaves should be cleaned, treated for mould, allowed to dry, and repaired or replaced as required once the moisture source is rectified.

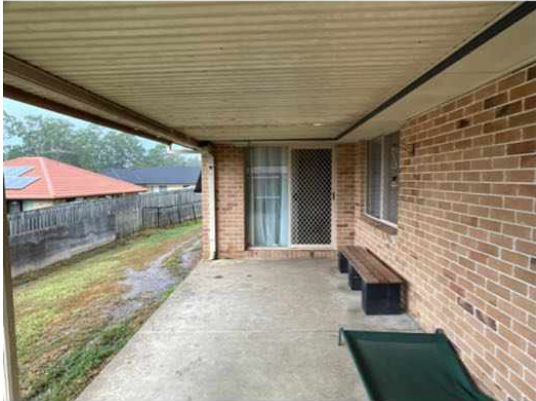
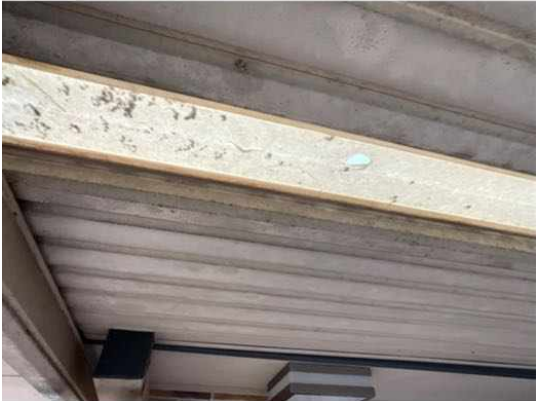
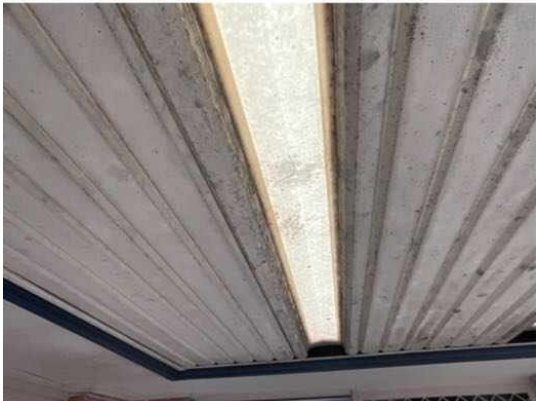
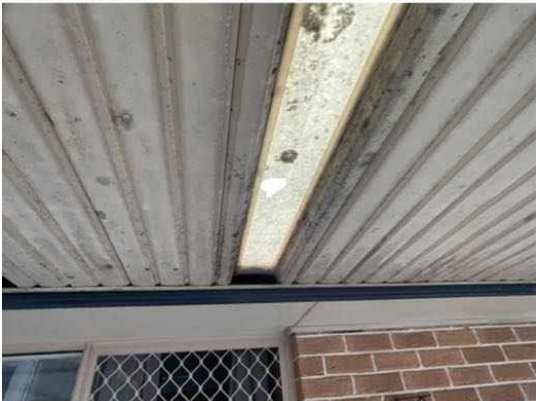
### Finding 3.07

Building:	Main Building
Location:	Rear Elevation
Finding:	Polycarbonate sheeting - Damaged
Information:	The polycarbonate sheeting has deteriorated as a result of exposure to weather conditions over a prolonged period of time. Exposure to elements, such as heavy rain and hailstorms, is likely to damage polycarbonate sheeting, which is not as strong as

Further deterioration of the polycarbonate sheeting is likely to occur if left unmanaged. Such deterioration creates potential for water penetration and secondary damage to the internal roofing structure, accelerating deterioration of all associated building elements.

Repair and replacement of several sections of the sheeting is required. Appointment of a roofing restorer is required to perform these works as soon as possible to prevent any further damage being sustained.

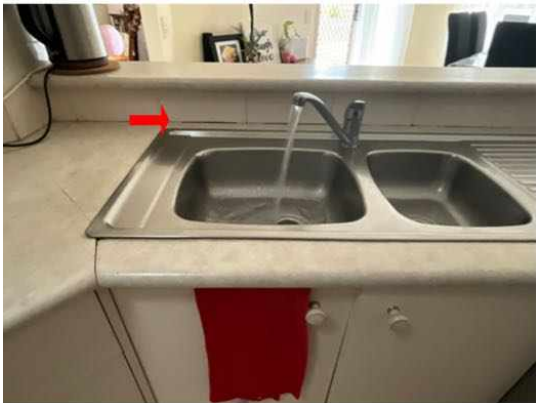
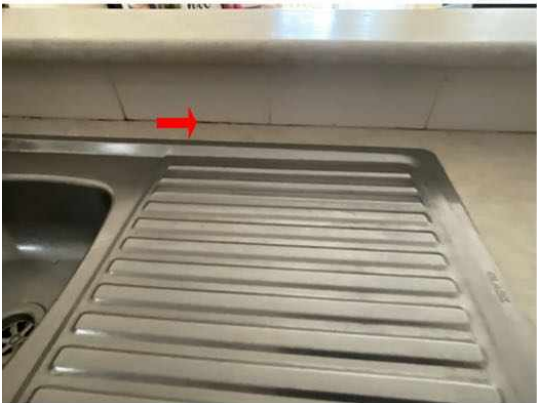
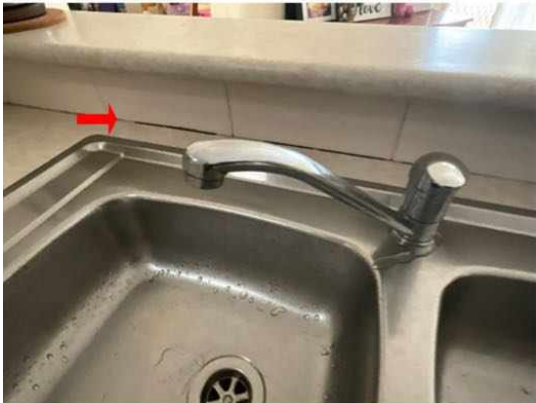
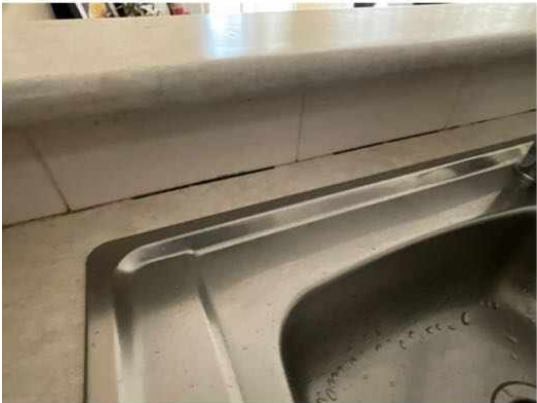
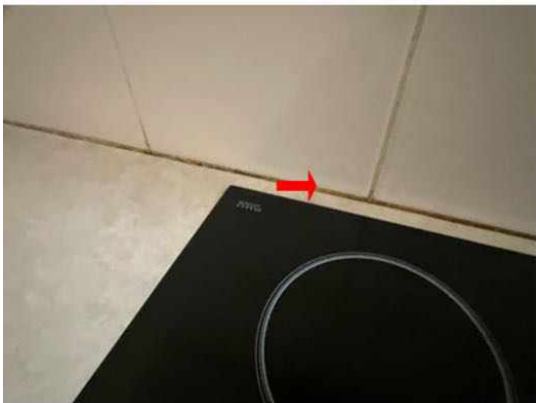
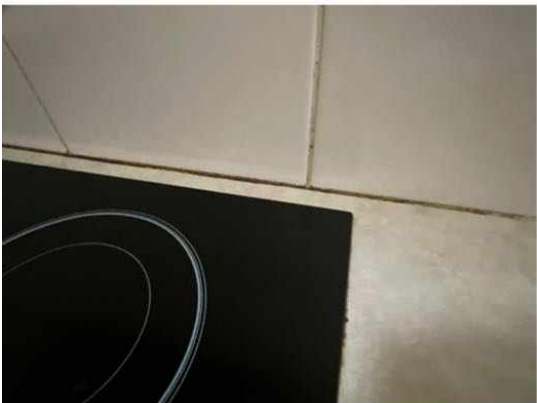
### Finding 3.09

Building:	Main Building
Location:	Kitchen
Finding:	Sealant - Missing or damaged kitchen bench
Information:	It was noted on inspection that sealant is degraded to the kitchen bench/splash back area

Sealant and in areas that come into regular contact with water should be maintained for the long term care of your property.

A sealant specialist or tiling contractor should be appointed to complete these works as soon as possible

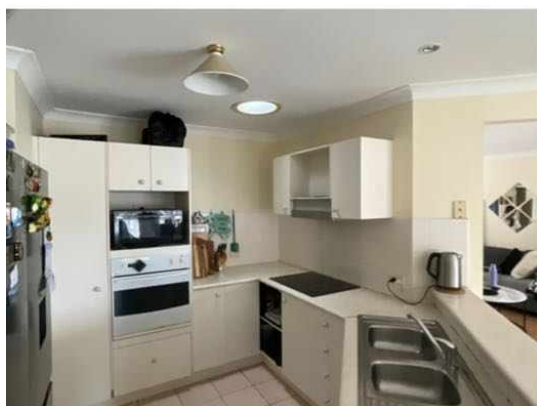
Finding 3.10

Building: Main Building  
Location: Kitchen  
Finding: Missing Cabinet Door – Kitchen Base Cupboard  
Information: Missing Cabinet Door – Kitchen Base Cupboard

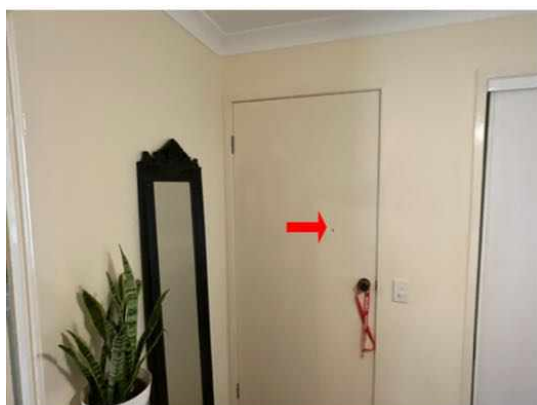
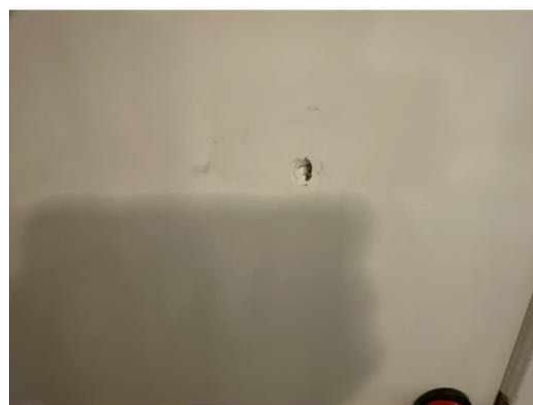
### Finding 3.11

Building:	Main Building
Location:	Bedroom
Finding:	Building element - Damaged door
Information:	Breakage occurs generally when the building materials have either aged and decayed, or as a result of damage (accidental or deliberate).

Repair and/or replacement of broken elements is advised to ensure that additional secondary defects do not arise as a consequence. Such works are necessary, as all building elements play a key role in the operation and function of the overall structure and its performance.

A relevant tradesperson should be appointed to repair or replace the affected building element prior to any subsequent damage being caused.

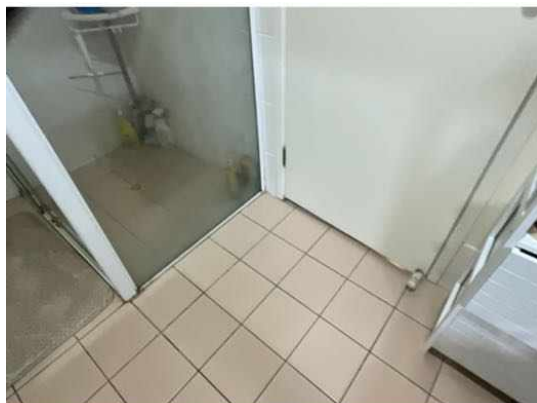
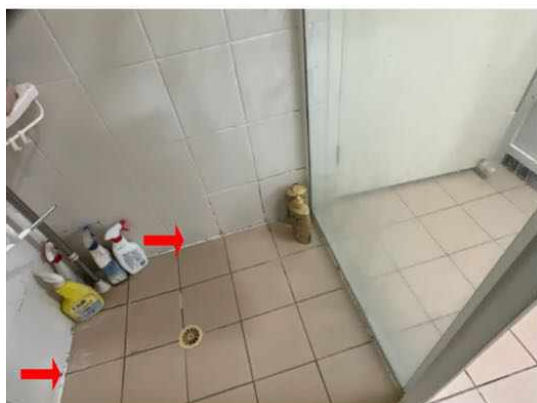
### Finding 3.12

Building:	Main Building
Location:	Bathroom
Finding:	Sealant and grouting - Missing or damaged
Information:	It was noted on inspection that sealant or grout is degraded to the tiled shower alcove and or other areas of the bathroom.

Flexible and mould resistant materials should be applied to affected areas to prevent any subsequent water damage that is likely to occur. Regular maintenance and replacement of damage or missing or damaged sealant and grout is highly recommended to the wet areas, as this is a regular wear and tear defect. Sealant and grouting in areas that come into regular contact with water should be maintained for the long term care of your property.

A sealant specialist or tiling contractor should be appointed to complete these works as soon as possible

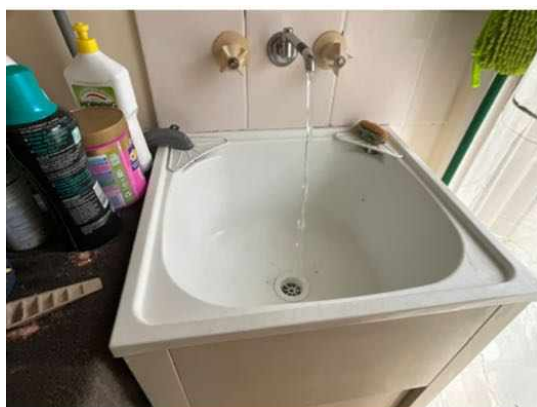
### Finding 3.13

Building: Main Building  
Location: Laundry  
Finding: Laundry – Splashback Tiles Loose / Gaps to Joints

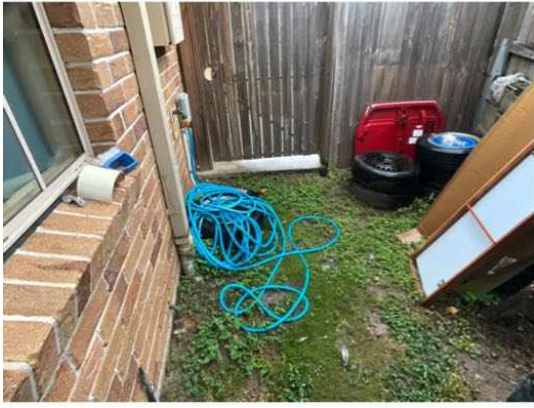
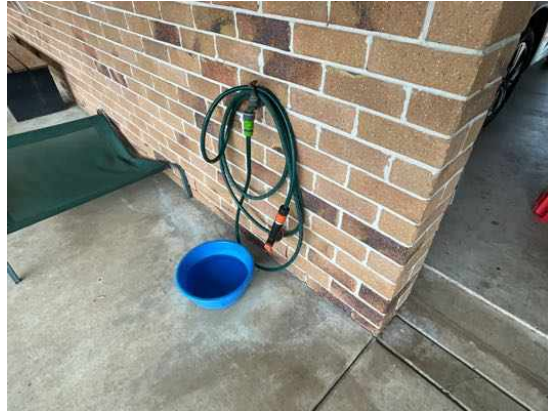
### Finding 6.02

To address this, consider maintaining a clear space between the vegetation and your home.

If you suspect a termite issue, it's advisable to consult with a licensed pest control professional for inspection and treatment.

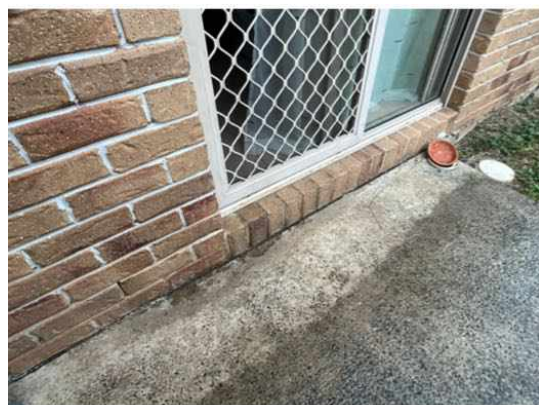
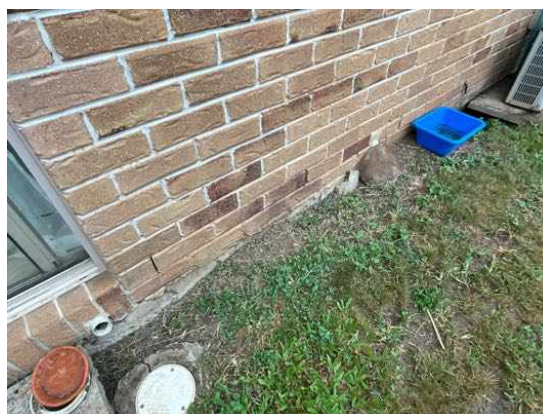
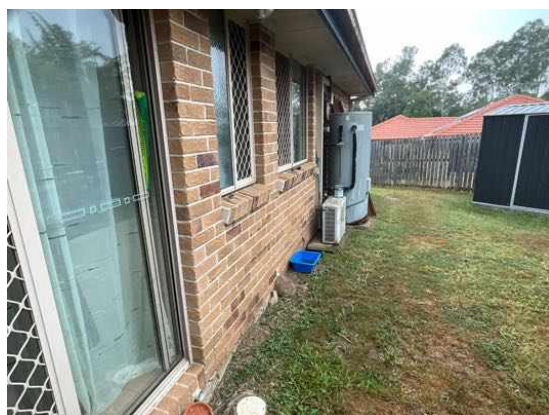
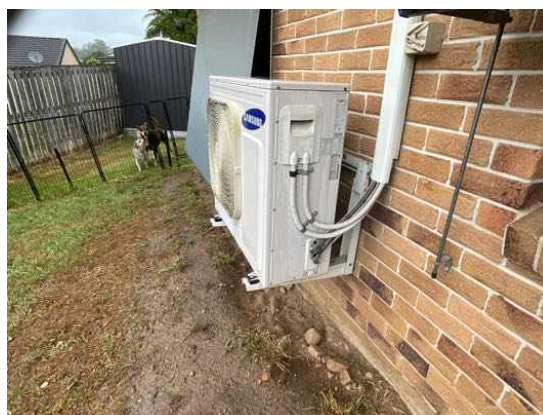
If the slab edge is not properly exposed there is a high risk of termite attack. Sometimes, in order to determine the type of slab, a suitably qualified person such as an architect or builder may be required to consult the construction plans.

Where the slab edge cannot be properly inspected, it is highly recommended that termite or timber pest inspections be carried out every 6-12 months to aid protection of the property against infestation.

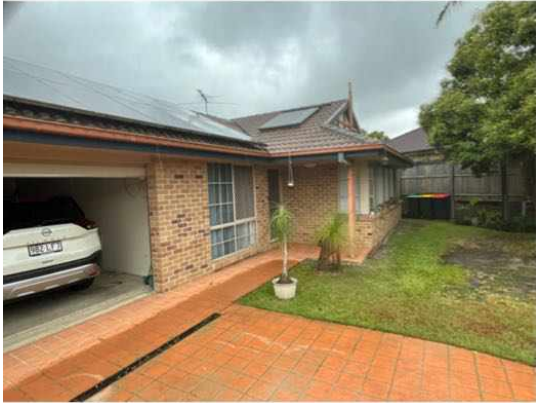
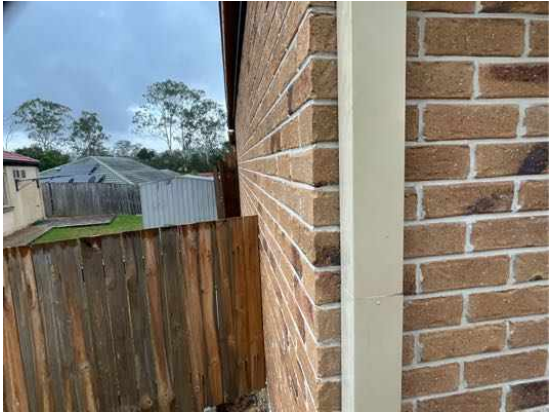
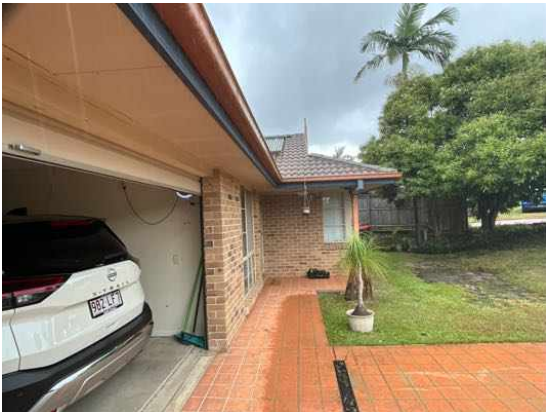
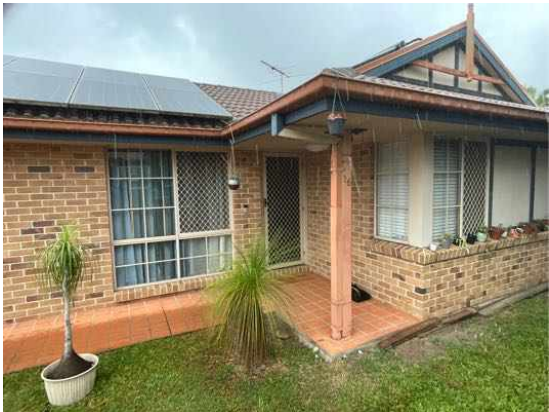
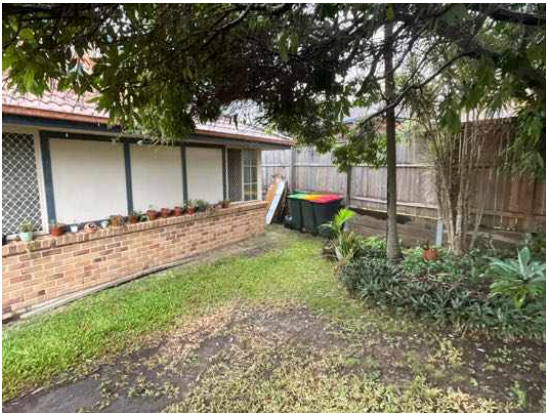
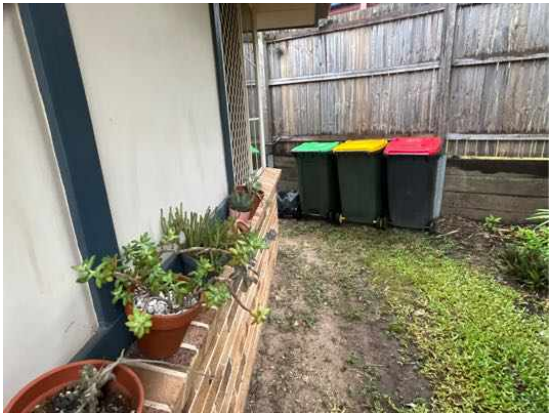
**Noted Item**

Building: Main Building  
Location: All Areas  
Finding: Additional Photos - Obstructions and Limitations  
Information: These photographs are an indication of the obstructions and limitations which impeded full inspection of the property at the time of inspection. These obstructions can hide an array of defects and should be removed to allow full inspection to be carried out. A re-inspection is recommended once the areas are made accessible.

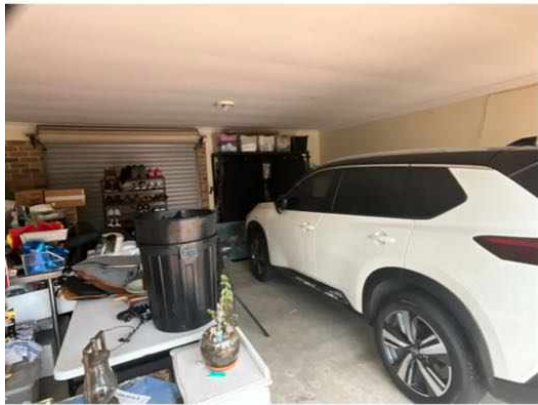
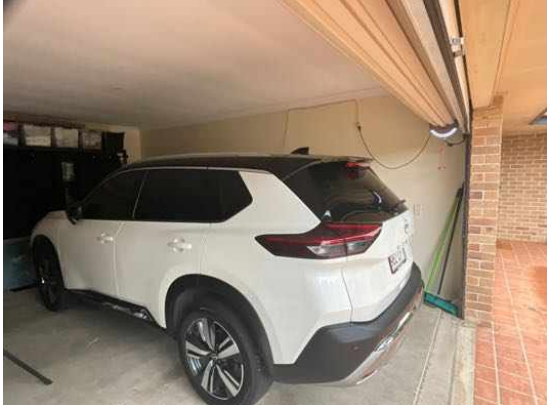
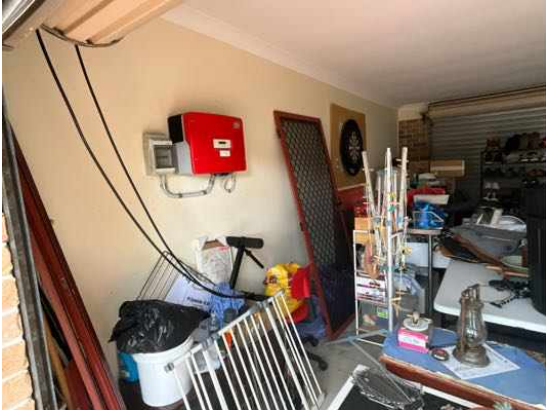
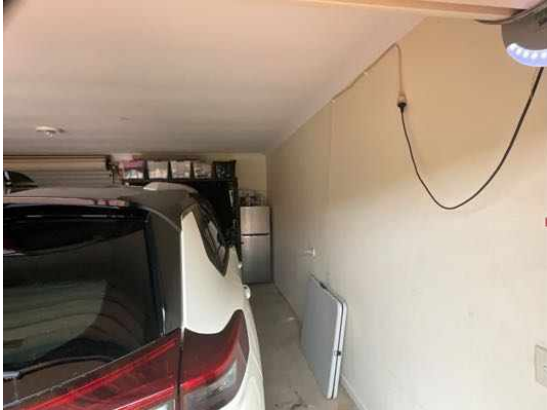
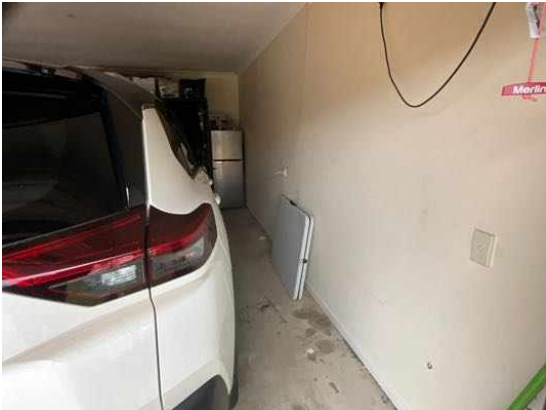
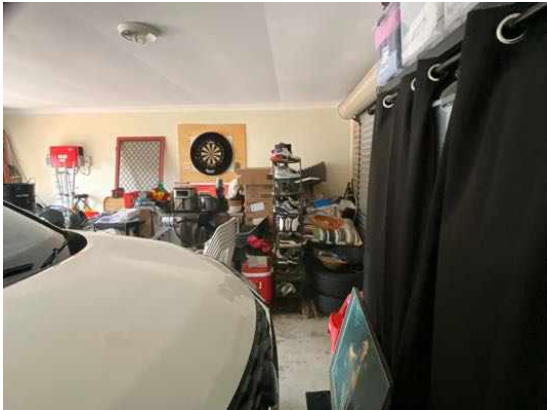
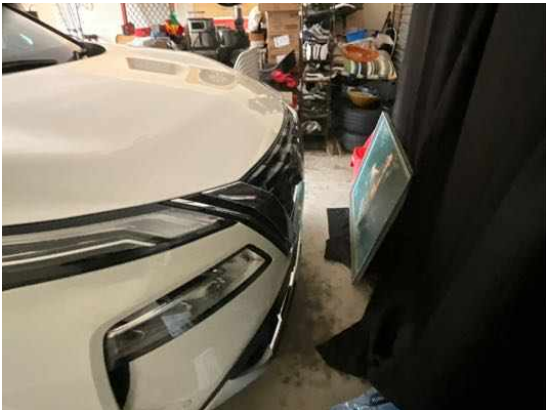
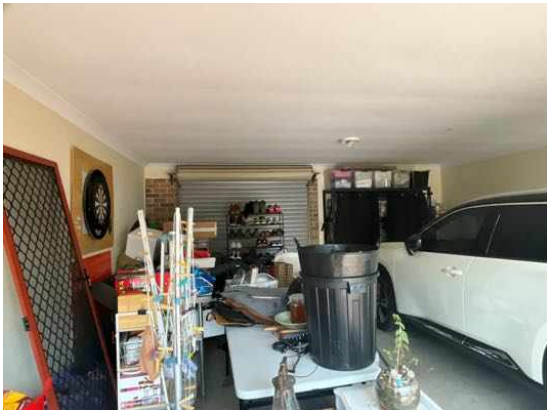
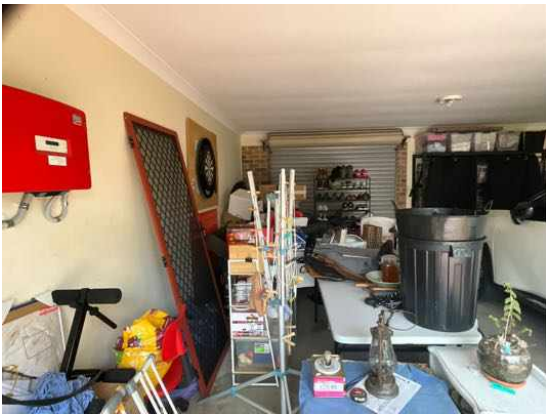
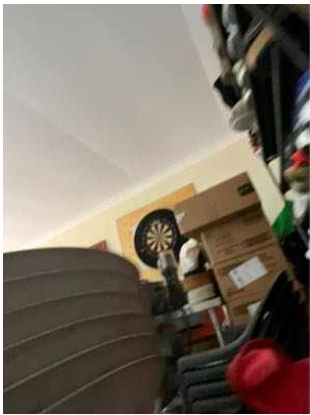
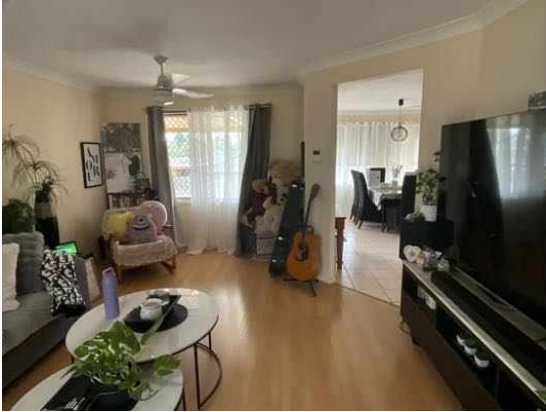
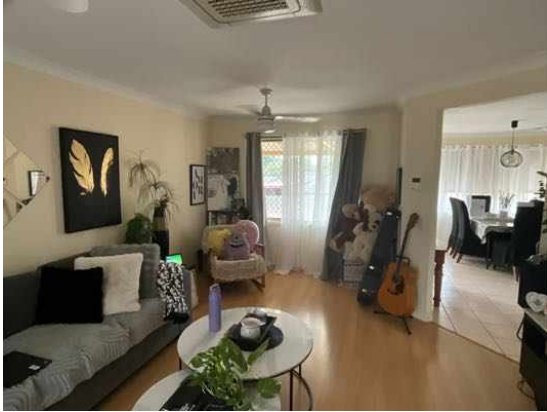
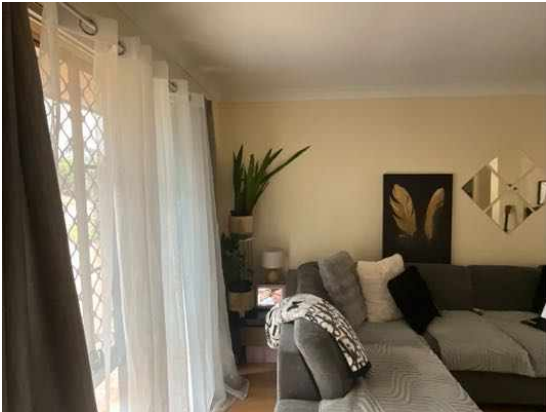
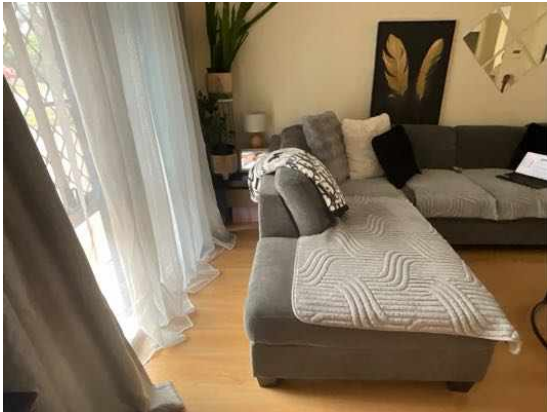
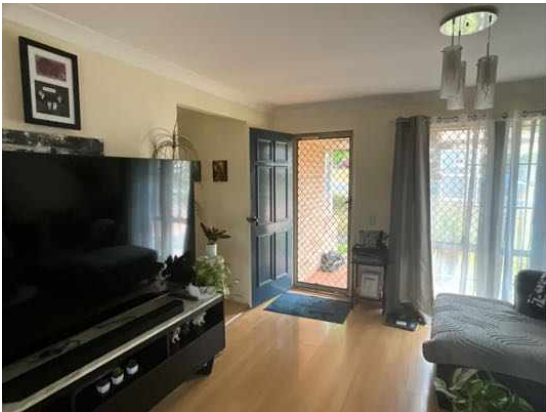
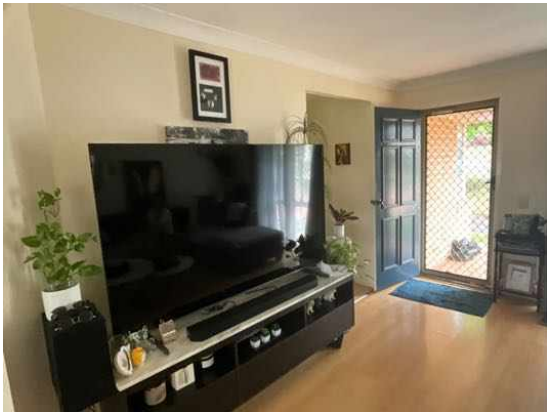
Building:	Main Building
Location:	All Areas
Finding:	Additional Photos - Obstructions and Limitations
Information:	These photographs are an indication of the obstructions and limitations which impeded full inspection of the property at the time of inspection. These obstructions can hide an array of defects and should be removed to allow full inspection to be carried out. A re-inspection is recommended once the areas are made accessible.
