# Building and Timber Pest Inspection Report VR

Inspection Date: Fri, 13 Feb 2026

Property Address: 16 Kurrajong St, Durack QLD 4077,  
Australia

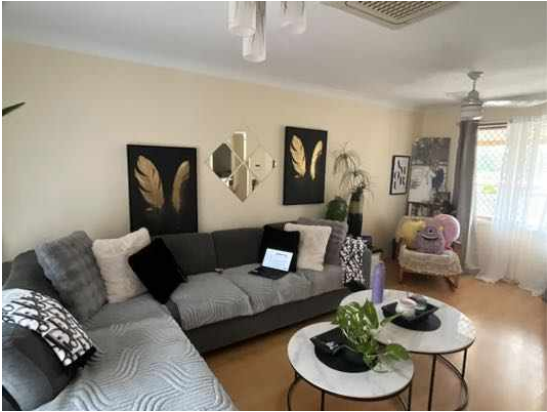
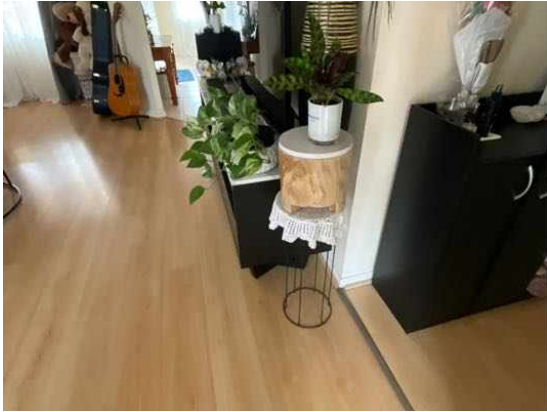
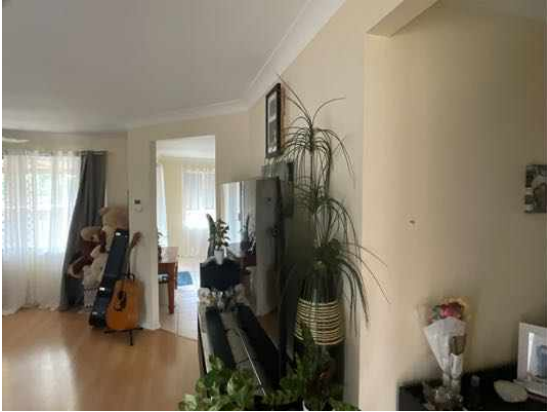
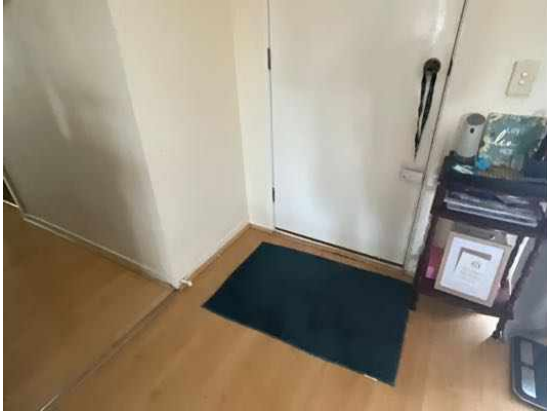
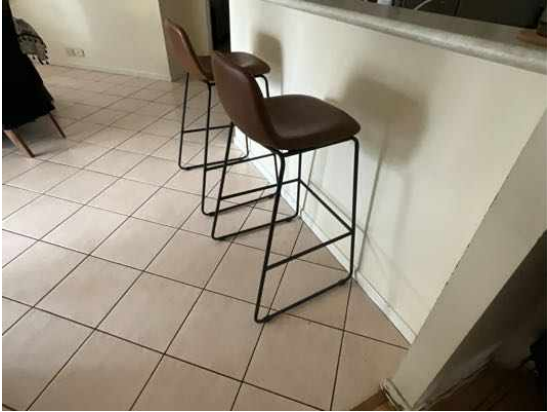
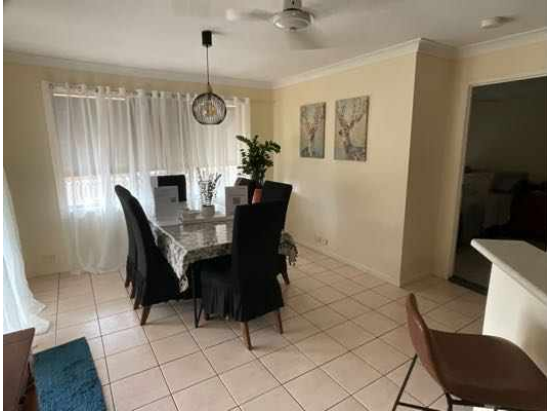
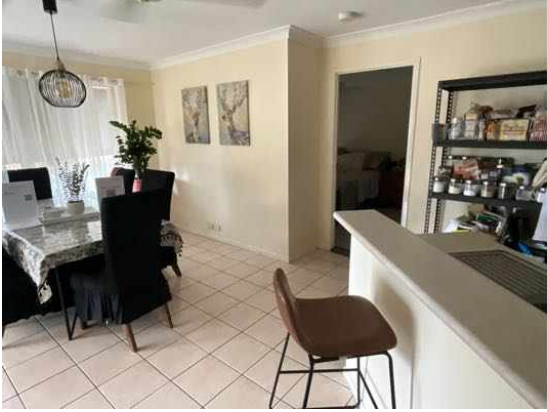
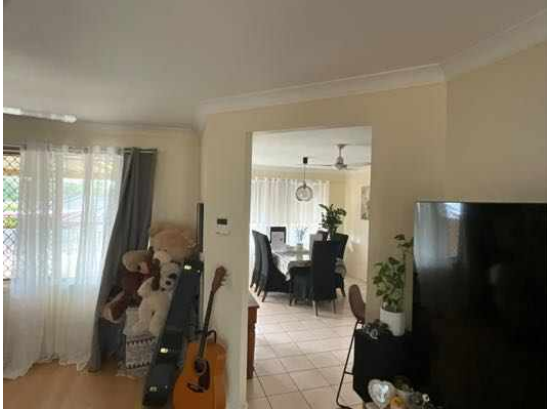
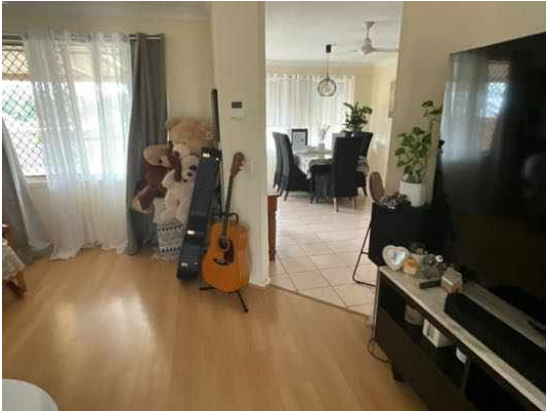
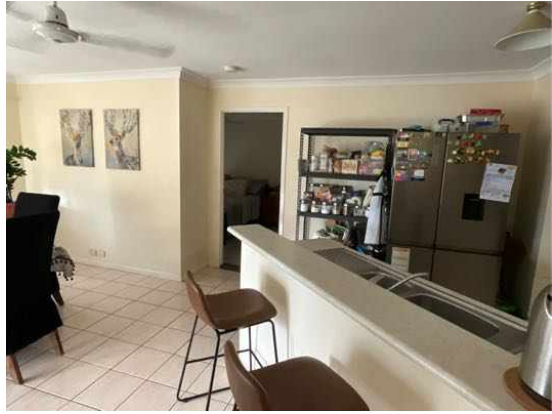
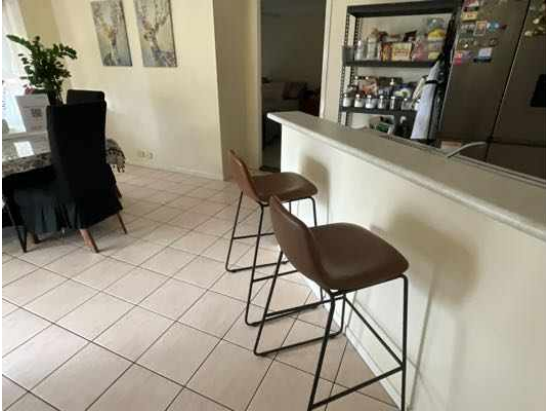
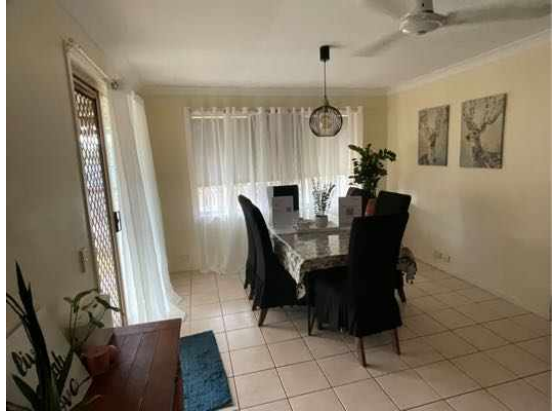
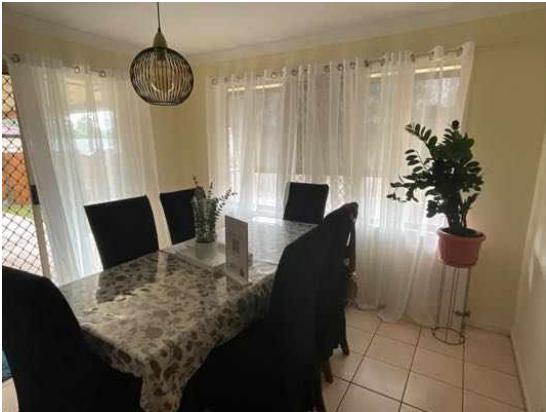
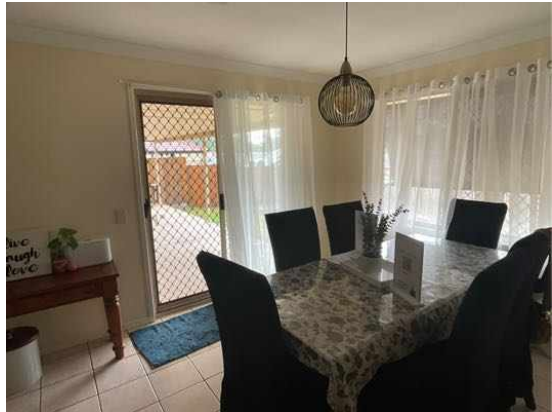
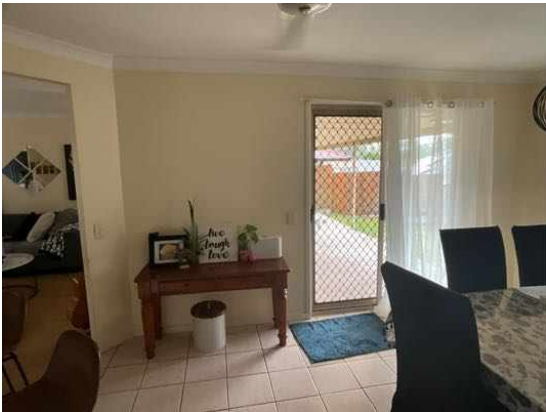
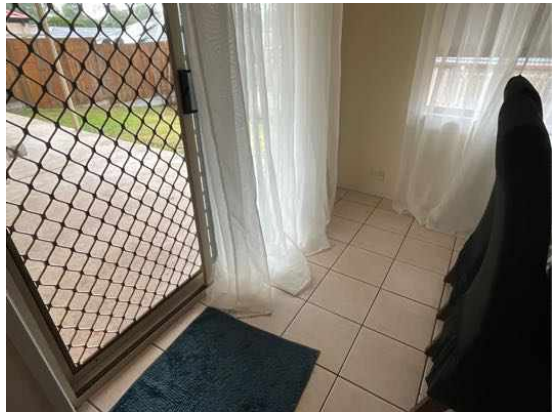
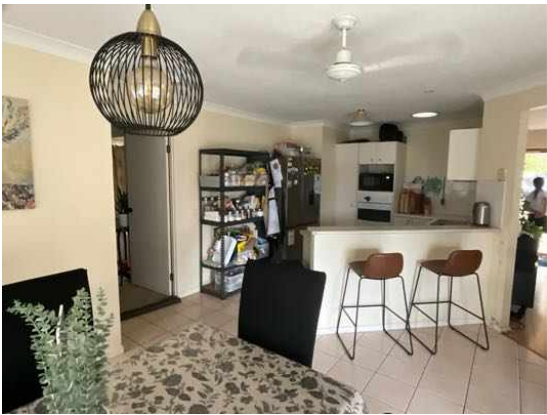
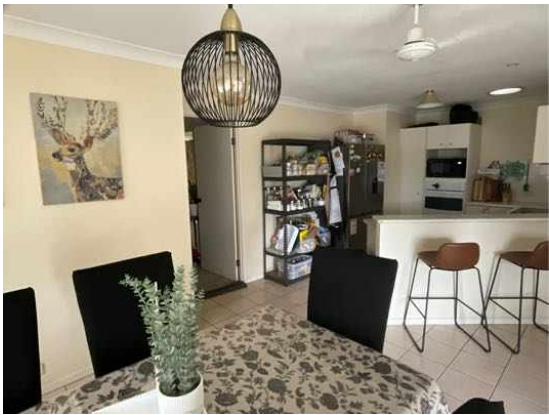
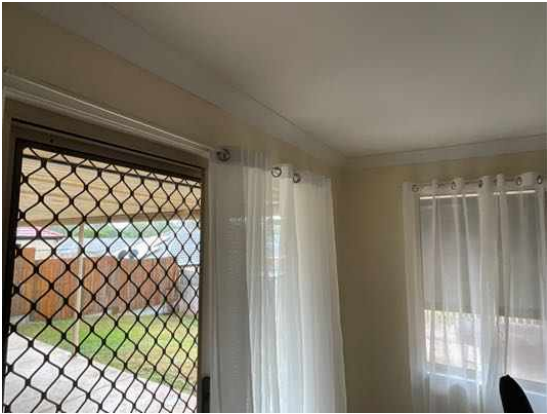
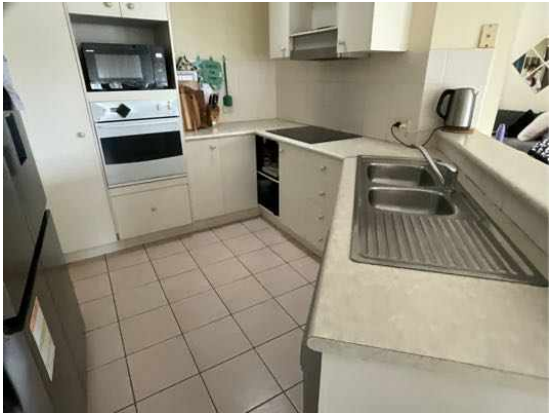
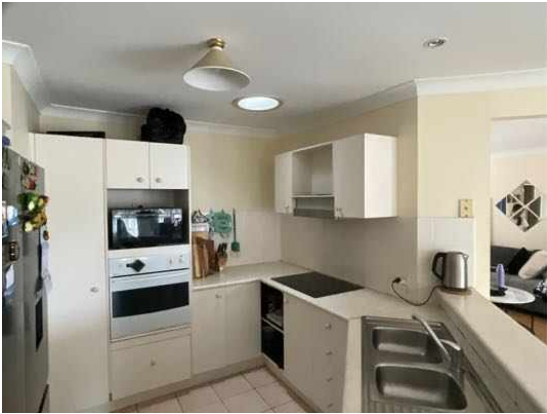
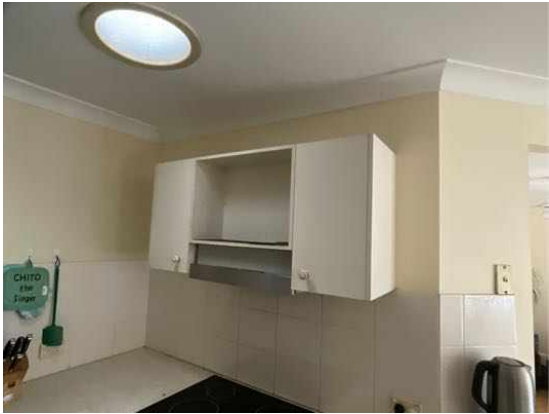
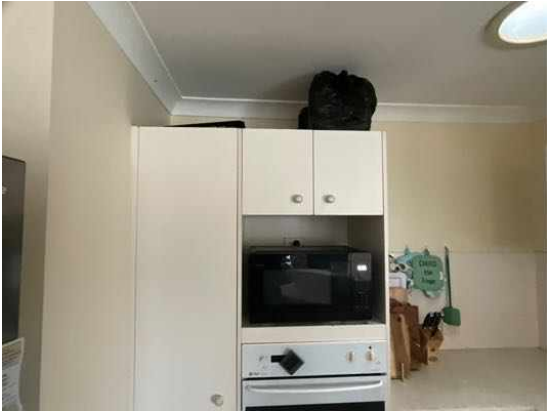
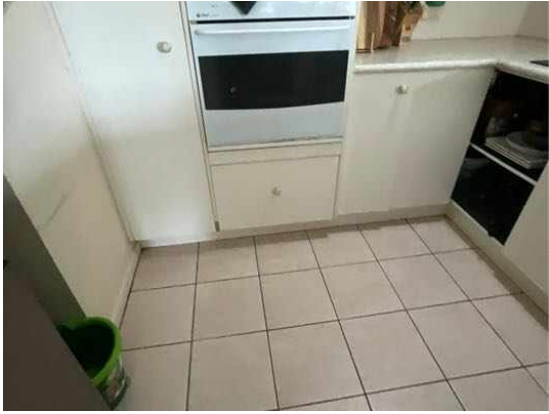
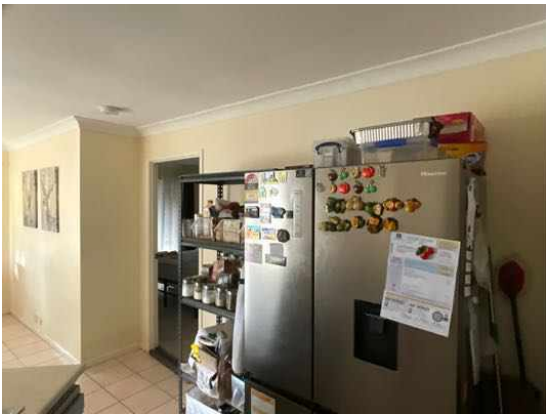
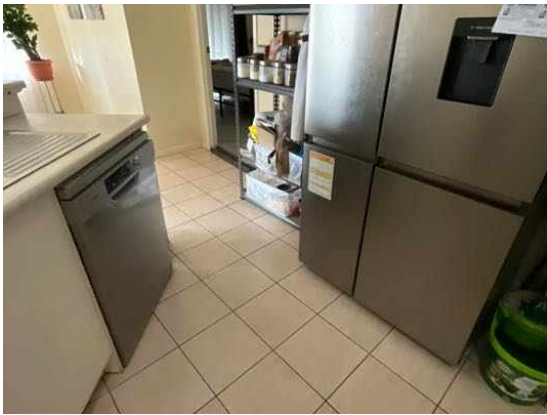
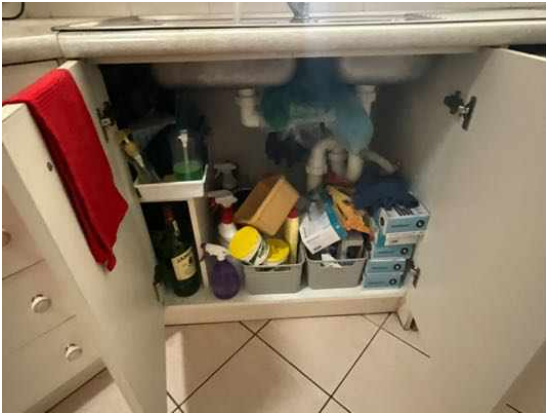
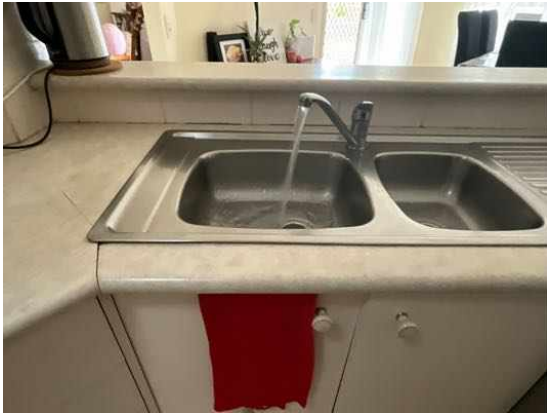
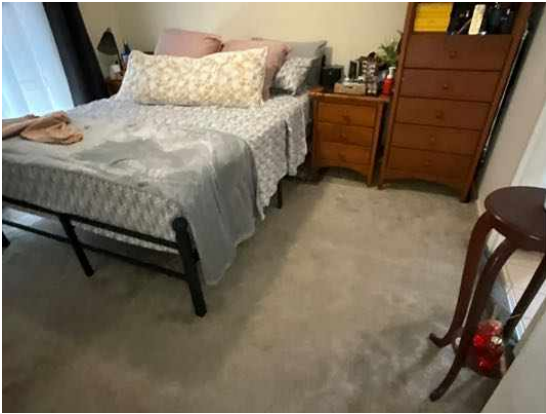
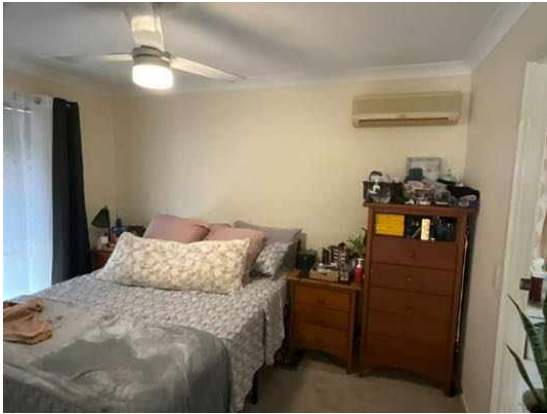
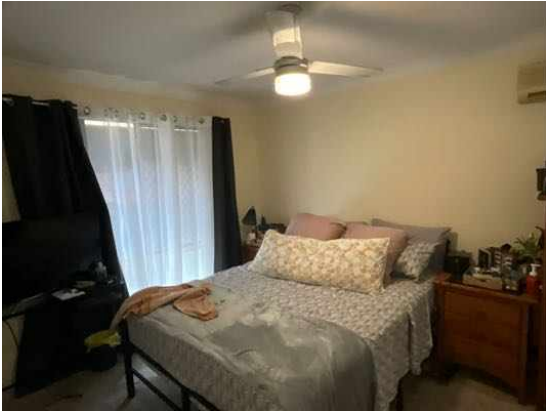
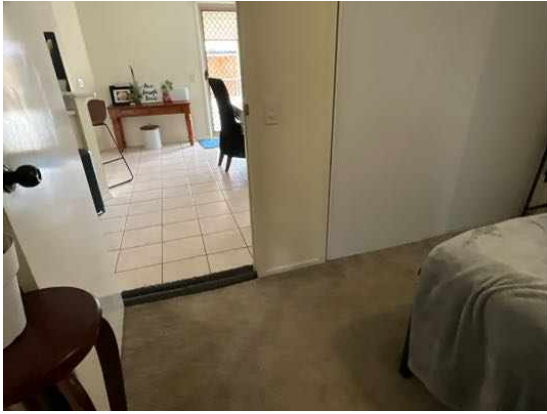
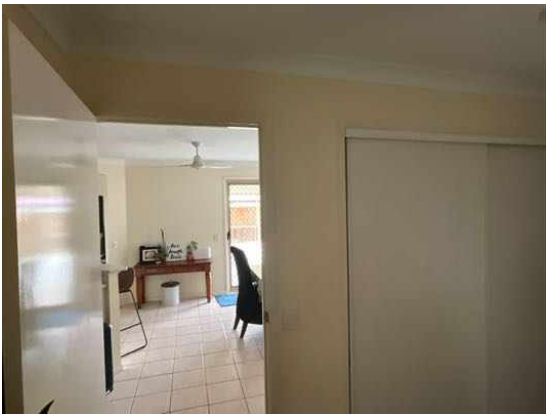
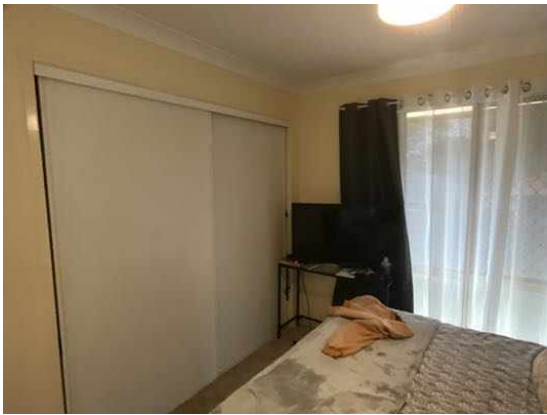
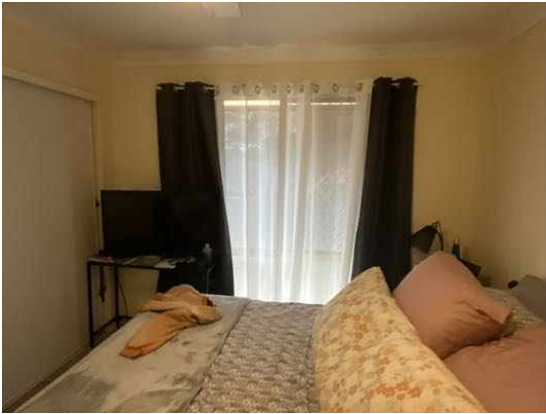
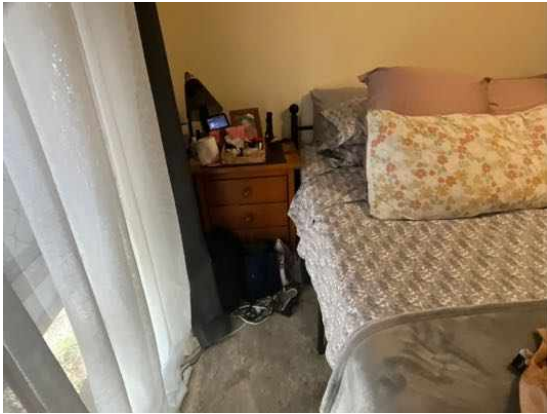
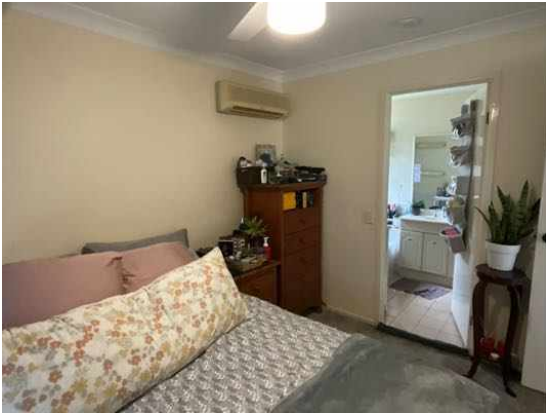
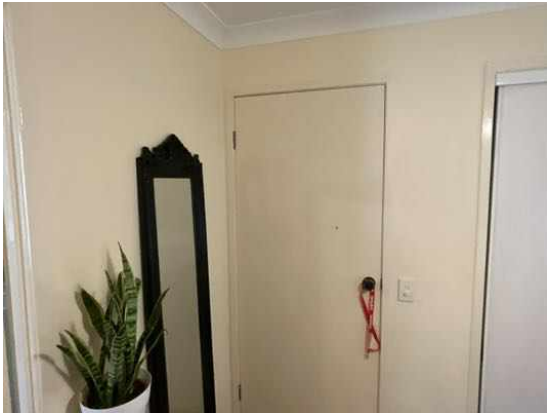
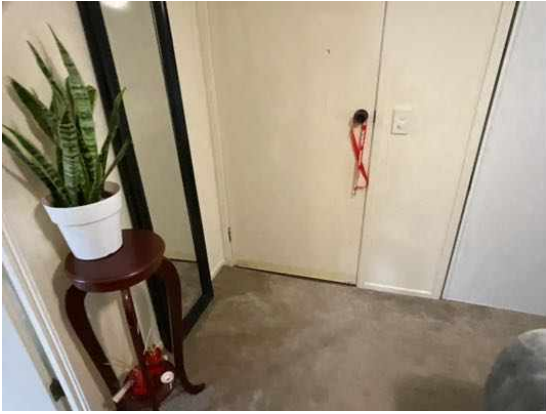
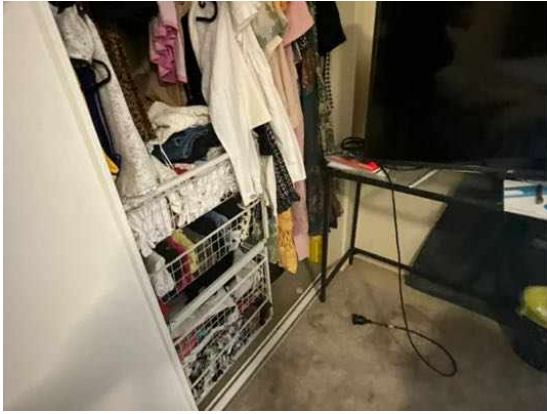
Building:	Main Building
Location:	All Areas
Finding:	Additional Photos - Obstructions and Limitations
Information:	These photographs are an indication of the obstructions and limitations which impeded full inspection of the property at the time of inspection. These obstructions can hide an array of defects and should be removed to allow full inspection to be carried out. A re-inspection is recommended once the areas are made accessible.

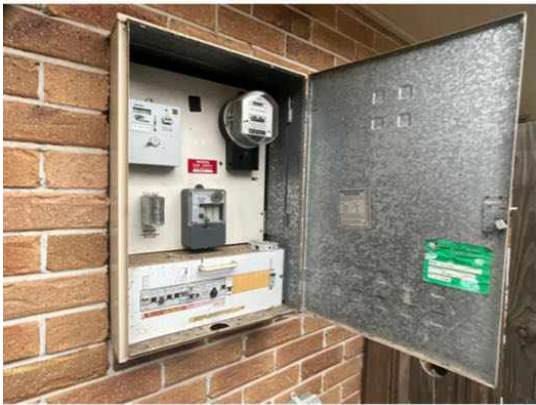
Building:	Main Building
Location:	Meter Box
Finding:	Termite durable notice present - out of date
Information:	The application of a post-construction chemical termite barrier is highly recommended for all properties.

The owner has provided the latest treatment as per photos attached.

The client may consider gaining further advice from a pest controller as to the costs and procedures involved with this application. It is recommended that obtaining such advice be a short-term priority.
