Building and Timber Pest Inspection Report

Inspection Date: Wed, 01 Apr 2026

Property Address: 24 Flinders St, Matraville NSW 2036,
Australia

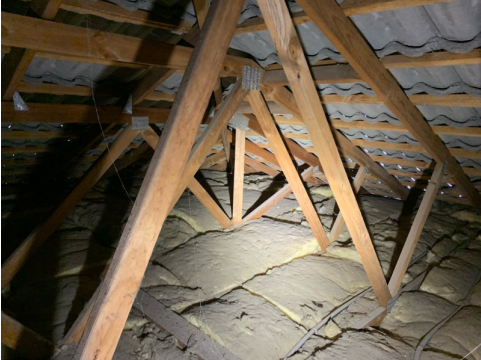
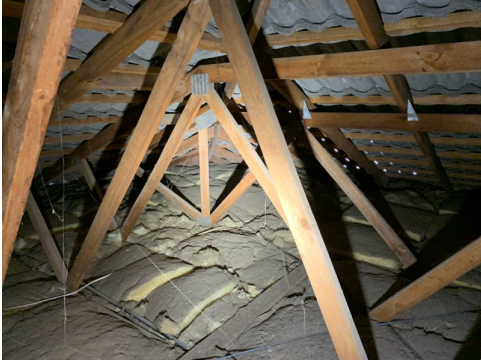
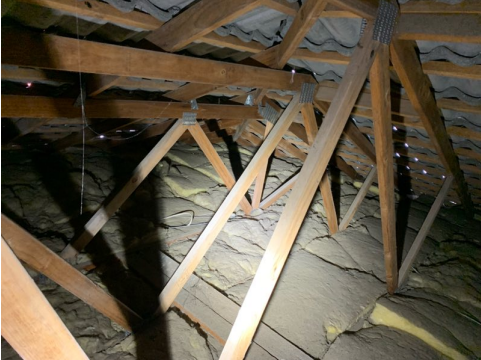
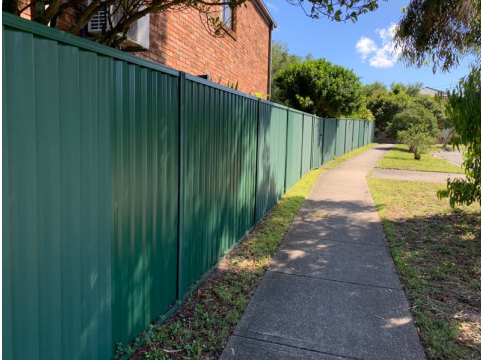
These photographs are an indication of the obstructions and limitations which impeded full inspection of the property at the time of inspection. These obstructions can hide an array of defects and should be removed to allow full inspection to be carried out.
