Building and Timber Pest Inspection Report VR

Inspection Date: Mon, 12 Jan 2026

Property Address: 78 Bingara Cres, Bella Vista NSW 2153, Australia

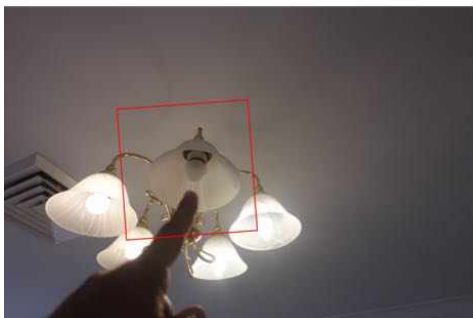
Building: Main Building
 Location: Living Room
 Finding: Down lights - missing
 Information: This light was found to be inoperable at the time of inspection.

It is advised to engage a licensed electrician to install such light.

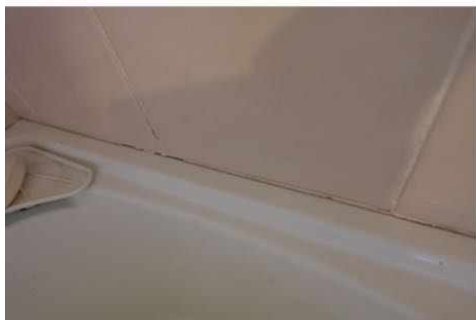
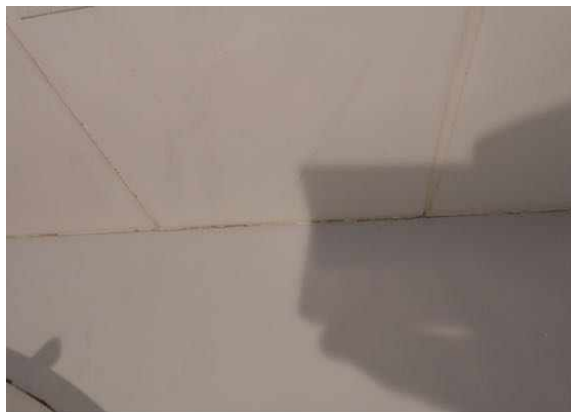
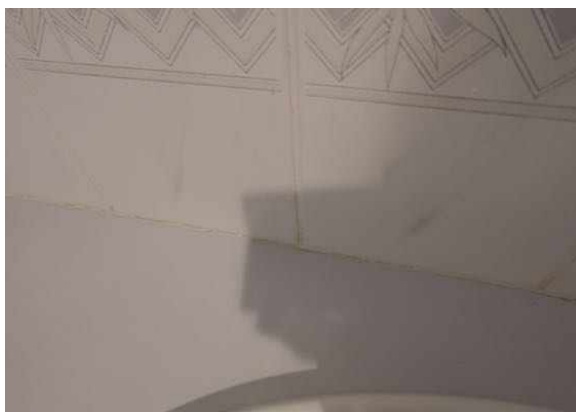
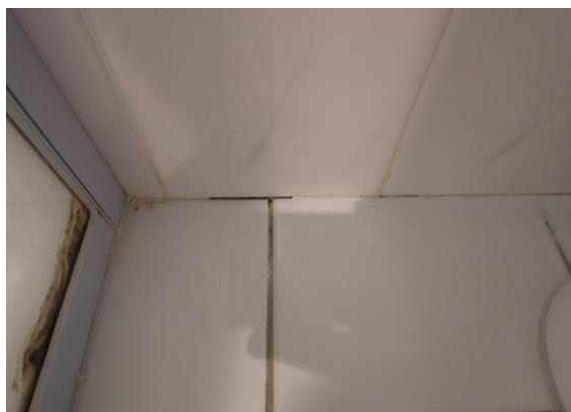
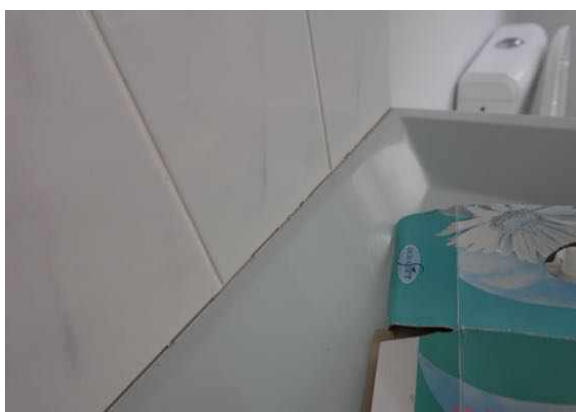
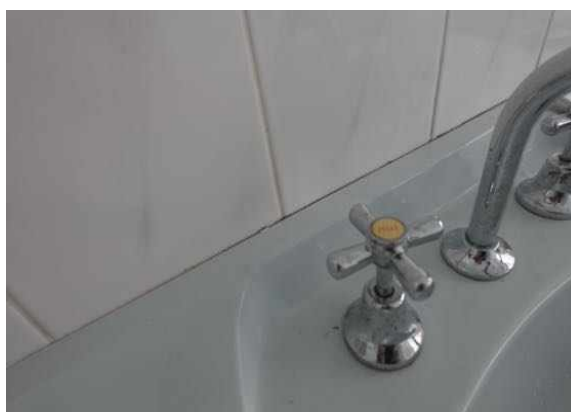
Finding 3.02

Building: Main Building
 Location: several wet areas
 Finding: Sealant and grouting - Inadequate
 Information: It was noted on inspection that sealant or grout is degraded to several wet areas. Different materials and floor areas move at different rates, generally causing cracking to grout or sealant at this point.

any subsequent water damage that is likely to occur. Regular maintenance and replacement of damaged or missing or damaged sealant and grout is highly recommended to the wet areas, as this is a regular wear and tear defect

Sealant and grouting in areas that come into regular contact with water should be maintained for the long term care of your property.

A licensed sealant specialist /licensed tiling contractor should be appointed to complete these works as soon as possible.

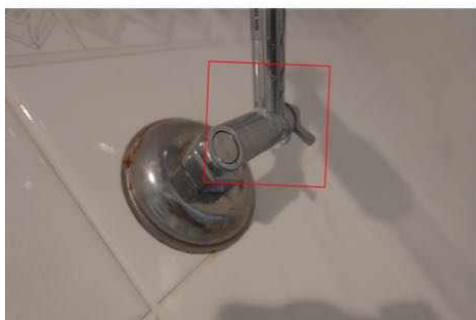
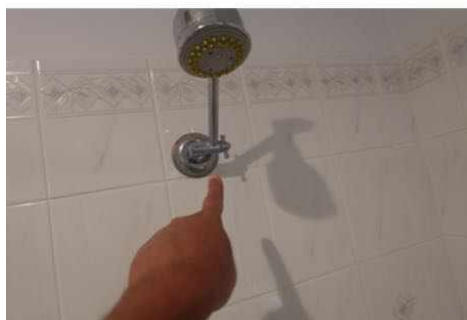
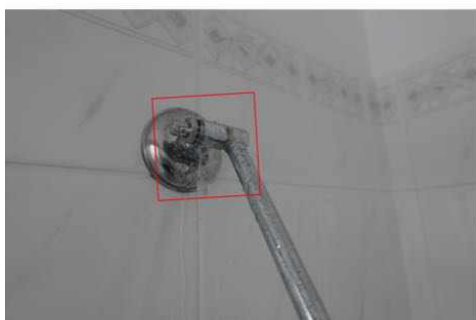
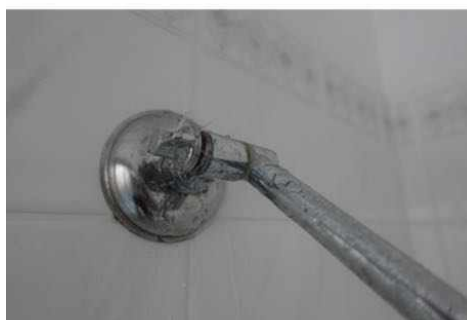
Finding 3.03

Location: Bathroom (both shower)
 Finding: Shower head - Loose
 Information: These taps have not been installed correctly, or has deteriorated with age, and is consequently loose.

Taps being loose creates potential for water leaks and subsequent water damage to the surrounding area.

Where taps or spouts are loose, a licensed plumber should be appointed to re-fix the plumbing fitting.

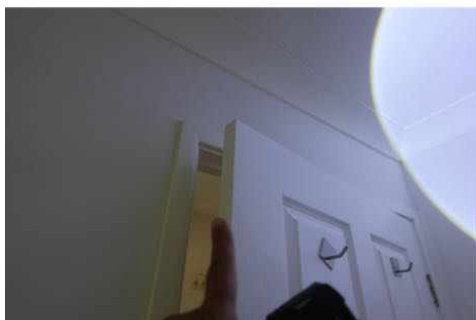
Finding 3.04

Building: Main Building
 Location: Bedroom - Master
 Finding: Door - Binding/jamming
 Information: Binding and/or jamming of these doors are evident during standard operation. This defect inhibits the functionality of the affected door as well as creating potential for secondary defects to associated building elements, such as damage to the floor covering.

A door that binds to flooring or to the associated door frame may have several causes, ranging from minor defects, such as poor installation of the door or

deteriorated hinges, through to major structural issues, such as damage to floor, door frames or subfloor structures if applicable.

Where door binding/jamming appears to indicate major structural issues, a registered builder should be appointed to provide an estimate on the cost of rectification.

For minor causes, a licensed carpenter should be appointed to perform minor rectification works at client discretion.

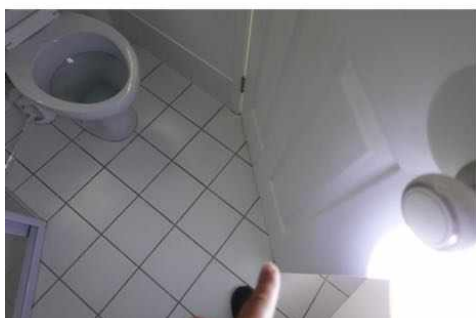
Finding 3.05

Building:	Main Building
Location:	Bathroom
Finding:	Door stop - Missing
Information:	The door stop was missing or is inadequate to stop the door handle from damaging the wall. Although some building elements may seem irrelevant or unnecessary, all building elements play a key role in the operation and function of the overall structure and its performance.

Re-installation or replacement of door stop is advised as soon as possible to prevent any subsequent damage to the door or associated structures.

A licensed carpenter may be appointed to perform these works at client discretion.

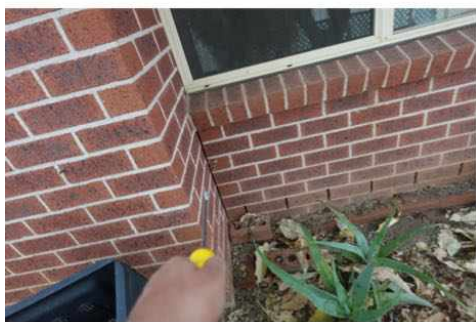
Finding 3.06

Building: Main Building
 Location: Brick Exterior
 Finding: Articulation joints - not sealed
 Information: The articulation or control joints throughout the exterior brickwork were not sealed.

The joint must be sealed with silicon to avoid any water penetration.

It is advice to use a sealant expert to carry out necessary work.

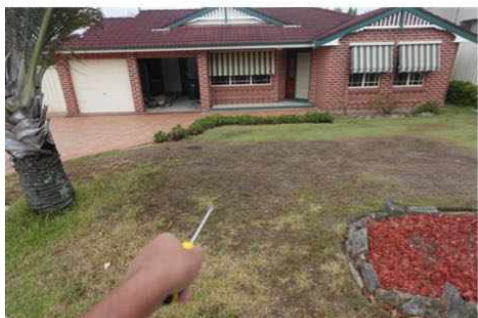
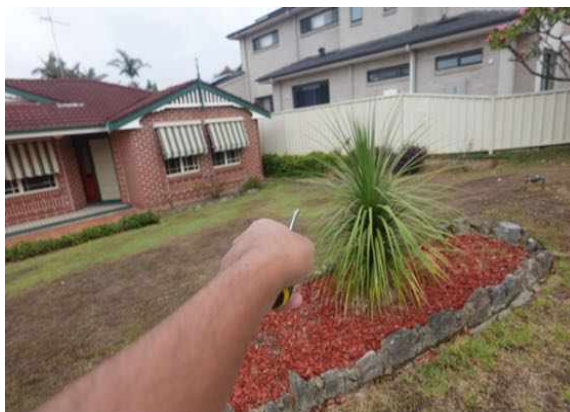
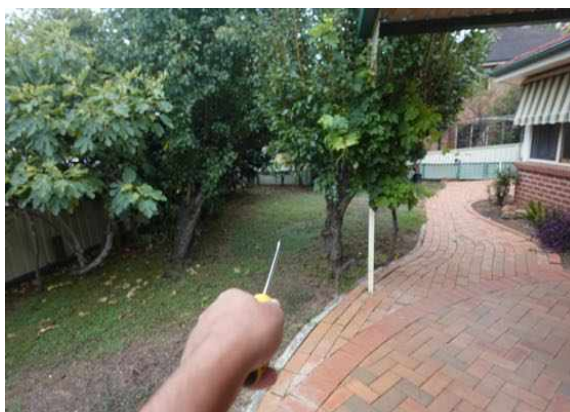
Finding 3.07

Building: Main Building
 Location: Building surrounding
 Finding: Site drainage - Inadequate
 Information: The site drainage in this area was found to be inadequate at the time of inspection, creating potential for subsequent water damage to associated building elements.

Where site drainage is inadequate, installation of an Agricultural (Aggie) Drain may be required. A licensed plumber should be appointed to further inspect the property and perform any remedial works as necessary. Water damage and secondary defects are likely to occur if left unmanaged.

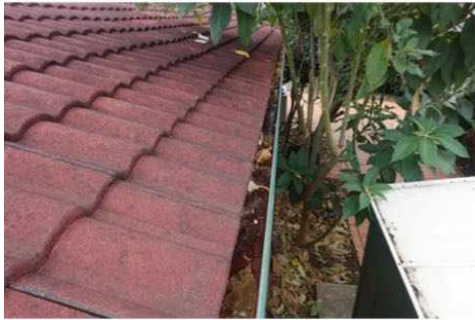
Finding 3.08

Building: Main Building
 Location: Roof Exterior
 Finding: Gutters - Blocked
 Information: Roof plumbing structures, such as guttering and downpipes, should be free of all debris to prevent blockages. Blockages of the guttering and downpipes will lead to pooling and accumulated water overflows, which is likely to subsequently flood eaves and exterior walls.

Blocked gutters are likely to lead to high levels of moisture in the affected areas. Such moisture will not only cause rust and decay of the associated building materials, but can also provide conditions that are conducive to termite and timber pest activity. Blockages in gutters should therefore be removed immediately to ensure dry conditions are maintained.

Consult a Licensed Plumber for further specific advice on remedial works that may be

required.

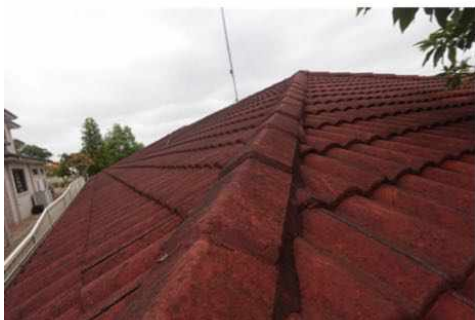
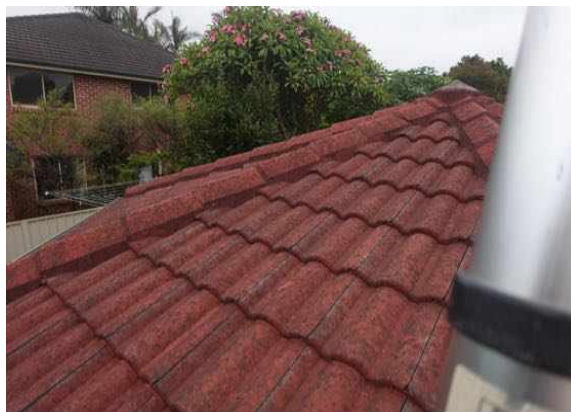
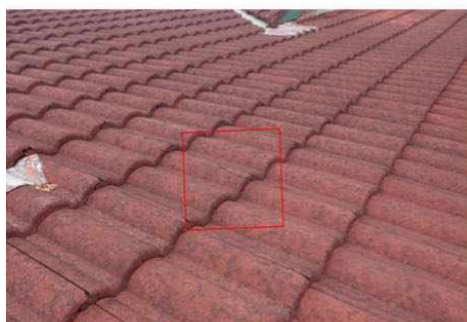
Finding 3.09

Building:	Main Building
Location:	Roof Exterior
Finding:	Roof tiles - Weathered
Information:	Upon inspection of the exterior roofing, the majority of roof tiles were considered to be in a fair condition. While weathering of the tiles is consistent with the age of the property, maintenance works are required.

Isolated areas of mortar have come loose in the valleys and minor cracking is also present. Re-pointing and re-sealing the may be considered as an interim solution by the client to help preserve and extend the life span of the tiles.

Where left unmanaged, deteriorating roof tiles are likely to lead to a number of secondary defects, including minor water leaks and weather exposure to internal roofing structures.

Consultation with a licensed roofing contractor is highly advised to gain advice on cost of remedial works that may be required in the short to medium term. Remedial works are likely to increase the longevity of the exterior roofing structure.

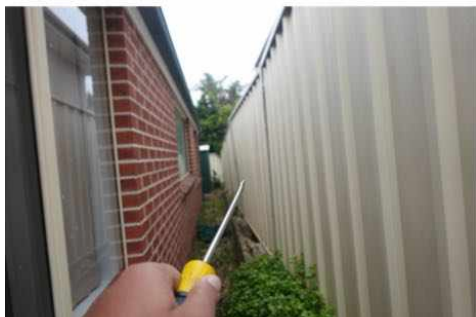
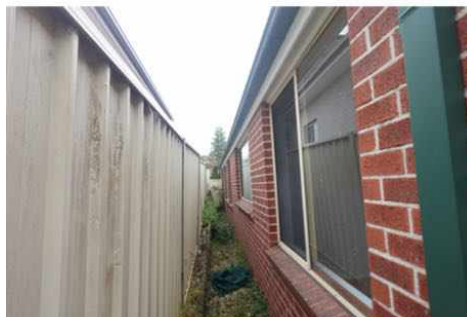
Finding 3.10

Building:	Main Building
Location:	Fencing
Finding:	Fencing - Deteriorated/leaned
Information:	It was noted at the time of inspection that some sections of the fencing throughout the property have leaned. Typically fencing deteriorates/leans due to age and or wear, rot and or rust and or due to vegetation which is generally expected for a structure of this age, due to prolonged exposure to weather conditions. Sometimes inadequate installation or maintenance can be to blame.

If left unattended, it is likely that further damage will occur. It is suspected that repair of several elements of the fencing may be required however replacement may be a

consideration of the client also.

A licensed fencing contractor should be appointed to provide further advice and perform rectification works as necessary.

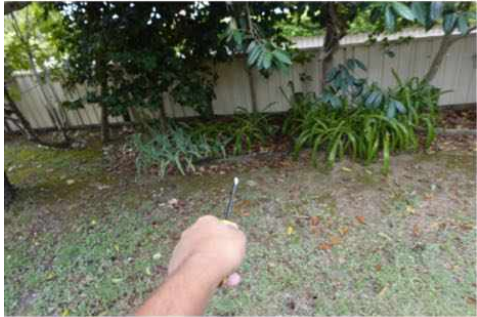
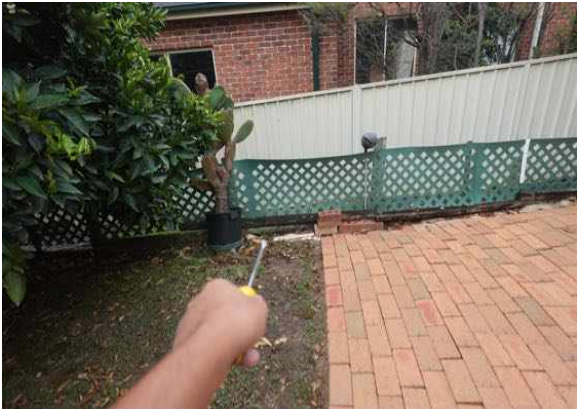
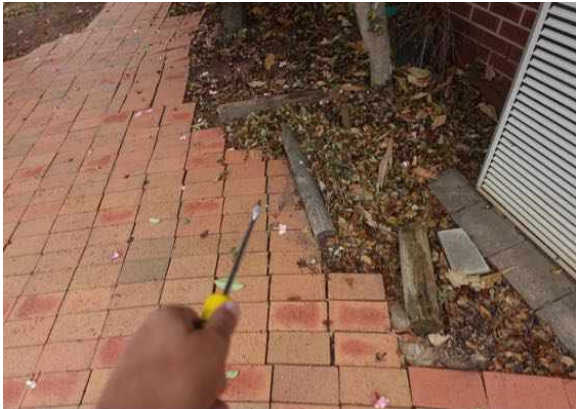
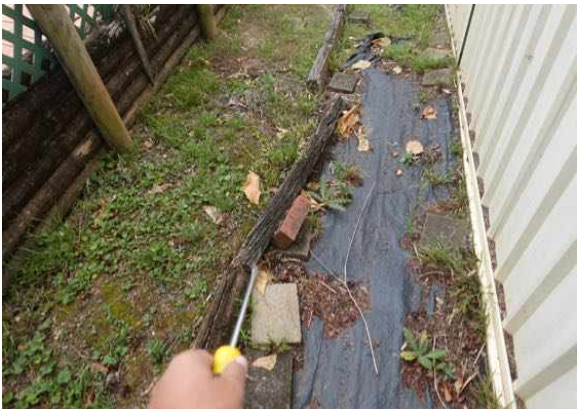
Building:	Main Building
Location:	Several external areas
Finding:	In ground contact
Information:	Any timbers in direct ground contact provide opportunity for concealed termite entry and are likely to be subject to premature rot and decay as the soil retains moisture or damp conditions against the timbers.

Remove untreated timber that is in direct contact with external grounds. Consider replacement with more durable materials i.e. treated timber or non timber elements. Frequent pest inspections are advised to readily identify any termite activity in these areas.

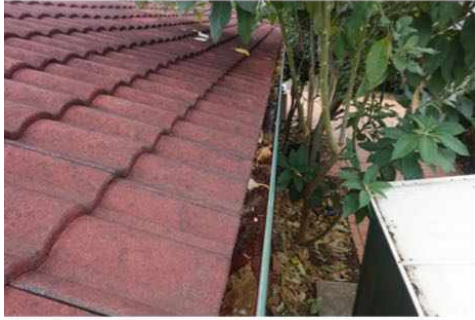
Finding 6.02

Building: Main Building
 Location: Several external areas
 Finding: Bridging - Vegetation
 Information: Where vegetation obstructs inspection of building elements, also known as bridging as it provides a bridging point for the access of termites, full inspection can not be achieved. Consequently moisture or dampness may be present and the areas becomes conducive to termite activity. Plants against or very close to buildings provide cover, shade and can provide an environment that is attractive to termite infestation.

existing vegetation will assist greatly in preventing Bridging from occurring.

The removal of any such materials that may be conducive to termite activity should be carried out as soon as possible and arrange re inspection to minimize the risk of termite attack.

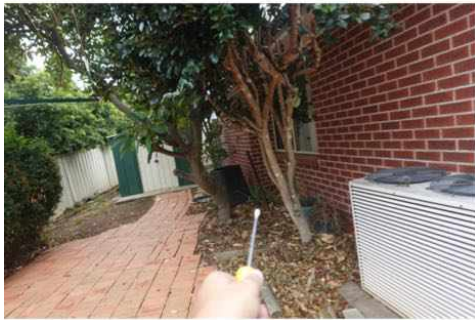
Finding 6.03

Building:	Main Building
Location:	Several external areas
Finding:	Garden Beds - Conditions Conducive to Termites
Information:	Garden beds were found to be evident in the garden area. These garden beds can include untreated timber, and with a combination of moisture from watering hosing can make conditions conducive to termite activity and termite ingress.

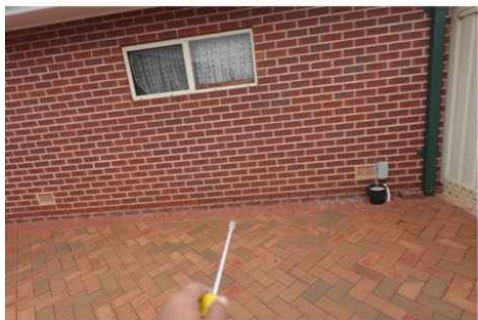
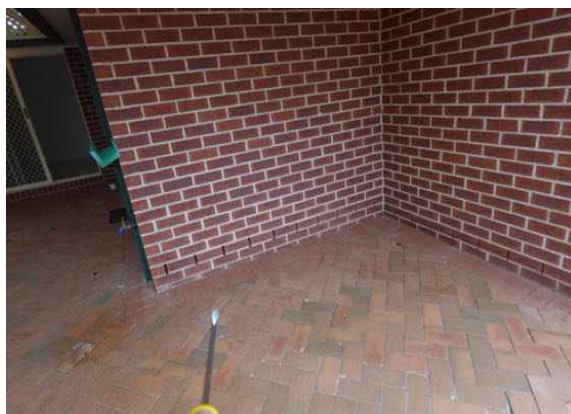
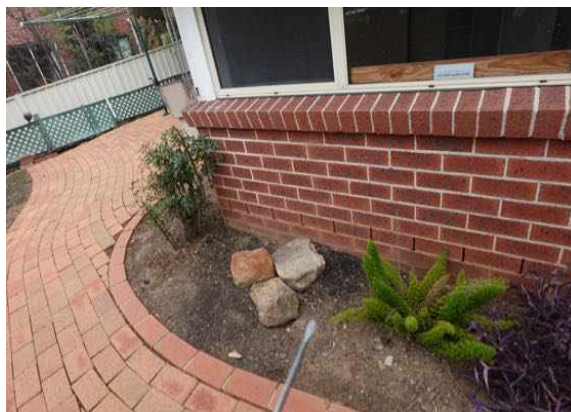
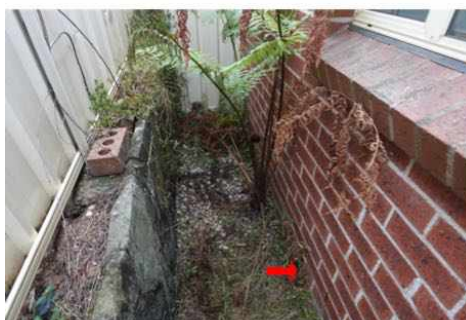
Finding 6.04

If the slab edge is not properly exposed there is a high risk of termite attack. Sometimes, in order to determine the type of slab, a suitably qualified person such as an architect or builder may be required to consult the construction plans.

Where the slab edge cannot be properly inspected, it is highly recommended that termite or timber pest inspections be carried out every 6-12 months to aid protection of the property against infestation.

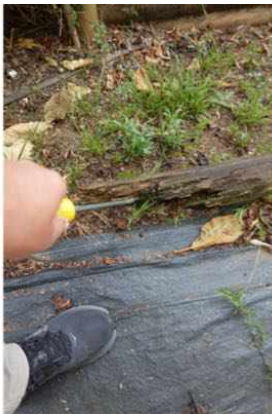
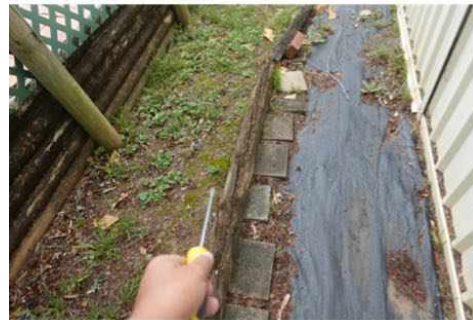
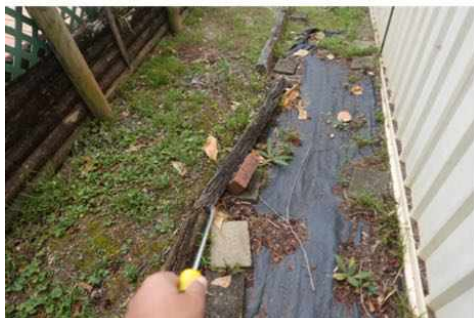
Finding 7.01

Building:	Main Building
Location:	External timber elements
Finding:	Wood rot
Information:	This building element shows evidence of wood rot. Wood rot, also known as Fungal Decay, occurs when timbers and other cellulose building materials are exposed to damp conditions on an ongoing basis. This could be the result of exposure to weathering over a prolonged period of time, or the attraction of excessive moisture

Wood rot is often associated with general damp problems and is evidenced by a 'musty' smell or mould and mildew occurring on surfaces. If left unmanaged, damp conditions can lead to further health problems and the decay of timbers will continue.

Early intervention and regular maintenance, particularly of exterior timbers, will prolong the useful life of these building elements. Prior to any works being performed, the cause of the moisture that has created the visible wood rot should be identified and addressed in a suitable manner. Replacement of affected timbers may then be a necessary step in protecting surrounding building elements from such deterioration.

A licensed plumber may be appointed to assess the cause of excessive moisture and to provide advice on any remedial works as required. A licensed carpenter or registered builder may also be required to replace affected building materials.

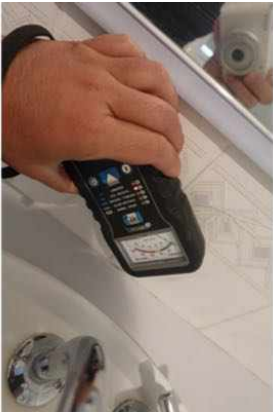
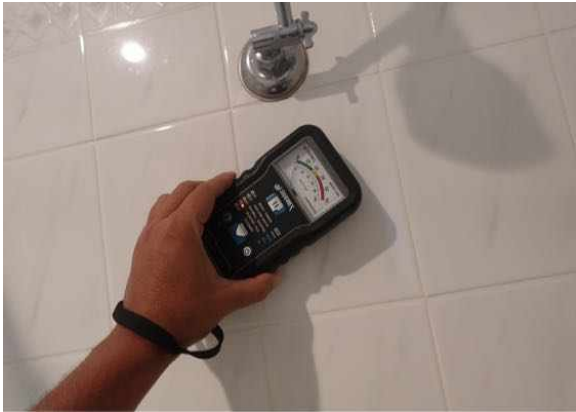
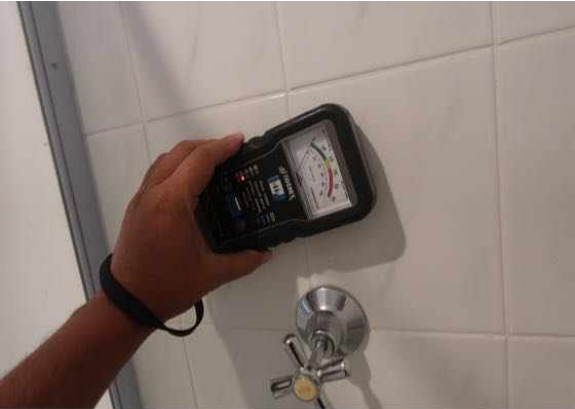
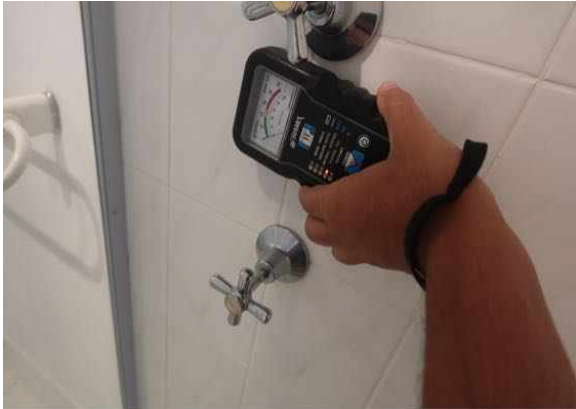
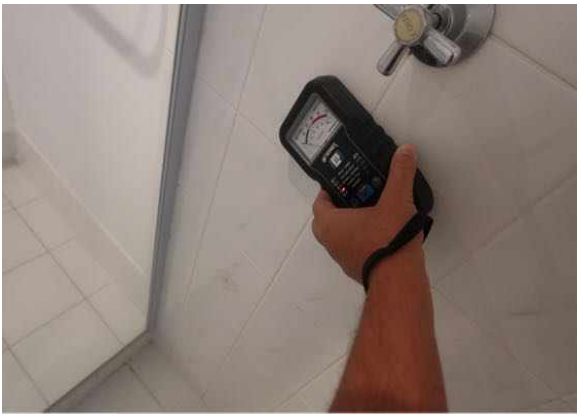
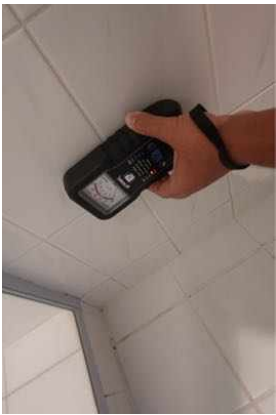
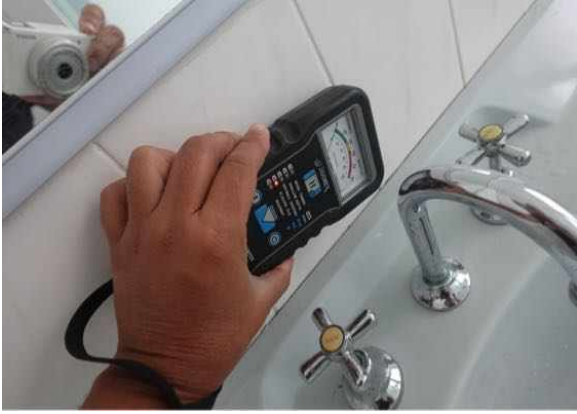
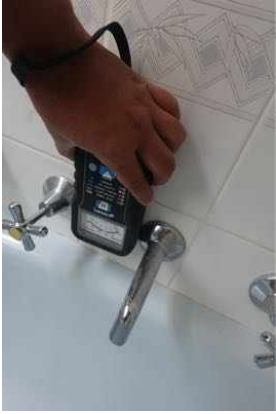
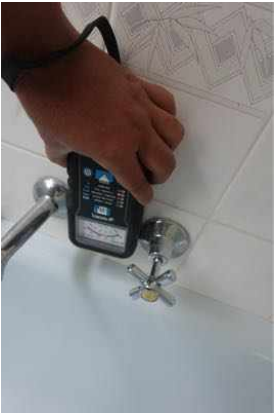
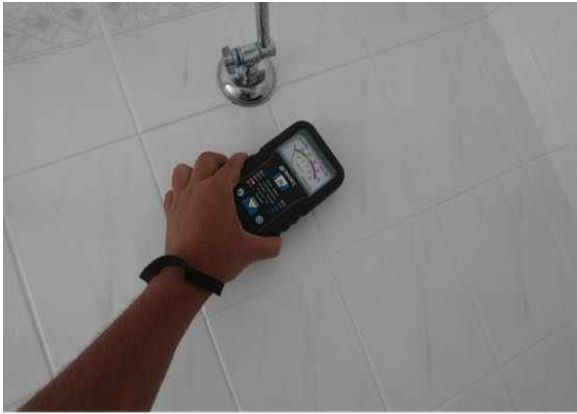
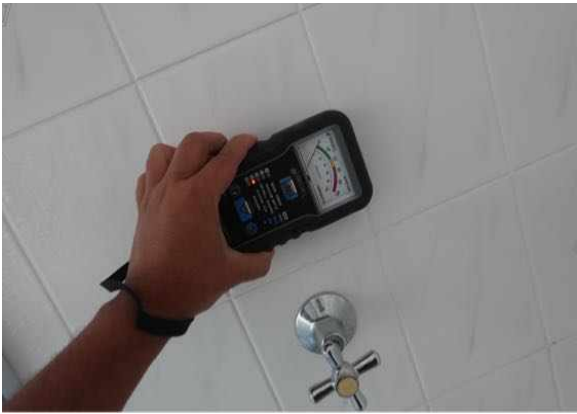
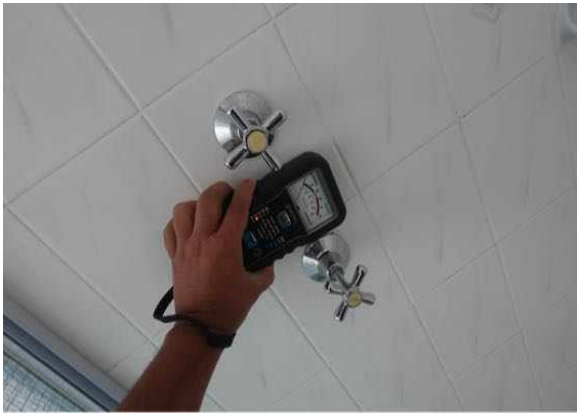
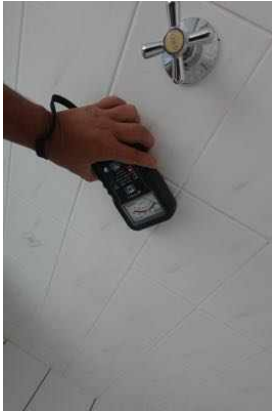
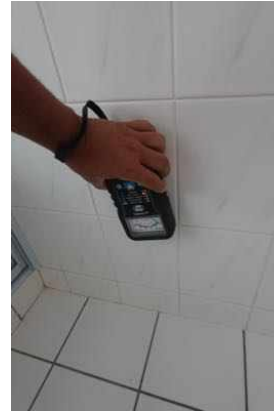
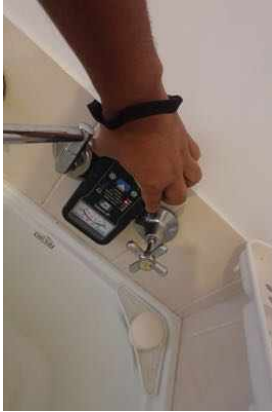
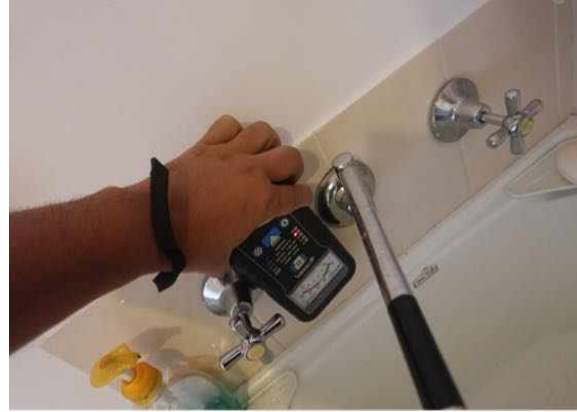
Building: Main Building
Location:
Finding: Moisture check
Information: During inspection, moisture meter was used and no high moisture detected at the time of inspection.

Please note if the wet areas have not been used for some time, moisture readings would not vary significantly and this can lead to erroneous results.

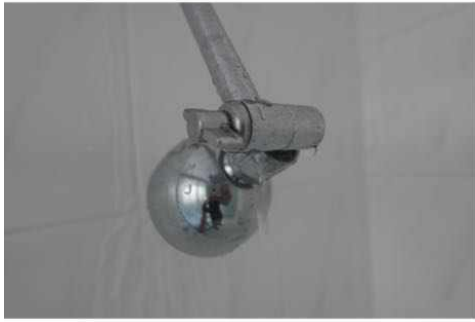
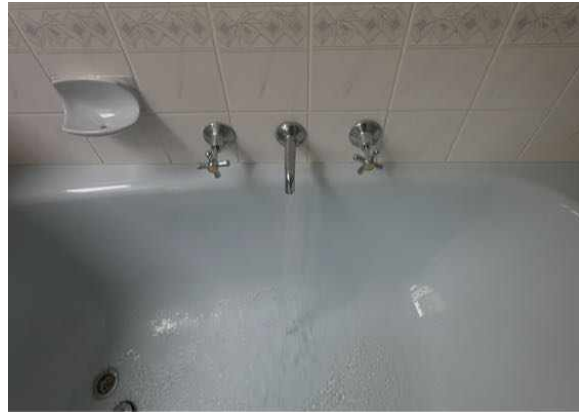
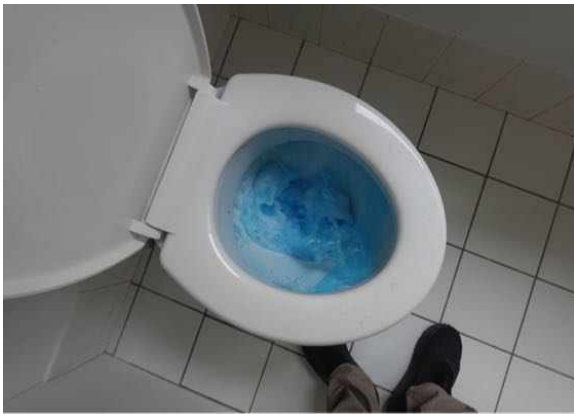
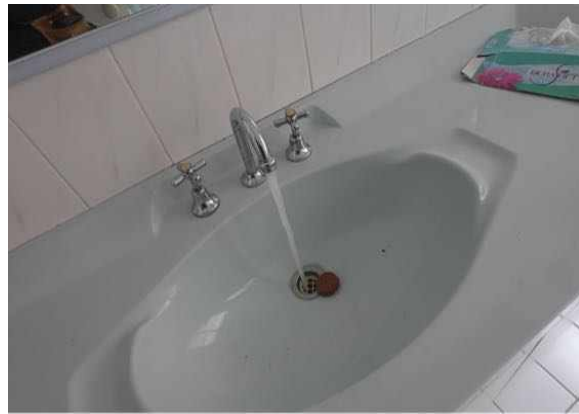
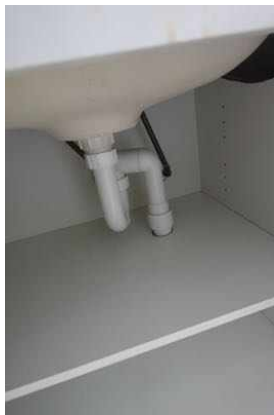
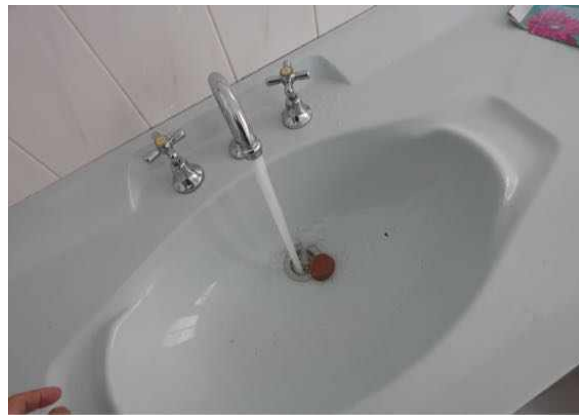
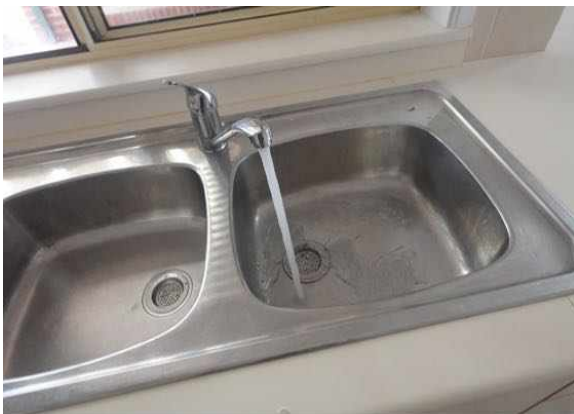
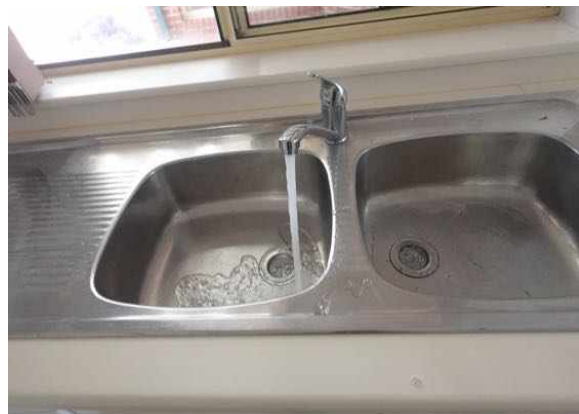
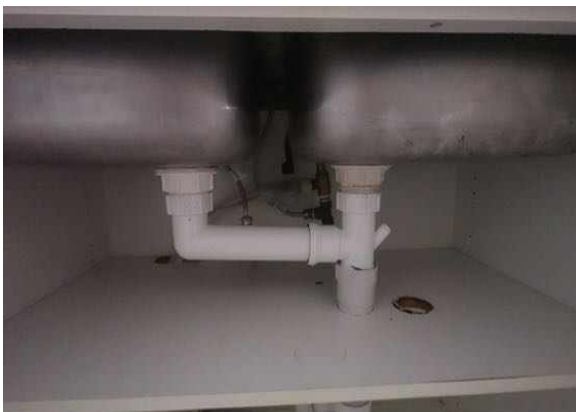
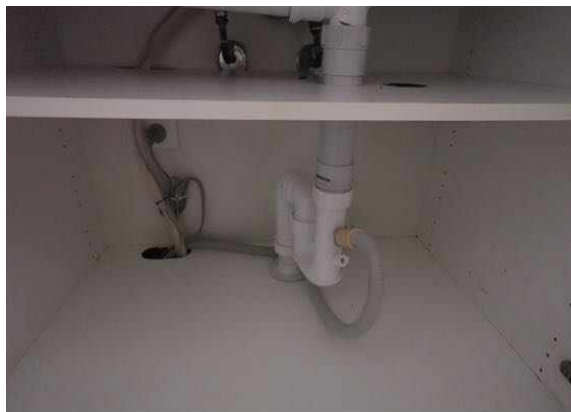
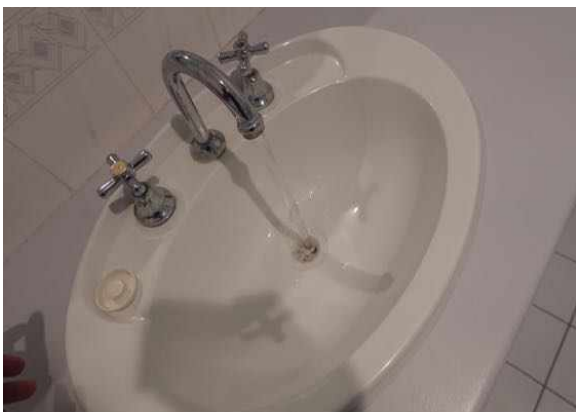
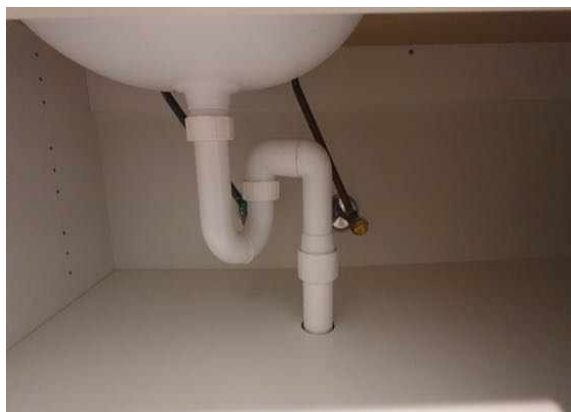
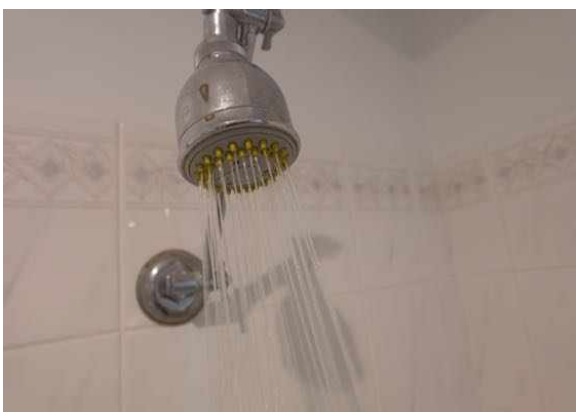
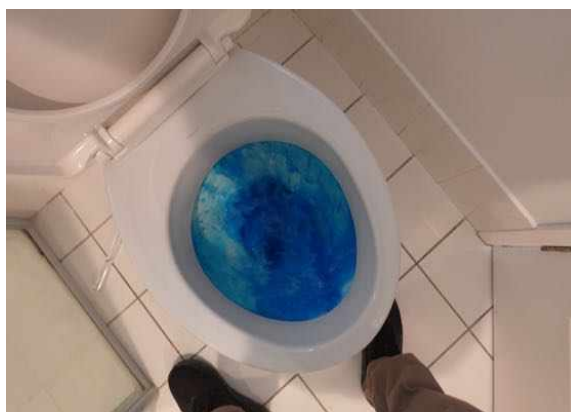
Building:	Main Building
Location:	All internal areas
Finding:	Taps, toilets and sinks tested : Visual only
Information:	Taps, drainage and toilets were checked for water flow and drainage was checked for leakage.

Unless identified in a separate defect, no remedial work appears to be required on these items at the time of the inspection.

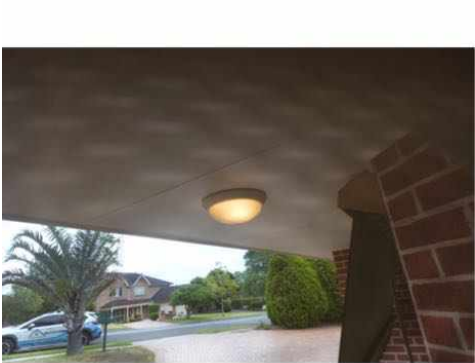
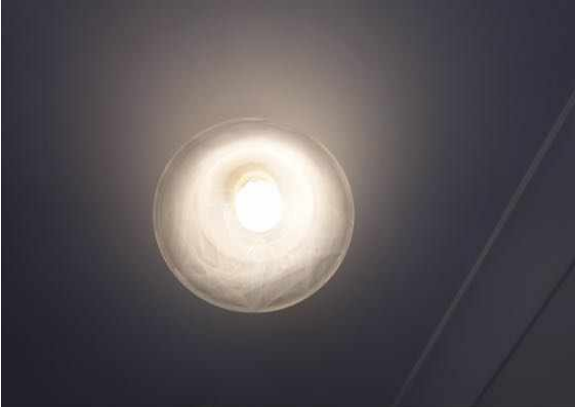
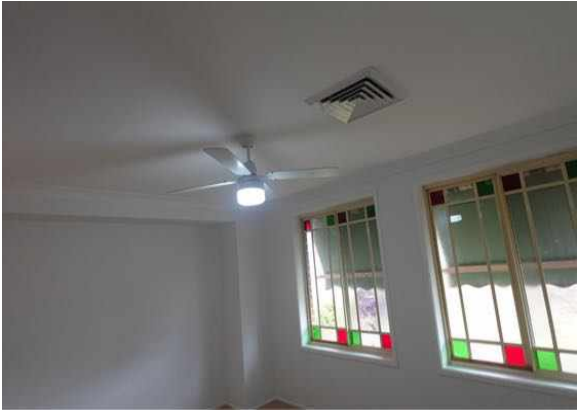
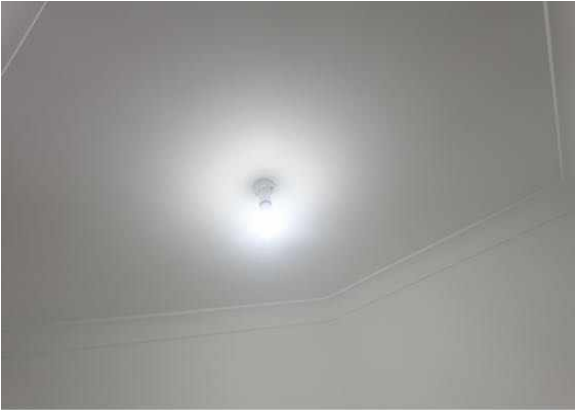
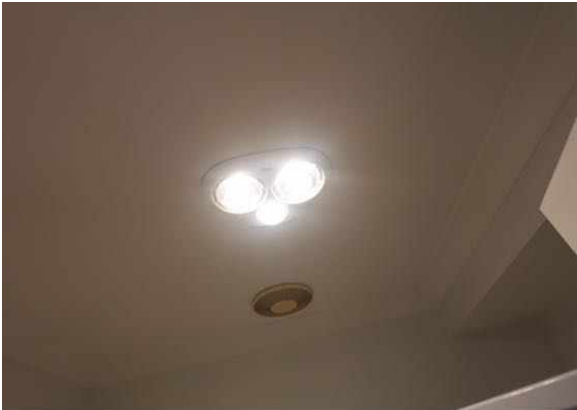
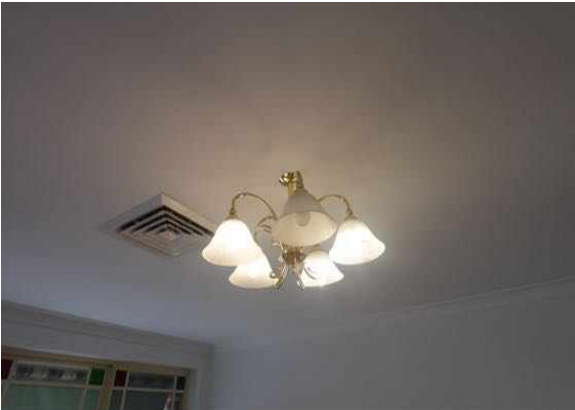
Building: Main Building
 Location: All Lights
 Finding: Electrical switches and light tested : Visual only
 Information: Electrical inspections are outside the scope of the building inspection and must be conducted by a Licensed and registered Trades person.

Whilst we note and comment of visually apparent defects that present during the building inspection, legislation requires the checking and documenting of compliance for plumbing and electrical requirements be done by licensed electrician to ensure they are functioning correctly.

It is highly recommended that the client makes arrangements to have the electrical checked by a licensed tradesperson to ensure that they are working safely and efficiently.

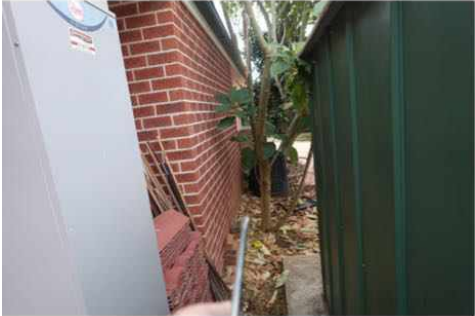
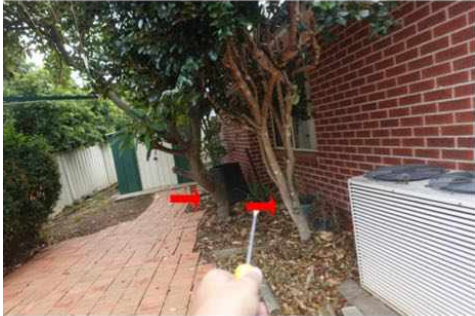
Building: Main Building
 Location: Yard :
 Finding: Local trees and vegetation : to wall exterior
 Information: Trees and other vegetation can have a significant local effect on drying of soils. Over a number of years, especially during drought conditions, adjacent trees and vegetation may draw excessive moisture from the soils. The opposite may also occur, where swelling of the soil results when the trees decline or are removed.

As the cumulative moisture deficient is reversed, the surface level around the tree will rise and expand laterally. This is often damaging to buildings unless the foundations have been strengthened or designed to cope with the effect.

Subsidence can have complex and varying causes, which will influence the required remedial works.

It is advised to monitor such trees and if necessary removal may be necessary.
