Building and Timber Pest Inspection Report VR

Inspection Date: Mon, 12 Jan 2026

Property Address: 78 Bingara Cres, Bella Vista NSW 2153, Australia

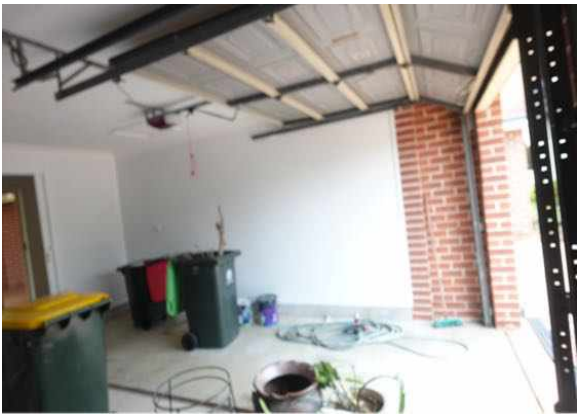
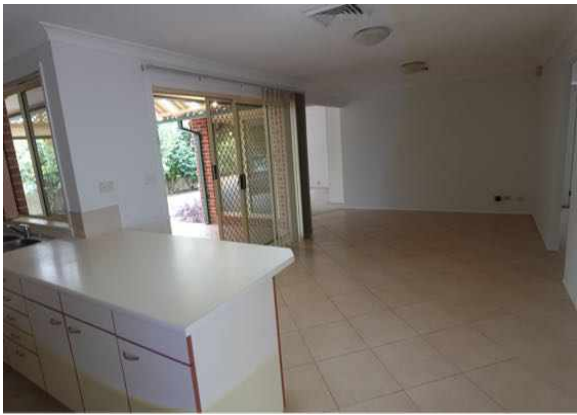
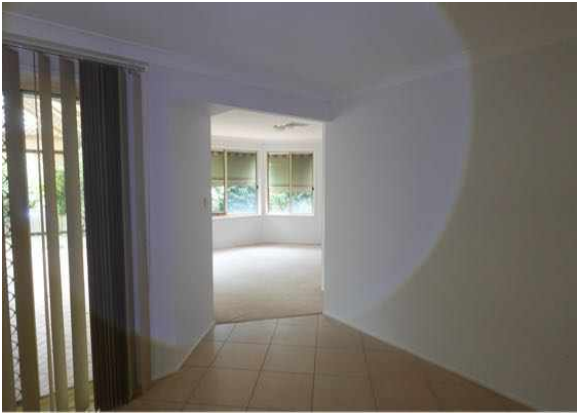
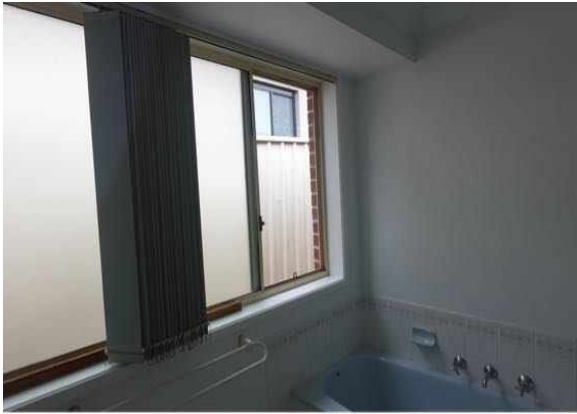
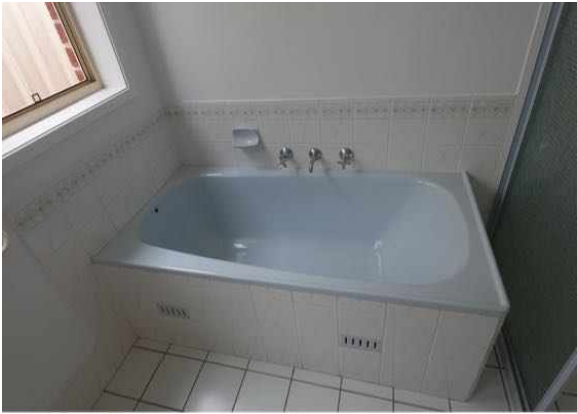
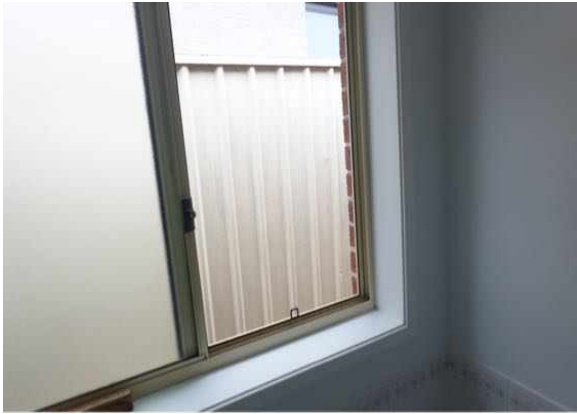
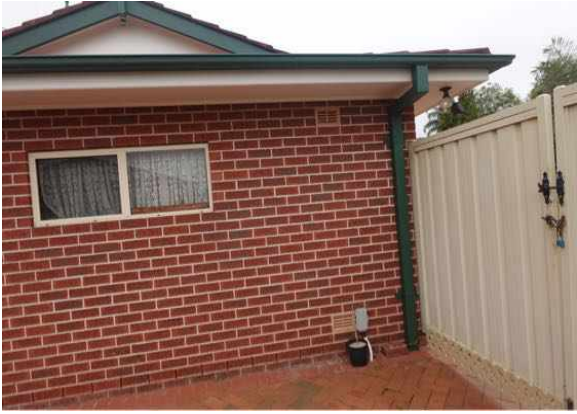
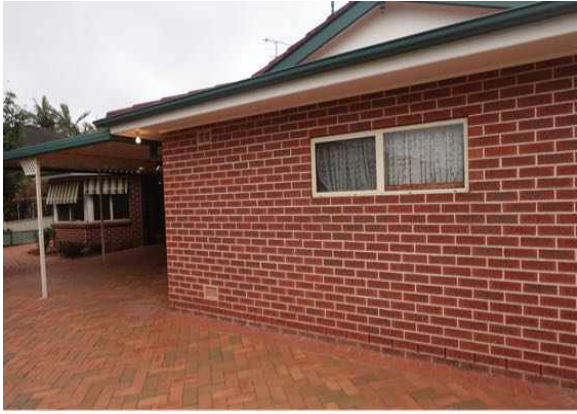
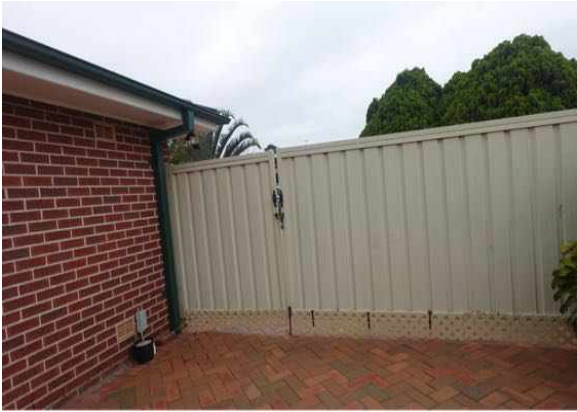
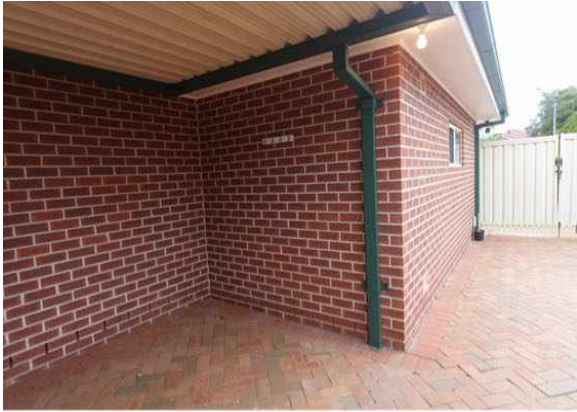
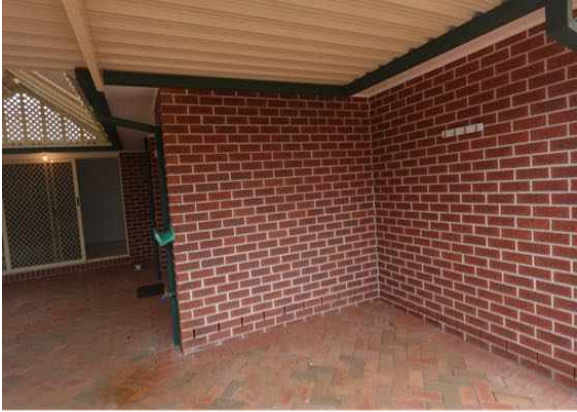
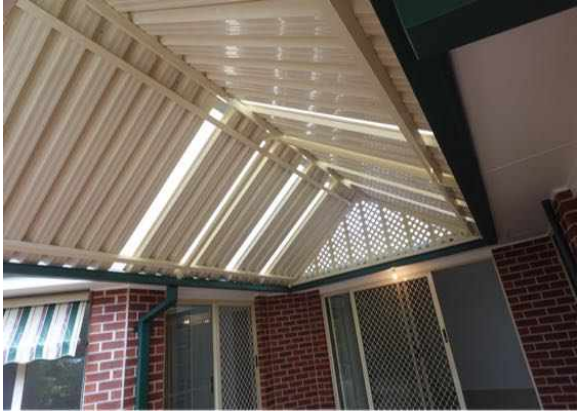
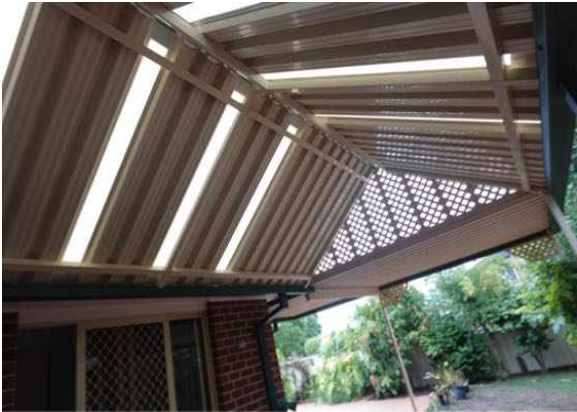
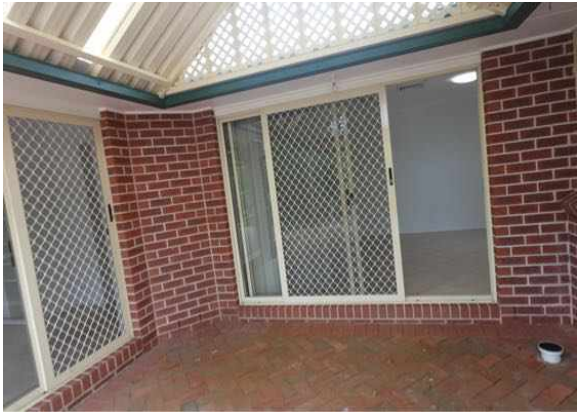
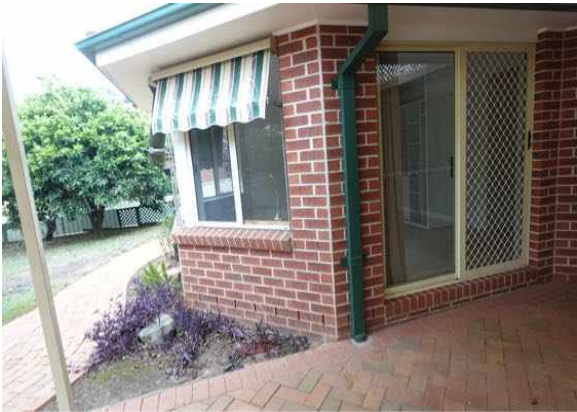
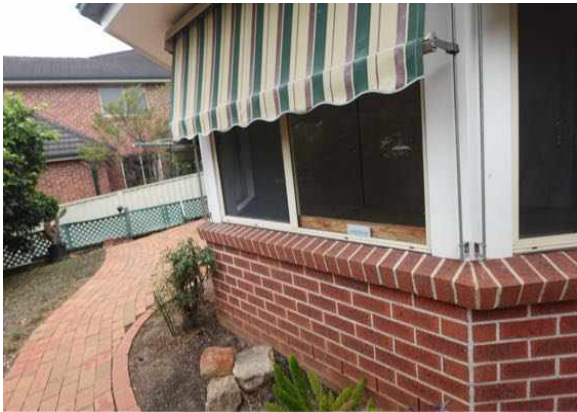
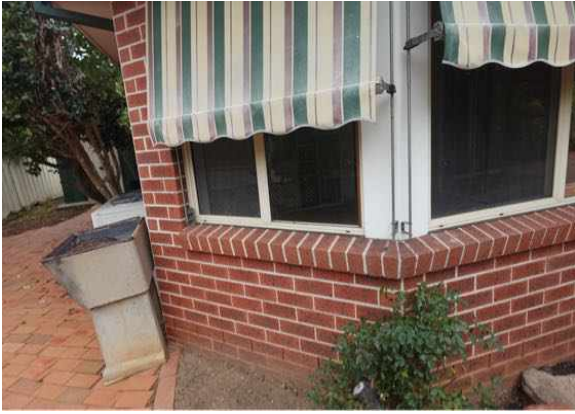
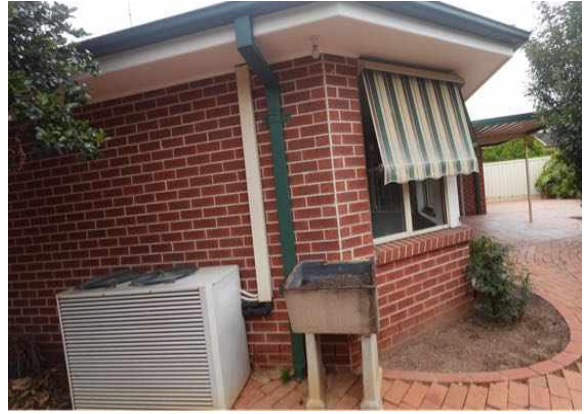
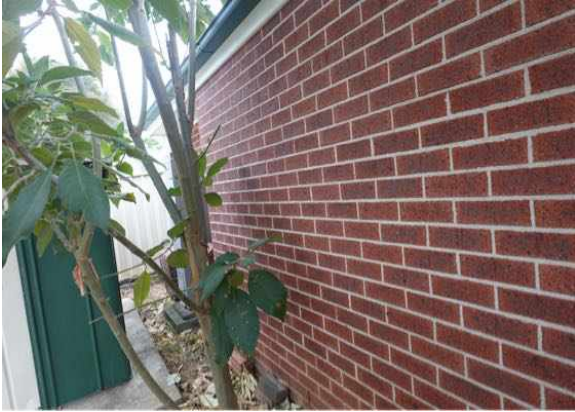
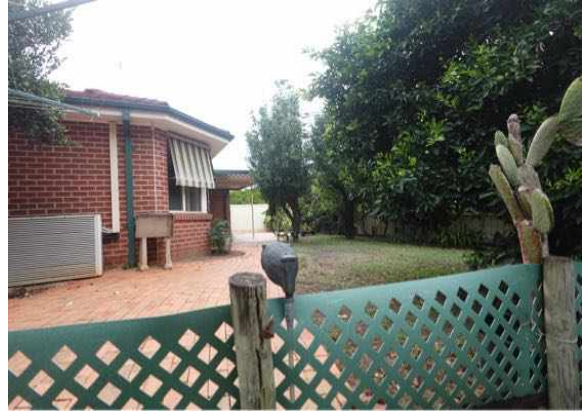
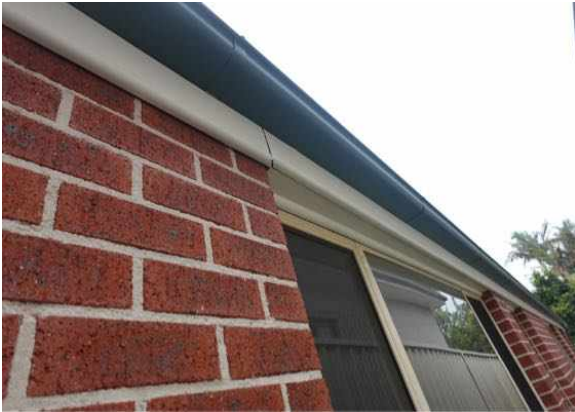
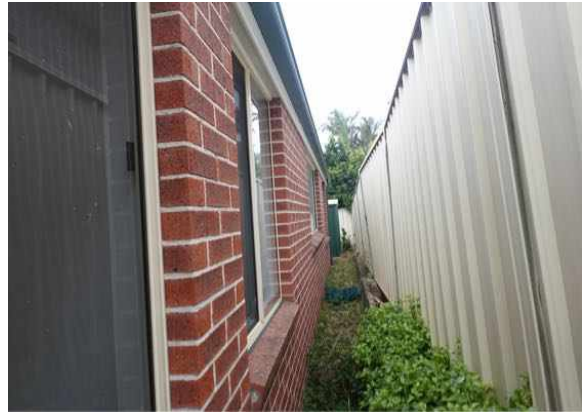
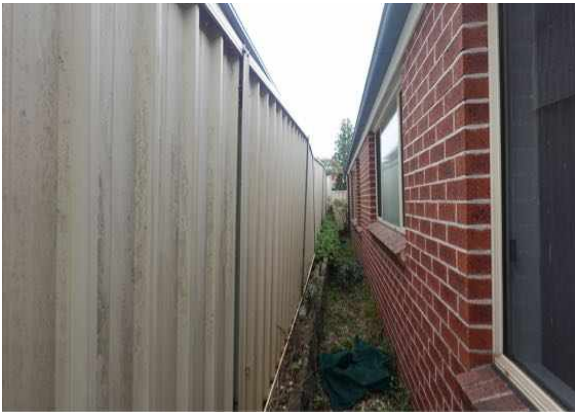
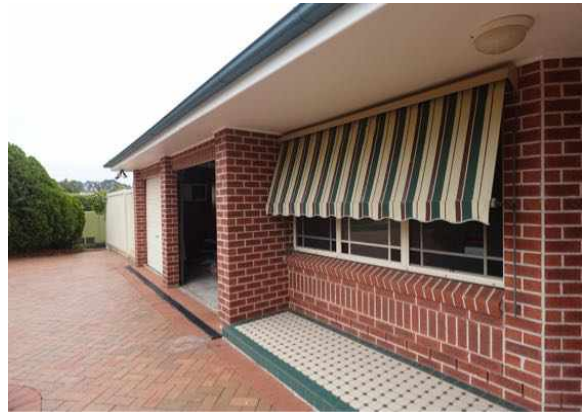
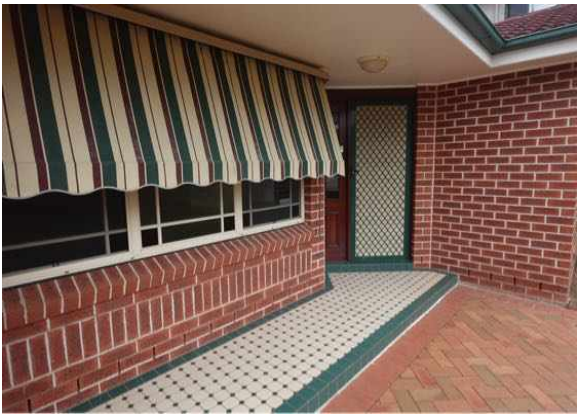
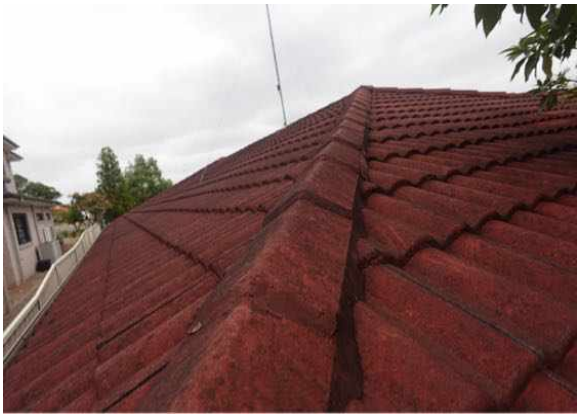
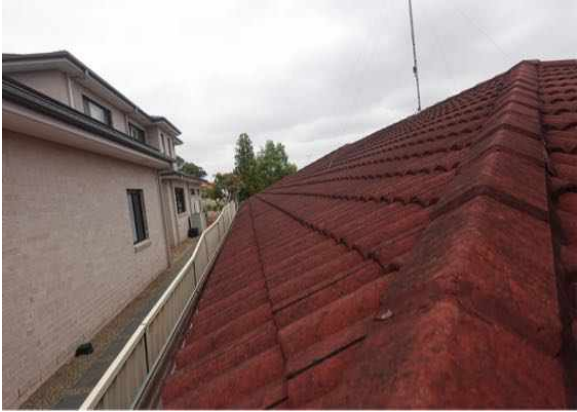
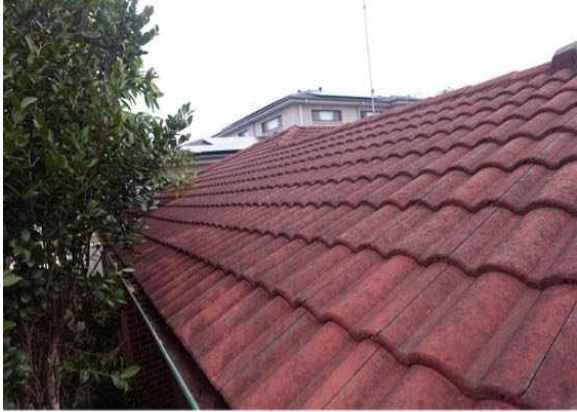
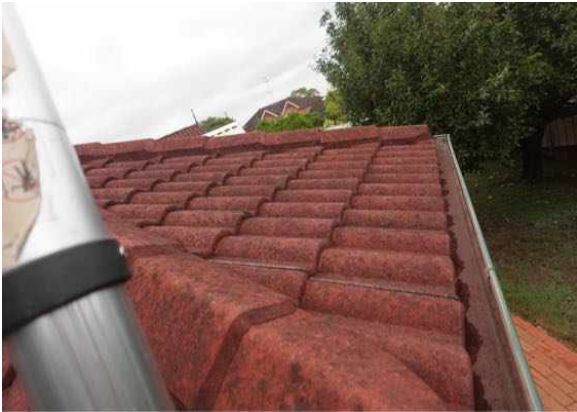
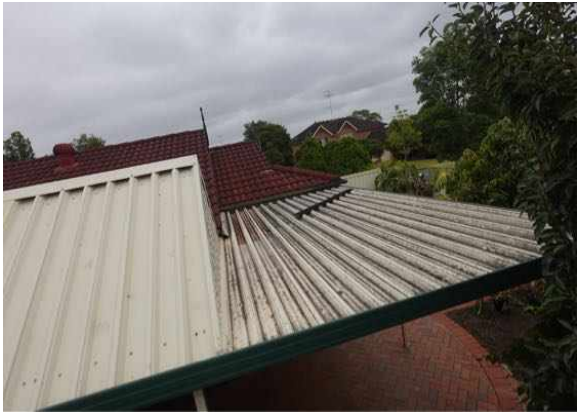
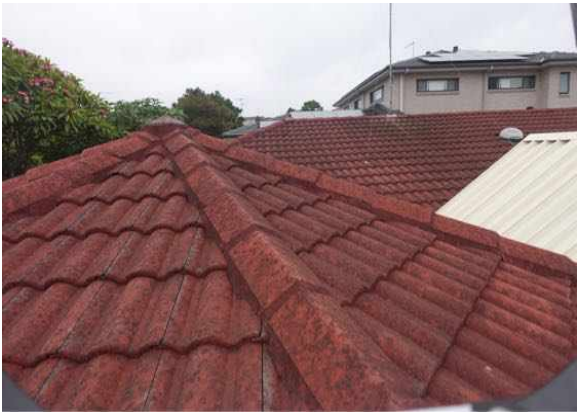
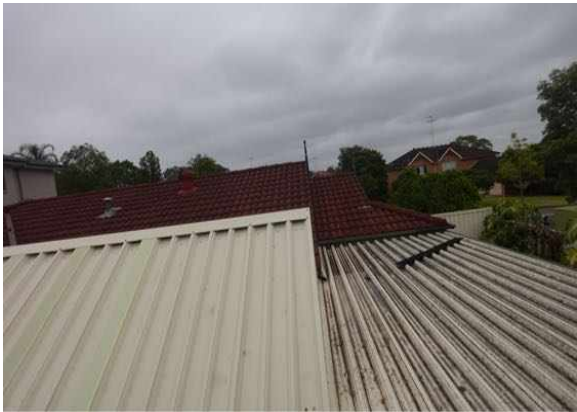
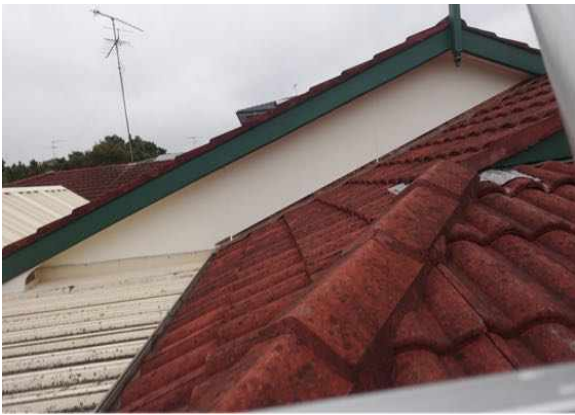
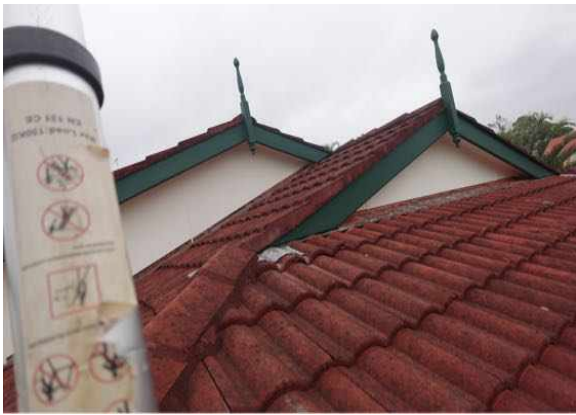
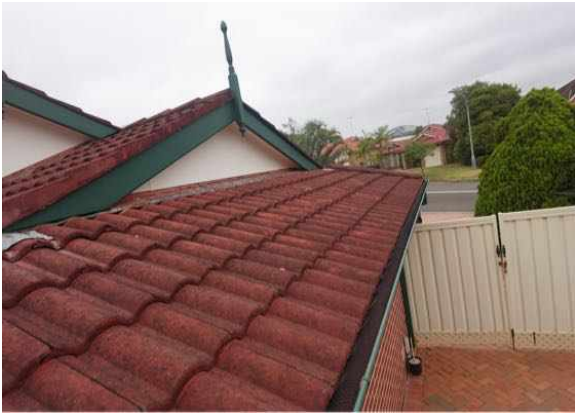
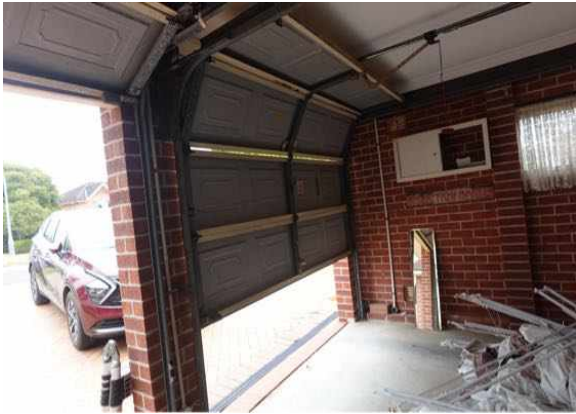
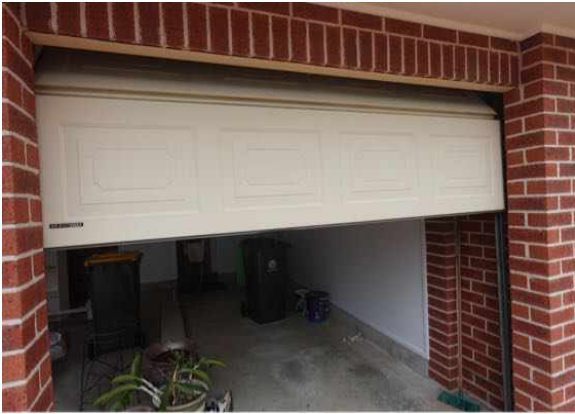
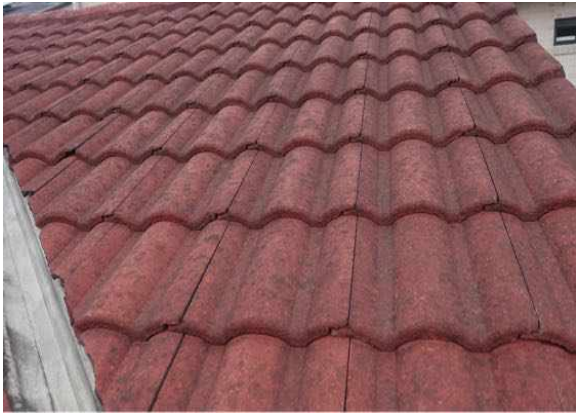
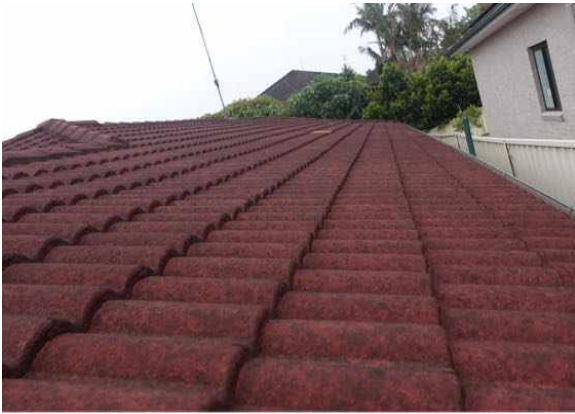
Building: Main Building
Location: All Areas
Finding: Additional Photos - Obstructions and Limitations
Information: These photographs are an indication of the obstructions and limitations which impeded full inspection of the property at the time of inspection.

These obstructions can hide an array of defects and should be to allow full inspection to be carried out.

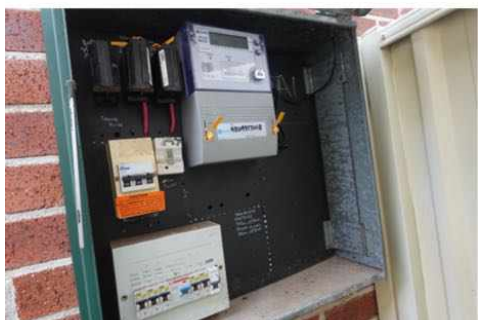
Information: The application of a post-construction chemical termite barrier is highly recommended for all properties, particularly if live termite activity has been found on the site previously. Such barriers are highly effective in preventing termite attack on any timber building elements throughout the property.

A durable notice should be placed in the switchboard unit to indicate current termite barriers. At the time of inspection, it appeared as though no termite management system has been installed, with no evidence to suggest preventative works taking place.

The client may consider gaining further advice from a pest controller as to the costs and procedures involved with this application. It is recommended that obtaining such advice be a short-term priority.
