Building and Timber Pest Inspection Report

Inspection Date: Fri, 6 Feb 2026

Property Address: 14 Varna St, Mount Colah NSW 2079,
Australia

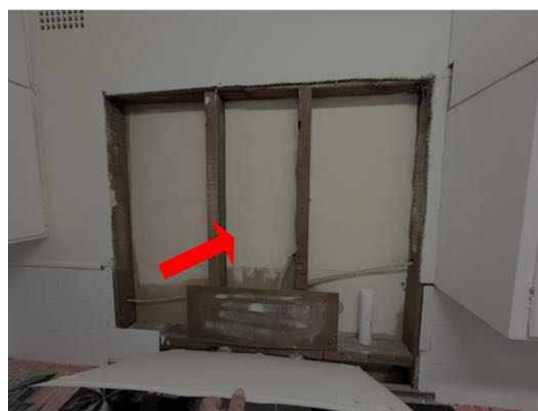
Finding 2.01

Building:	Main Building
Location:	Studio
Finding:	Plasterboard - incomplete
Information:	A section of plasterboard is missing from the wall, likely resulting from previous plumbing or remedial works. The wall lining has not been reinstated, leaving the timber framework exposed. This is considered incomplete workmanship. The plasterboard is required to be reinstated, properly fixed, set and finished, and the affected area painted to match the surrounding wall surfaces to achieve an acceptable standard of finish.

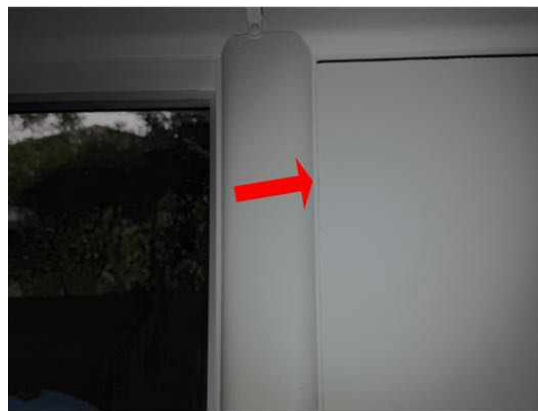
Finding 3.01

Building:	Main Building
Location:	Laundry
Finding:	Door - Binding/jamming
Information:	Binding and/or jamming of this door is evident during standard operation. This defect inhibits the functionality of the affected door as well as creating potential for secondary defects to associated building elements, such as damage to the door and jamb.

A door that binds to flooring or to the associated door frame may have several causes, ranging from minor defects, such as poor installation of the door or

deteriorated hinges, through to minor building movement.

For minor causes, a qualified carpenter or general handyperson should be appointed to perform minor rectification works at client discretion.

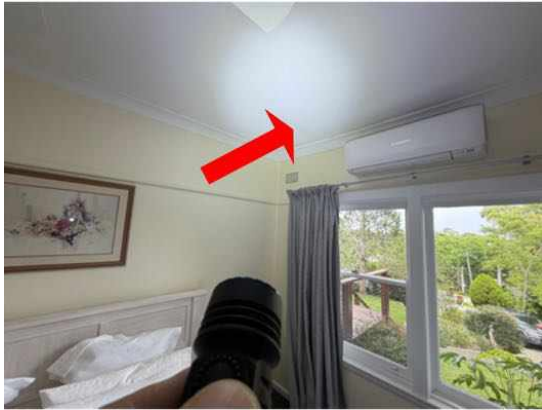
Finding 3.04

Building:	Main Building
Location:	Bedroom
Finding:	Ceiling – Staining from Previous Water Leak
Information:	Staining is present to the ceiling consistent with a past water leak. Moisture readings were taken at the time of inspection and no elevated moisture levels were recorded, the roof void in that area was inspected also and no signs of an ongoing issues were noted, indicating the leak is not currently active. While no ongoing moisture issues were identified, the staining remains visible. The affected area requires preparation and repainting to restore an acceptable finish and appearance.

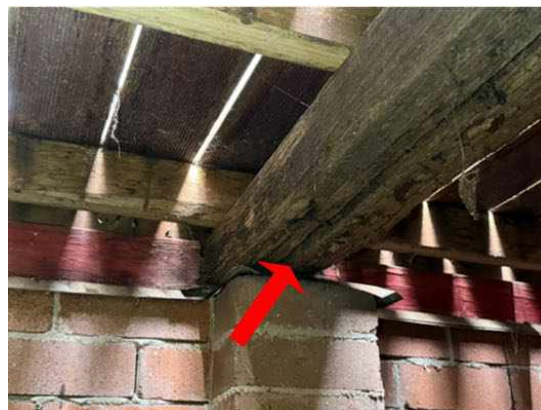
Building: Main Building
 Location: Front Deck lhs
 Finding: Wood Rot - Decking bearers
 Information: One area of structural timber bearers located beneath the front timber decking shows visible signs of wood rot and deterioration. This condition indicates prolonged

exposure to moisture and may compromise the long-term structural integrity of the decking if it continues to deteriorate. While immediate replacement may not be required at this stage, the affected bearers should be regularly monitored, and allowance made for repair or replacement in due course to prevent further degradation and potential structural issues.

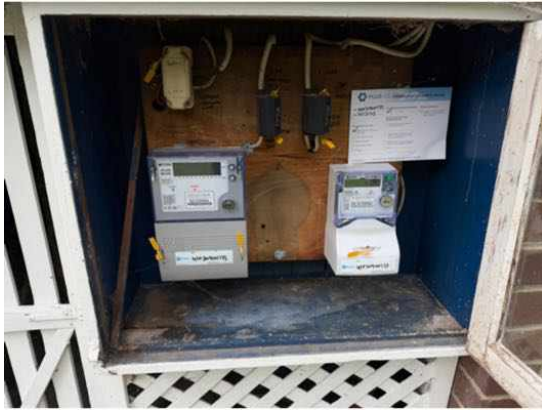
Building:	Main Building
Location:	Electrical Meter-box
Finding:	Termite Management System - no evidence of installation
Information:	The application of a post-construction chemical termite barrier is highly recommended for all properties, particularly if live termite activity has been found on the site previously. Such barriers are highly effective in preventing termite attack on any timber building elements throughout the property.

system has been installed, with no evidence to suggest preventative works taking place.

The client may consider gaining further advice from a pest controller as to the costs and procedures involved with this application. It is recommended that obtaining such advice be a short-term priority.

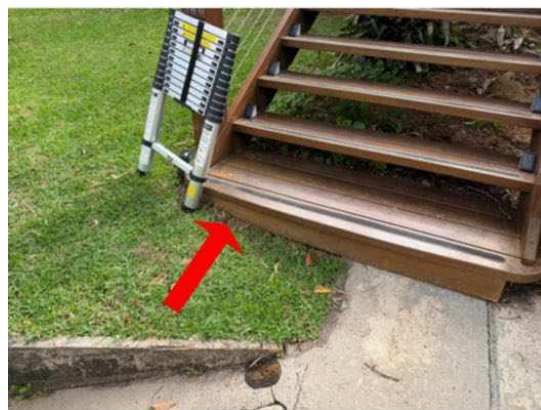
Finding 6.03

Building:	Main Building
Location:	All Areas
Finding:	Stored timbers - subfloor space or external area
Information:	The storing of timbers in the subfloor space or around the external property (including bark mulch) increases the risk of termite activity being present. As they are likely to come into contact with weather conditions or excessive moisture wood rot is likely to develop on timbers that are not treated.

It is highly recommended that any stored timbers be immediately removed from areas in which they may attract any termite / timber pest attack. Minimisation of risk / prevention of termite attack is far more adequate than dealing with the presence of termite activity.

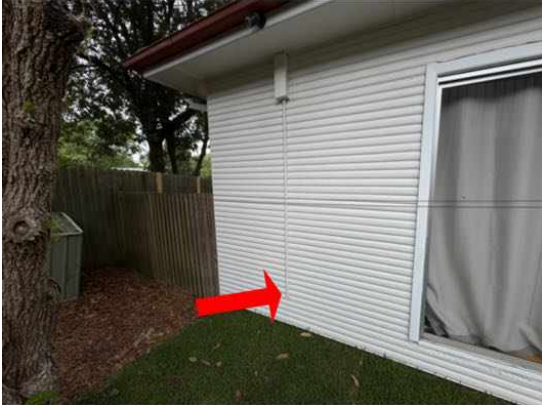
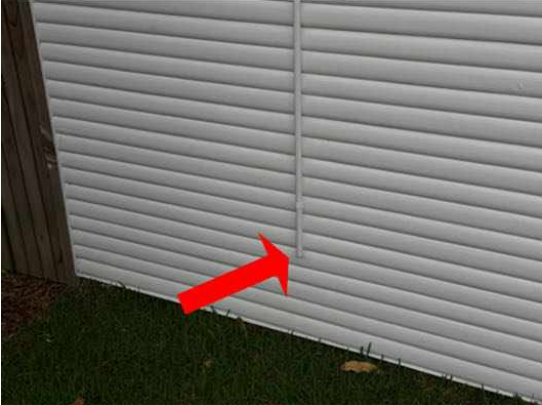
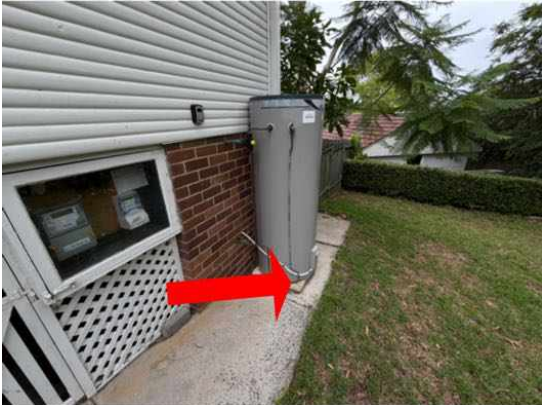
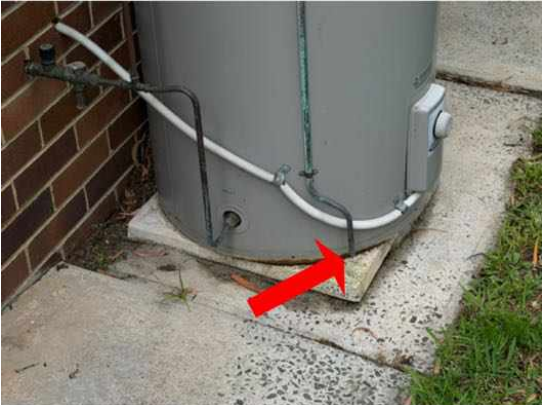
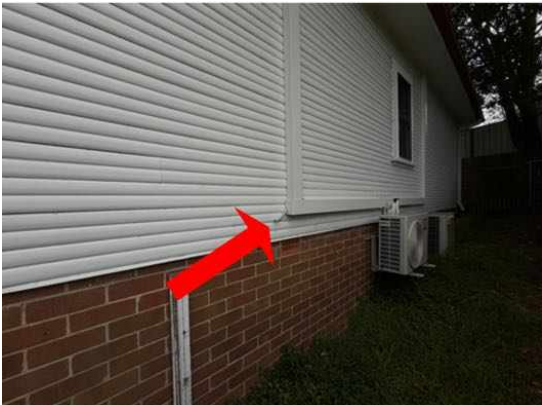
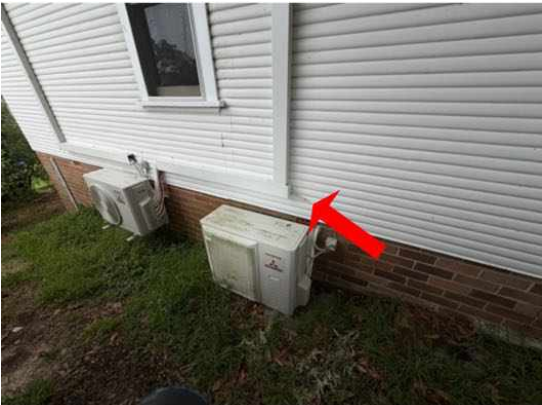
These damp conditions can lead to secondary defects such as rot, rust or corrosion of associated building elements, the formation of fungal decay, or even the creation of potential slip hazards. When coupled with poor site drainage, pooling of water may also attract termite activity to this area.

It is highly recommended that a qualified plumber be appointed to install adequate drainage to the overflow. These works will ensure that the area remains dry and free of any secondary defects.

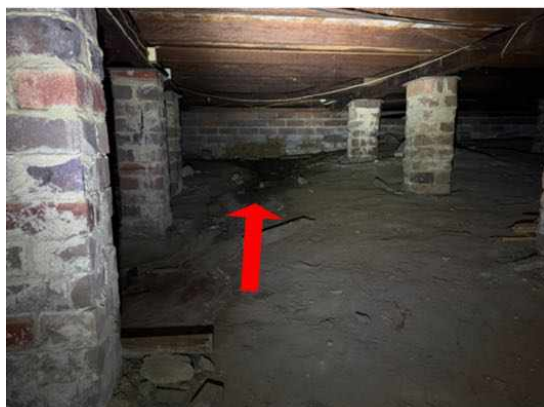
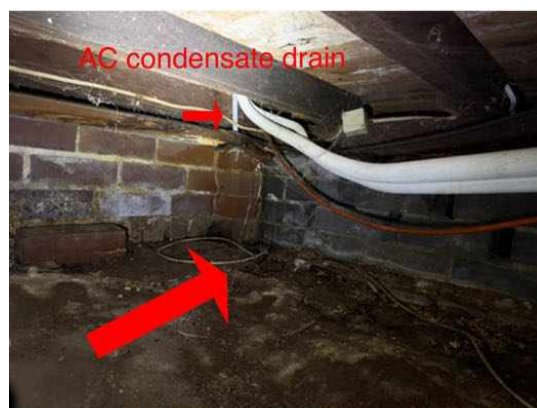
Finding 6.06

Building:	Main Building
Location:	Subfloor
Finding:	Excessive subfloor moisture
Information:	Excessive moisture can attract termites and produce conditions that promote termite attack fungal growth and wood decay.

Excessive moisture is generally caused by inadequate subfloor ventilation and poor site drainage.

There appear to be inadequate vents installed to the perimeter of the building and I would suggest that further solar powered fans or the like be installed to improve cross flow ventilation and aid in keeping the subfloor area relatively dry.

The installation of additional surface drainage to the rear of the property would also be beneficial to keeping the subfloor dry.

It is highly recommended that both subfloor ventilation and site drainage be improved and maintained regularly in order to prevent excessive moisture being present in the external / internal property.

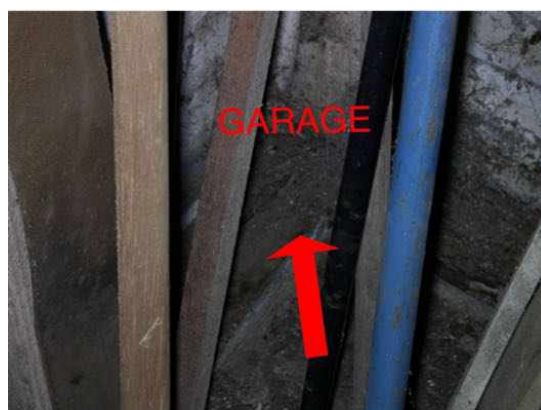
Finding 7.01

Building:	Main Building
Location:	Rear steps/detached Garage
Finding:	Fungal decay - present at the time of inspection
Information:	Fungal decay also known as wood decay or wood rot occurs when timbers and other

cellulose building materials are exposed to damp conditions on an ongoing basis. This could be the result of exposure to weathering in the long term or the pooling of water or absorbed moisture from other abutting building materials or a shower leak. It is advisable to remove these affected timbers to prevent any chance of attack in the future.

Wood decay is more susceptible to termite attack and these timbers should be replaced to limit termite attack.

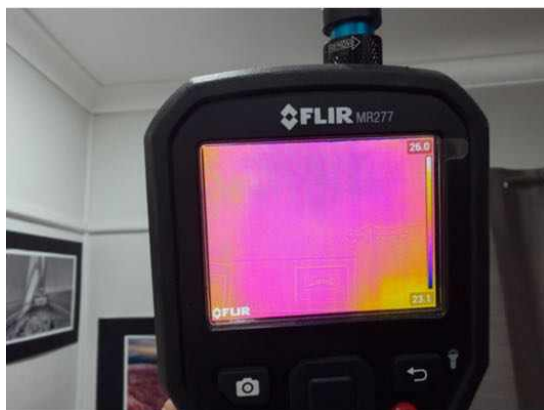
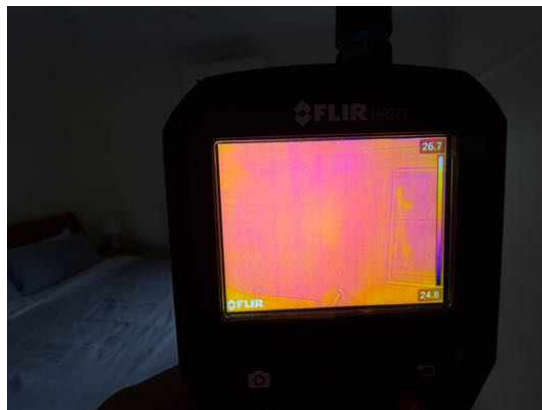
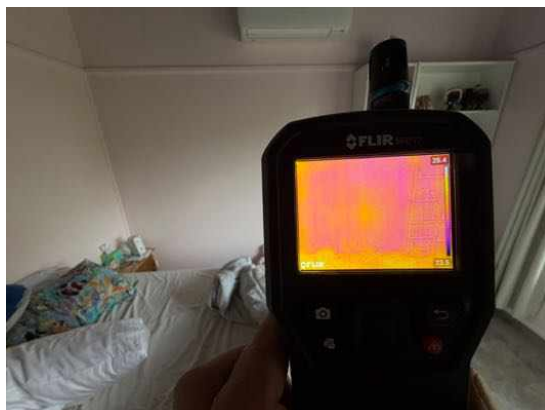
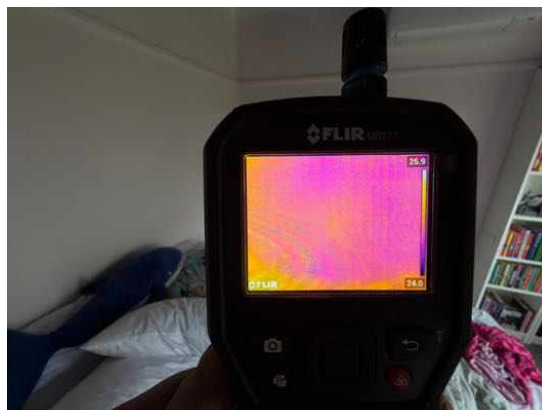
Building: Main Building
 Location: All Internal Areas
 Finding: For your information-Thermal camera
 Information: AS 3660.2:2017 is the recommendation for the carrying out of 'Additional Tests' using specialist non-destructive tools:

A thermal imaging inspection was carried out throughout the interior of the house using a Flir MR277 thermal camera. No thermal anomalies were noted that would be consistent with any current termite activity, however various factors must be taken into effect which may hamper or impede the reading obtainable by the imager. These factors include obstructions, ambient temperature, wall material and thickness etc. If any surface is restricted visually or otherwise, a proper thermal reading is not possible and is not within the scope of this inspection. Any findings or otherwise is reported on at the time of the inspection only.

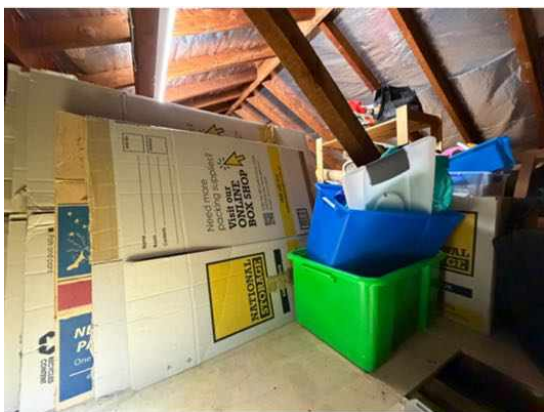
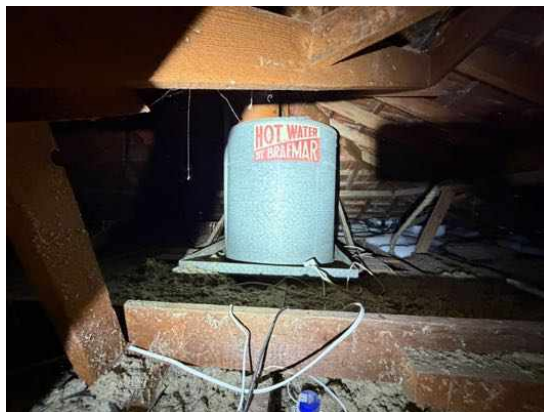
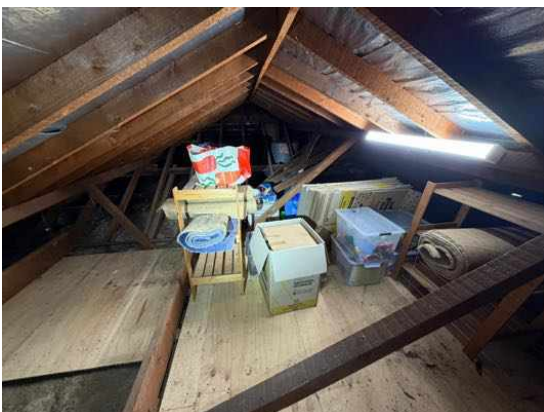
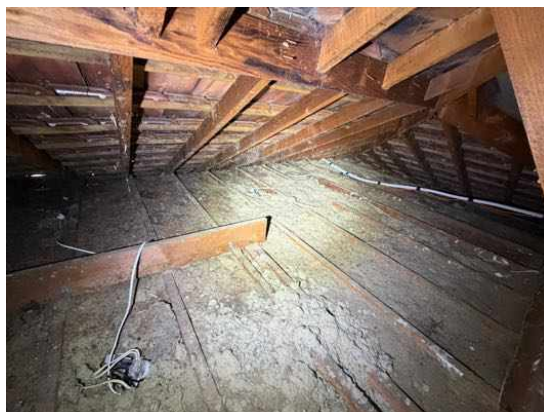
Noted Item

Building:	Main Building
Location:	Roof Void
Finding:	Obstructions and Limitations-Roof Void
Information:	<p>These photographs are an indication of the obstructions and limitations that impeded the full inspection of the roof cavity at the time of inspection. Note that the insulation covered nearly all the ceiling joists, which are a major structural element of the ceiling; the inspection was also limited to areas with an allowable crawl space of 600mm x 600mm, in particular towards the external walls where the roof line diminishes, it was not accessible. These obstructions and limitations can hide an array of defects and should be removed to allow a full inspection to be carried out. A re-inspection is recommended once areas are made accessible.</p>

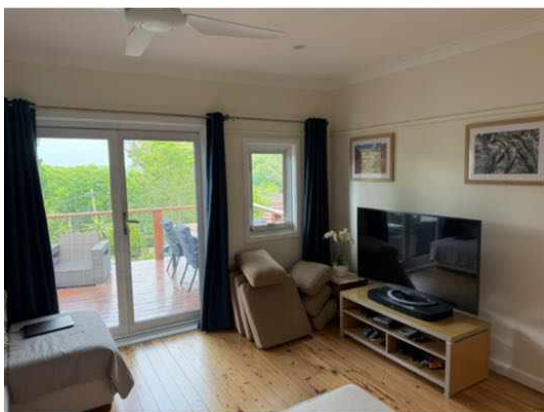
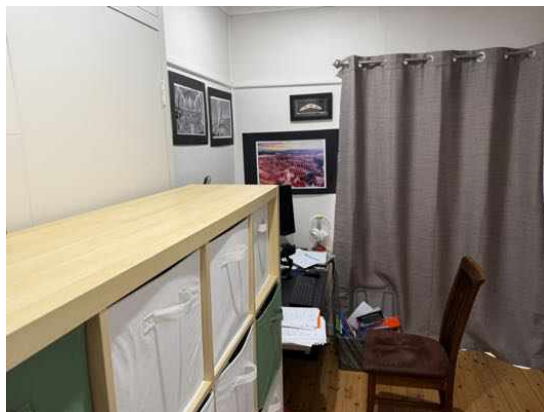
Noted Item

Building: Main Building
 Location: Internal Areas
 Finding: Obstructions and Limitations-Internal areas
 Information: These photographs are an indication of the obstructions and limitations which impeded full inspection of the internal areas at the time of inspection. These obstructions can hide an array of defects and should be removed to allow a full inspection to be carried out. A re-inspection is recommended once the areas are made accessible.

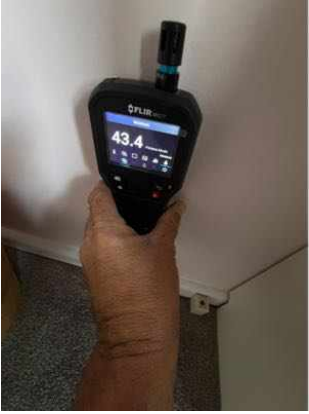
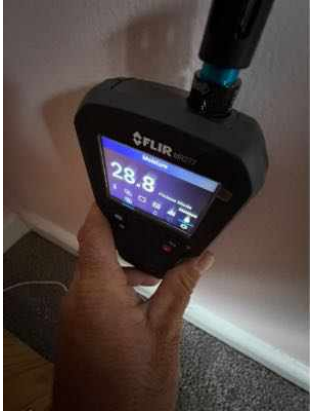
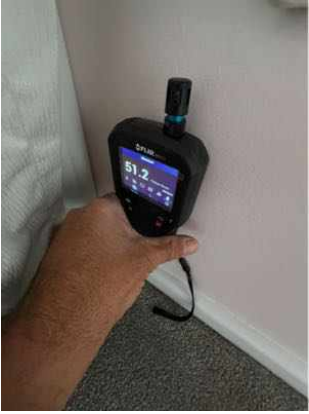
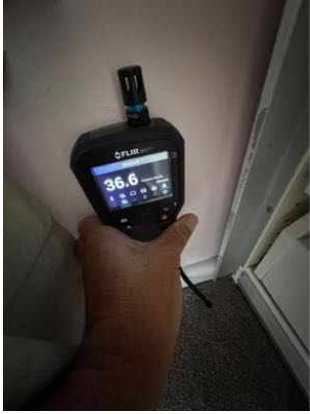
Building:	Main Building
Location:	All Areas
Finding:	FYI-Moisture Readings
Information:	Moisture readings taken during the inspection were recorded using a FLIR MR277 moisture meter, which provides numerical values rather than direct percentage readings. These values are not expressed as a percentage of moisture content but rather as relative indicators of moisture presence within building materials. Each material-such as plasterboard, timber, tile or concrete wall surfaces -has its own baseline range of ambient moisture, and the meter's readings reflect deviations from that baseline.

In short, while percentages are familiar, the meters numeric scale offers a more nuanced and material - sensitive method of identifying moisture issues. Elevated readings – especially those exceeding baseline values by around 20 points or more – are flagged for further investigation, even if no visible damage is present.

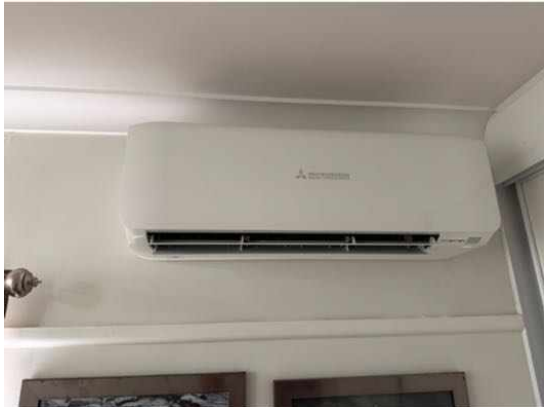
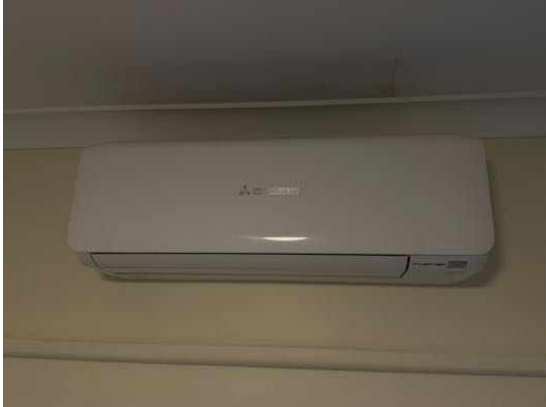
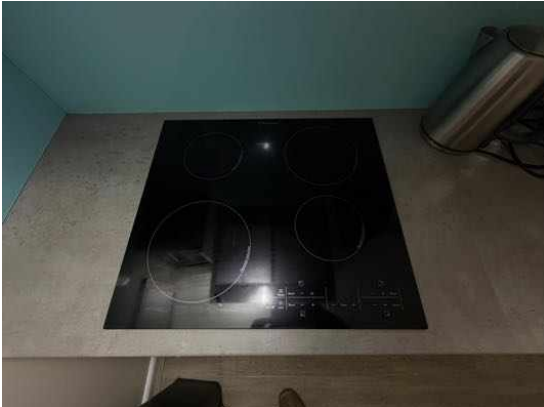
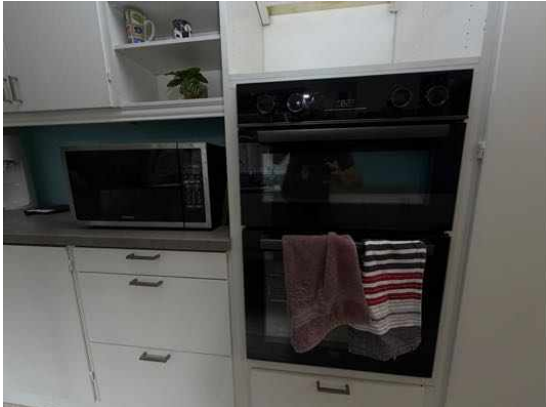
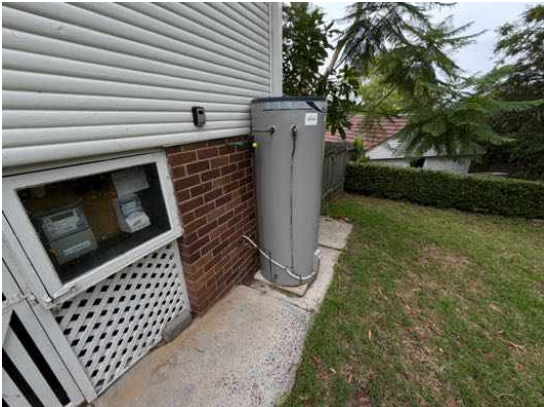
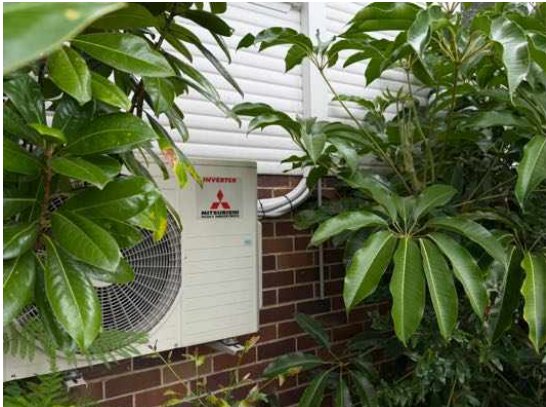
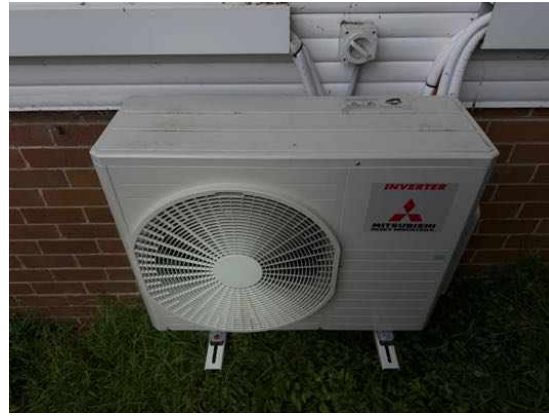
Building: Main Building
 Location: Plumbing/electrical/gas/aircon/pool equipment etc
 Finding: FYI-Plumbing and Electrical
 Information: Plumbing and Electrical inspections are outside the scope of the building inspection

It is highly recommended that the client makes immediate arrangements to have the gas appliances checked by a licensed gas plumber to ensure that the appliances are working safely and efficiently.

We recommend all other installations be checked also.

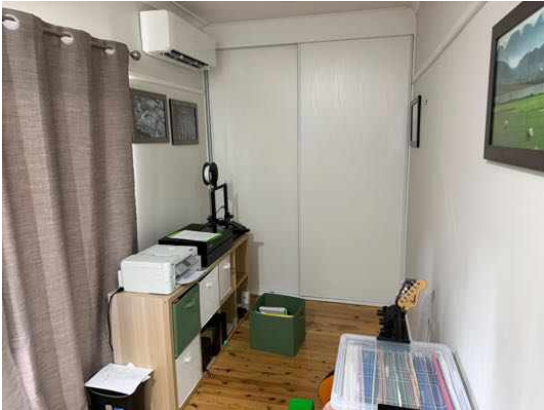
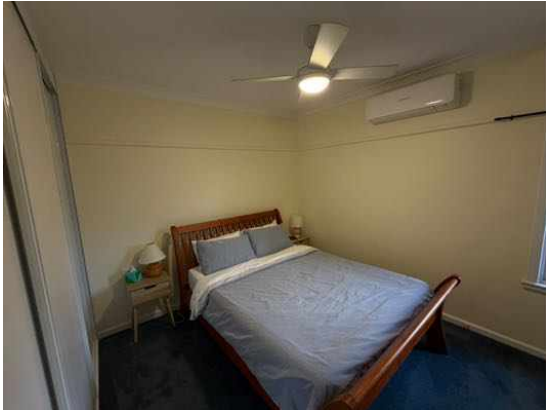
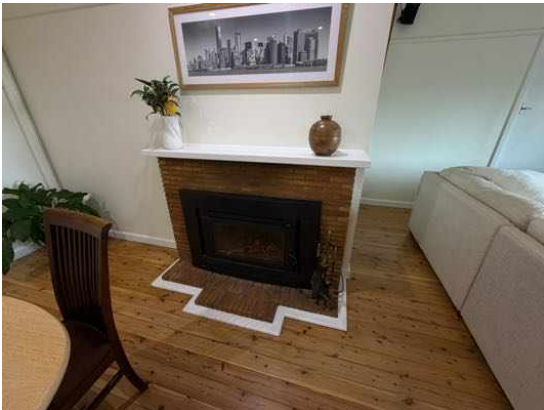
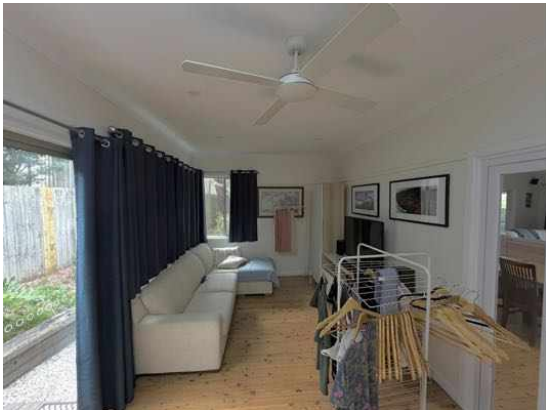
Building: Main Building
Location: All Areas
Finding: FYI-Additional Photos
Information: Additional photos are provided for your general reference and may include obstructions, testing of water and windows, moisture readings or minor maintenance items.
