## Building Inspection Report

Inspection Date: Fri, 6 Mar 2026

Property Address: 47 Grafton St, Goulburn NSW 2580,  
Australia

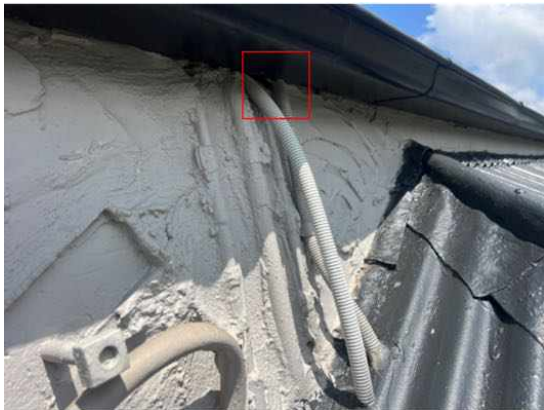
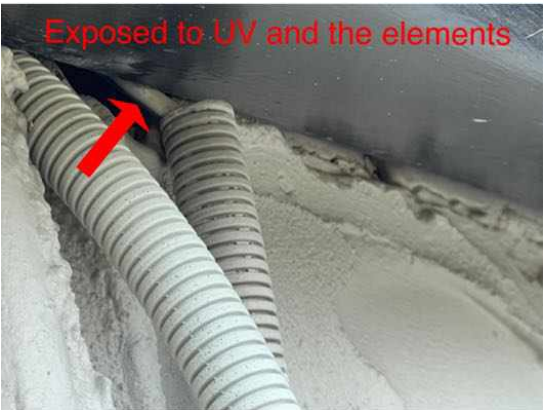
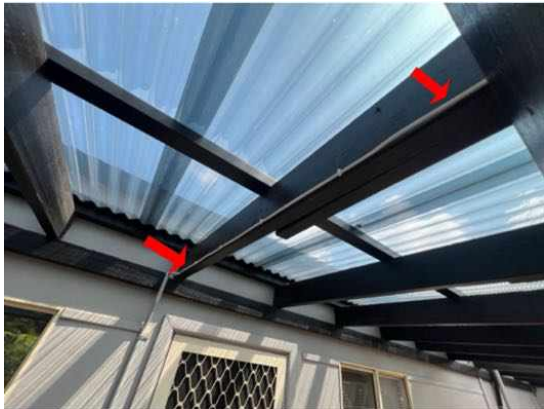
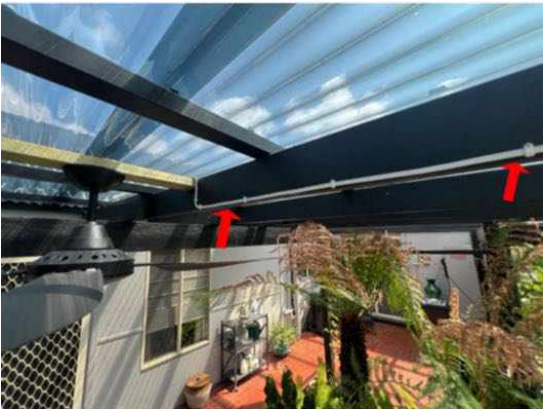
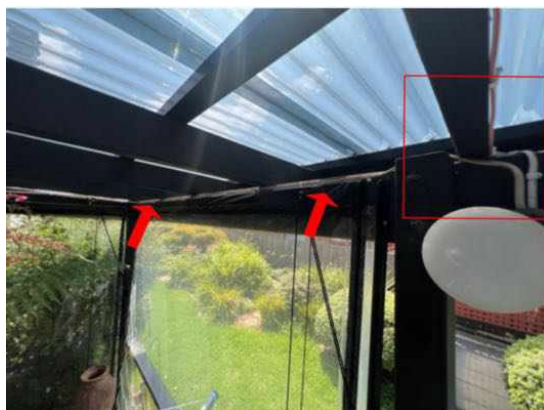
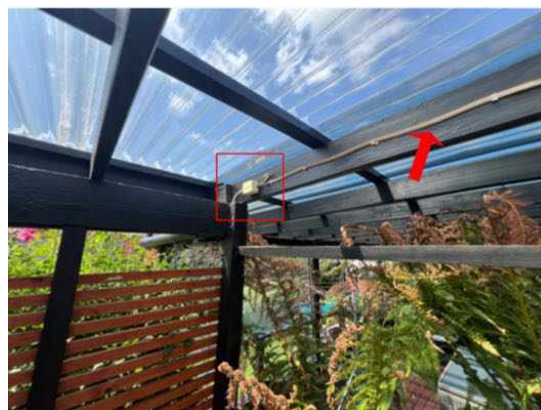
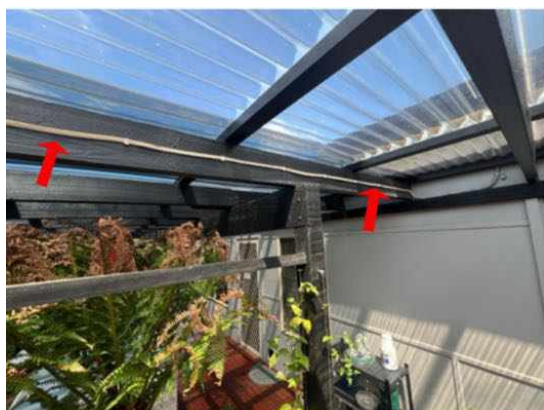
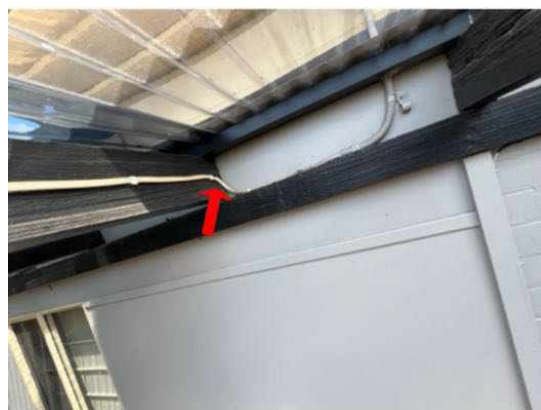
#### Defects 1.01

Building: Main Building  
Location: Pergola  
Finding: Electrical wires exposed  
Information: Exposed electrical wiring was identified. Exposed electrical wiring represents a potential safety hazard including for fire and personal contact. Contact a licensed electrician urgently for further inspection investigation and rectification.

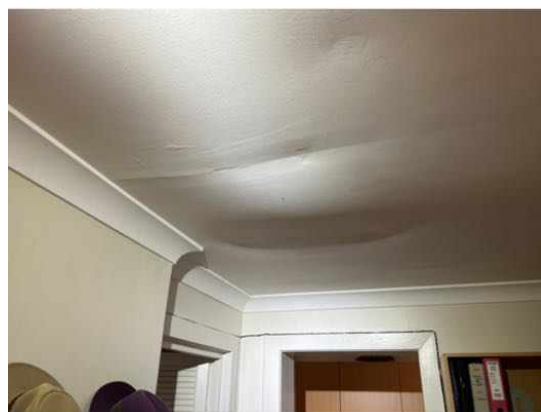
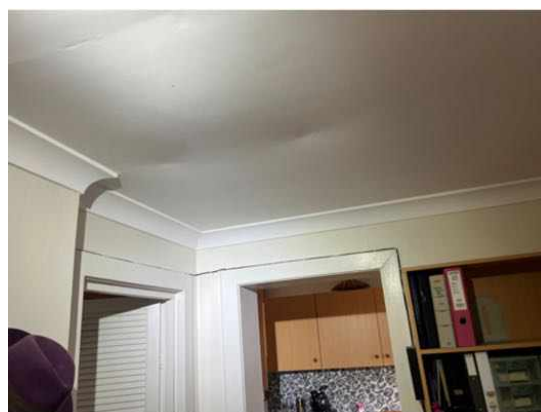
## Defects 1.02

Building:	Main Building
Location:	Lounge Room
Finding:	Ceiling - Sagging
Information:	Sections of the ceiling were found to be sagging at the time of inspection. Sagging to the fixed ceiling structure generally indicates that the building materials have swollen, due to contact with water, or that fixings (e.g. nails or glue) have become loose and require reattachment.

In some cases, sagging ceiling linings may also indicate that there are structural issues, causing surfaces to warp, twist or sag. Where sagging appears to be major, appointment of a structural engineer is advised to further inspect the property and identify the source and rectification works required.

Where minor sagging is evident, comparatively minor works, such as re-gluing of ceiling sheets, may be required. Such works may be performed by relevant tradespeople, such as plasterers and painters. Where excessive moisture has caused the roofing structure to swell and sag, the source of the water leak should primarily be identified prior to any remedial works being performed.

The appropriate action should be taken by the client as soon as possible to ensure that any potential further damage is limited.

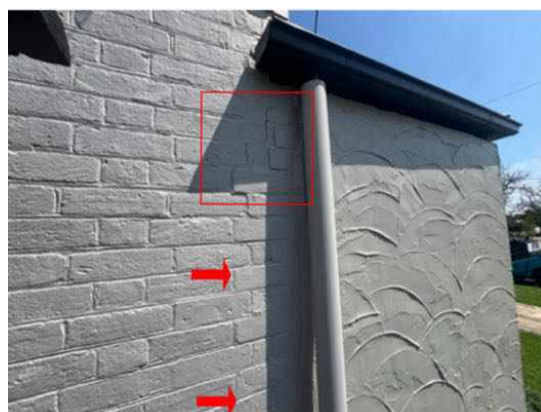
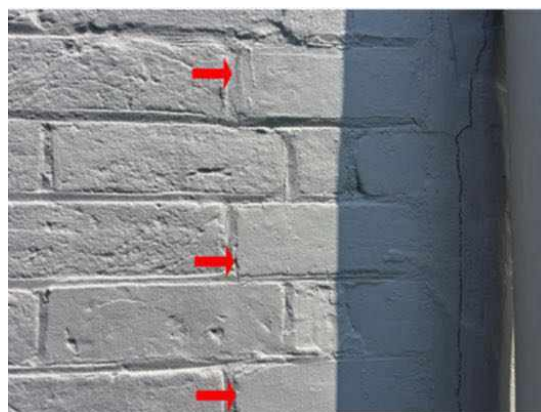
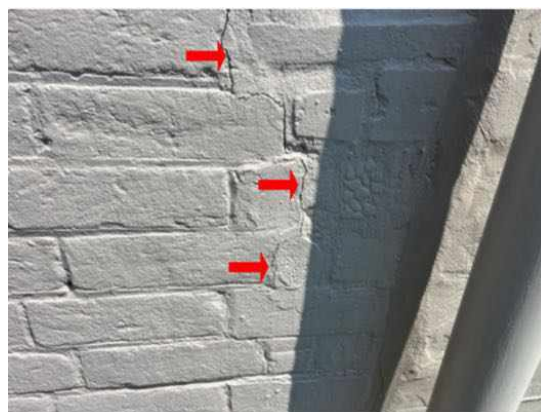
### Defects 3.01

Building: Main Building  
 Location: Exterior walls - left side  
 Finding: Brickwork - Step cracking  
 Information: Step cracking was identified to the brickwork in this area at the time of inspection. Step cracking, which is similar to other forms of cracking, has a variety of possible causes. However, the most common is the subsidence of adjacent footings.

Step cracking is a relatively common defect, and is most likely to occur adjacent to windows, doors and other openings. Mortar failure in the gaps between affected bricks indicates the stresses and tensions affecting the wall.

Where step cracking is extensive or severe, the client is advised to consult a structural engineer. Minor step cracking can be used as a warning sign to address factors causing stress to the wall, which can include the effect of surrounding trees, water

leaks, soil erosion, or even the presence of reactive soils in the surrounding area.

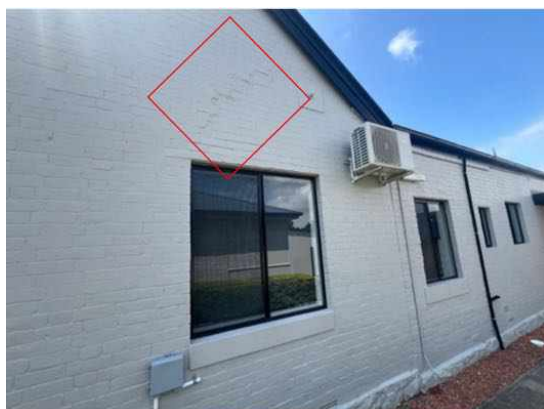
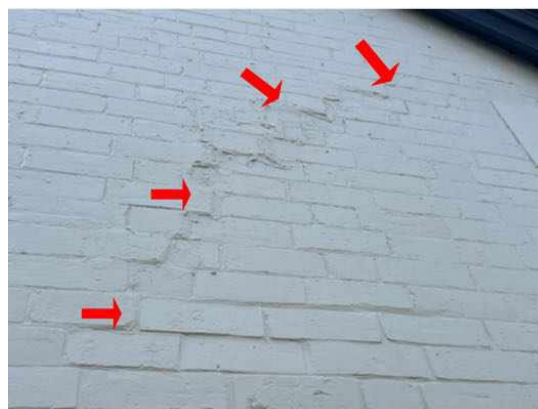
### Defects 3.02

Building:	Main Building
Location:	Exterior walls - right side
Finding:	Brickwork - Step cracking (substandard patching)
Information:	Step cracking was previously identified to the brickwork in this area and appears to have been patched or repaired prior to repainting. Step cracking, which is similar to other forms of cracking, has a variety of possible causes. However, the most common is the subsidence of adjacent footings.

Step cracking is a relatively common defect, and is most likely to occur adjacent to windows, doors and other openings. Mortar failure in the gaps between affected bricks indicates the stresses and tensions affecting the wall.

Where step cracking is extensive or severe, the client is advised to consult a structural engineer. Minor step cracking can be used as a warning sign to address factors causing stress to the wall, which can include the effect of surrounding trees, water leaks, soil erosion, or even the presence of reactive soils in the surrounding area.

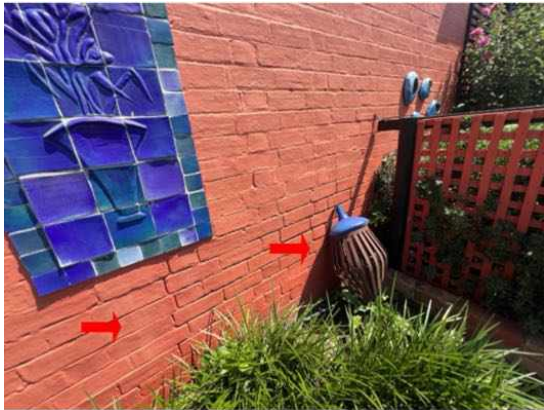
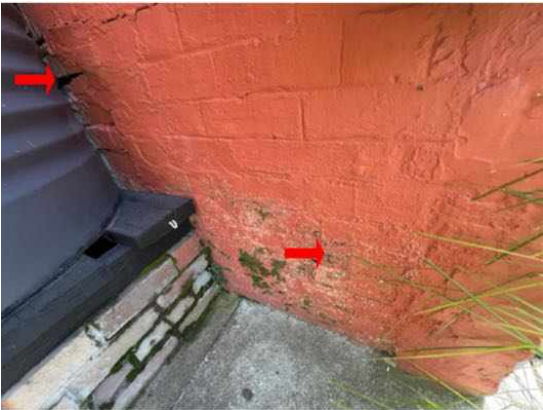
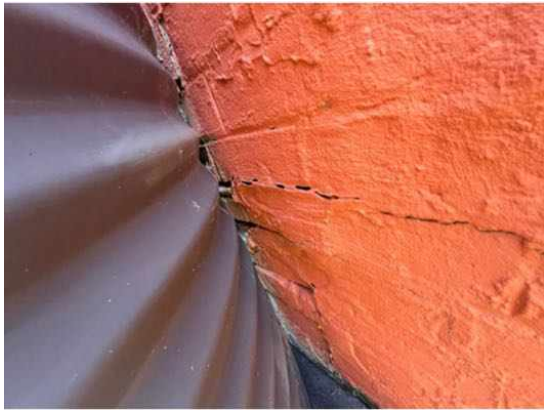
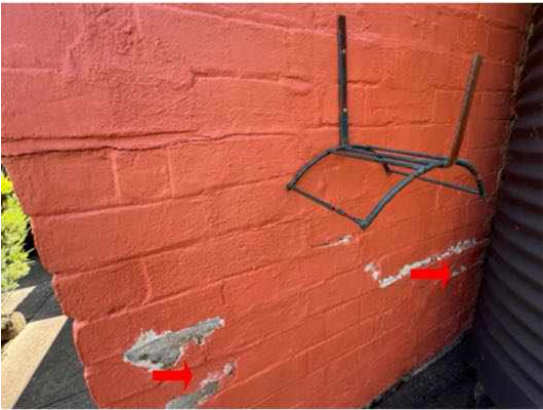
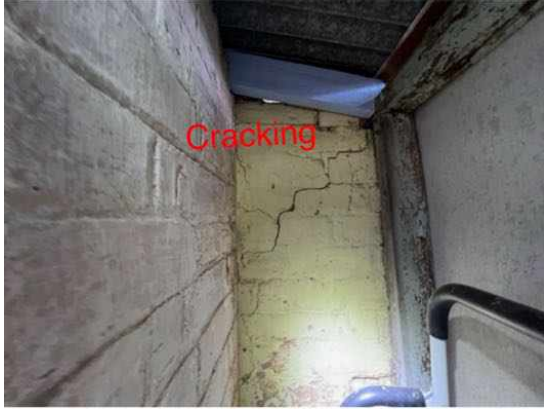
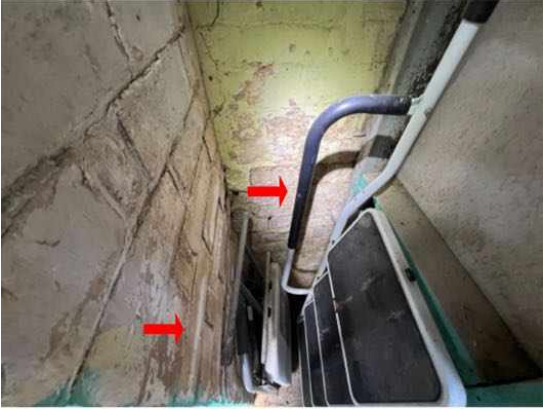
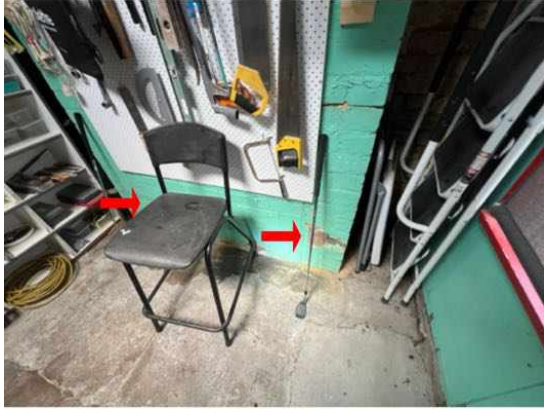
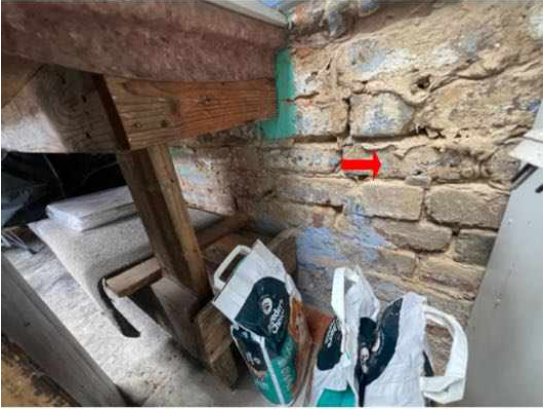
### Defects 3.03

Building:	Out Building
Location:	Shed - Brick
Finding:	Damp - Rising
Information:	Rising damp describes the upward movement of water in low sections of building elements (e.g. walls) by capillary action - the movement of water through porous materials such as bricks, sandstone or mortar.

Rising damp is generally managed by the installation of a damp proof course during construction. A Damp Proof Course (DPC) is an impermeable barrier at the base of the wall above ground level. However, many 19th Century buildings have no damp course installed, or the materials have failed. The DPC may have been omitted as a consequence of poor workmanship, or it may have been bridged where materials built up against the side of the house allow moisture ingress above the DPC level.

The first step in addressing rising damp is to diagnose the cause. The identified cause should be addressed first before addressing the appearance and other defects which have resulted from the rising damp. If the original cause is not resolved, further cases of damp are likely to ensue, resulting in secondary defects.

Consultation with a qualified plumber is advised immediately to identify the cause of

the damp and perform remedial works as required.

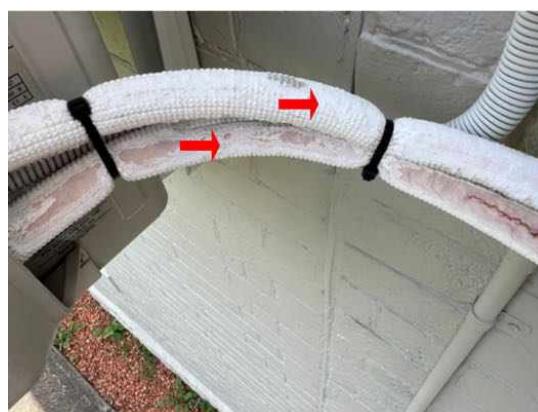
### Defects 3.08

Building:	Main Building
Location:	Exterior walls - right side
Finding:	Pipework - Insulation deteriorated
Information:	Sections of the pipe insulation show evidence of damage and deterioration. It is suspected that this deterioration has developed as a result of excessive exposure to weather, including UV exposure in daylight. Deteriorated insulation reduces the effectiveness of the material in helping to maintain the desired temperature and work most efficiently.

If left in an exposed position, it is likely that the deterioration will continue and worsen over time, potentially resulting in secondary building defects as well as a further loss in insulating properties.

Some areas of replacement of pipe insulation is likely to be required. Further preventative measures to remove or protect the material from future exposure are also advisable. Consultation with a licensed plumber is advised to gain quotes for the repair and/or replacement of deteriorated insulation.

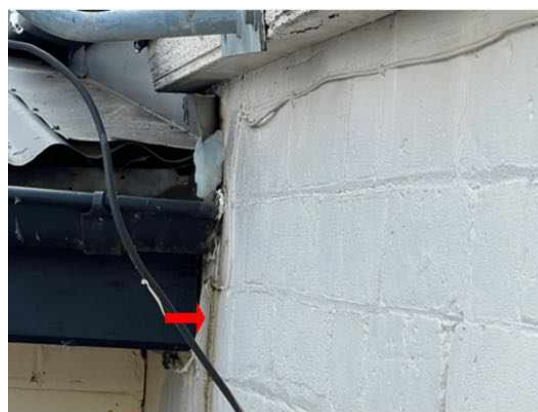
### Defects 3.10

Building:	Main Building
Location:	Exterior walls - rear
Finding:	Walls - Water stained

**Information:** Water staining to sections of the walls in this area was evident at the time of inspection. Water staining indicates that surfaces have been exposed to excessive moisture over time. The minerals and other elements in the water lead to staining, which may graduate to corrosion and deterioration if left unmanaged.

While mostly an appearance defect, water staining can be indicative of more serious defects, which may be currently concealed by wall linings.

Where water staining is active, a licensed plumber must be consulted to identify the cause of the staining and to provide advice on any reparation works that may be required. Replacement of any broken or damaged structures is advised.

Conversely, where water staining is old and inactive, affected building materials may be repaired or replaced at client discretion.

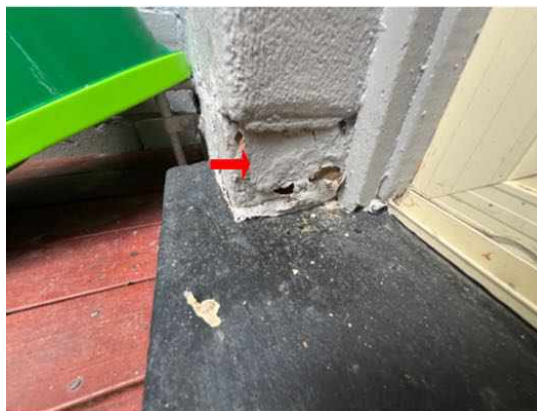
### Defects 3.11

**Building:** Main Building  
**Location:** Exterior walls - rear  
**Finding:** Brickwork - Paint Deterioration to Mortar Joints  
**Information:** The painted masonry in this area was observed to exhibit bubbling and deterioration primarily along the mortar joints. Paint failure of this nature is commonly associated with moisture movement through masonry joints, which can cause loss of adhesion and blistering of the paint coating.

Older masonry construction can allow moisture to migrate through mortar joints from sources such as ground moisture, external moisture exposure, or trapped moisture within previously painted masonry surfaces. Where moisture is present within the wall structure, painted finishes may deteriorate prematurely.

The condition appears localised to this section of wall. However, continued moisture migration through the masonry may contribute to further deterioration of finishes if left unmanaged.

It is recommended that a licensed builder be appointed to inspect the affected area

and determine the underlying source of moisture. If moisture migration through the masonry is confirmed or the condition is found to be more widespread, further assessment by a specialist in rising damp or masonry moisture remediation may be required.

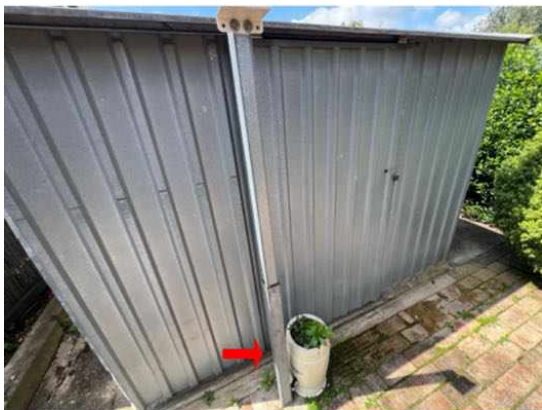
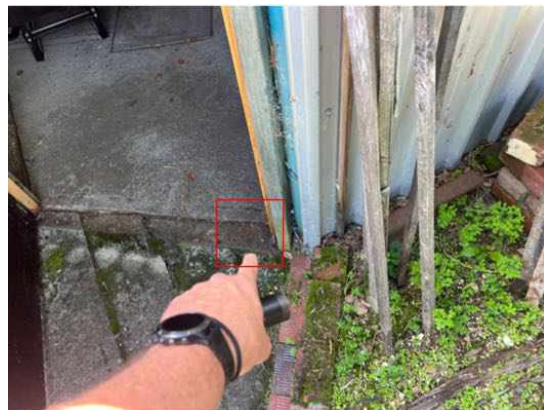
### Defects 3.13

Building:	Out Building
Location:	Shed, Shed 3
Finding:	Doors - Binding/Jamming
Information:	Binding and/or jamming of doors were evident during standard operation. This defect inhibits the functionality of affected doors as well as creating potential for secondary defects to associated building elements, such as damage to flooring.

A door that binds to flooring or to the associated door frame may have several causes, ranging from minor defects, such as poor installation of the door or deteriorated hinges.

A qualified carpenter or general handyperson should be appointed to perform minor rectification works at client discretion.

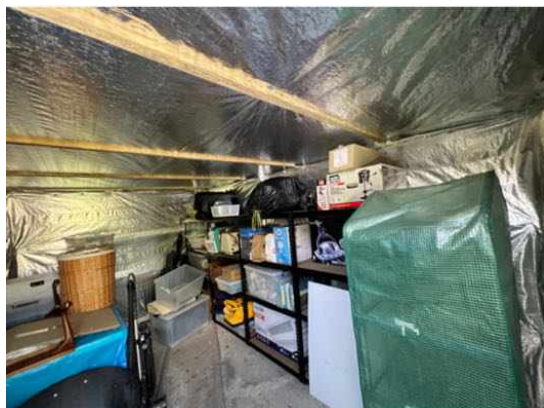
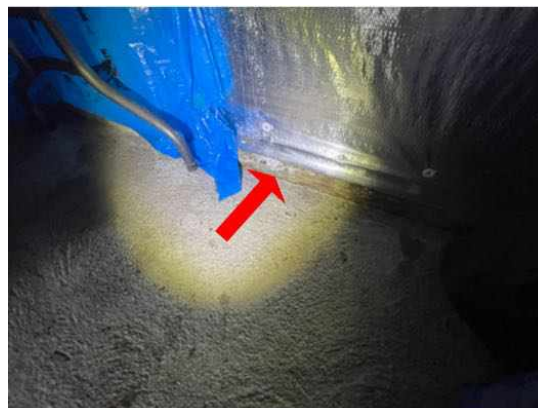
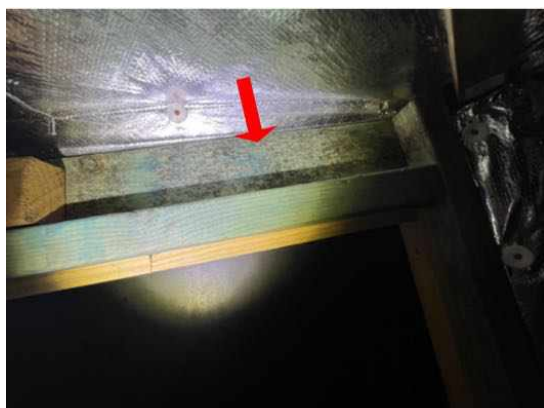
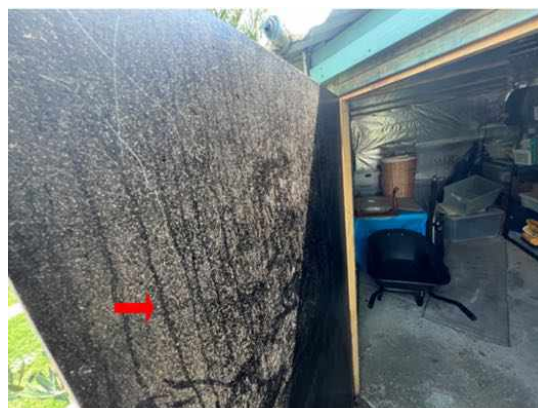
### Defects 3.14

Building:	Out Building
Location:	Shed 3
Finding:	Mould - Present
Information:	Where evidence of mould growth was noted, there may be environmental, biological or health issues associated with the report. A specialist inspection by a suitably qualified

Generally, the client is advised to ensure that the general environment is free of moisture and humidity to aid in the prevention of mould formation and development. Any mould found during the inspection should be cleaned immediately by a cleaning contractor or the homeowner as applicable.

Please note that severely affected building elements may require replacement by a registered builder or qualified carpenter.

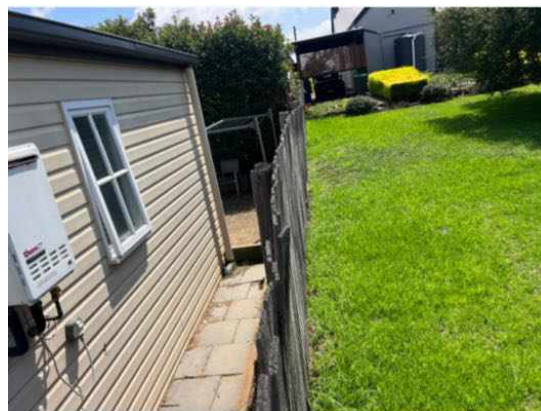
### Defects 3.15

Building:	Yard
Location:	Yard - Back
Finding:	Fencing - Deteriorated
Information:	It was noted at the time of inspection that sections of the fencing throughout the property have deteriorated. Typically fencing deteriorates due to age and or wear, rot and or rust which is generally expected for a structure of this age, due to prolonged exposure to weather conditions. Sometimes inadequate installation or maintenance can be to blame.

If left unattended, it is likely that further damage will occur. It is suspected that repair of several elements of the fencing may be required however replacement may be a

consideration of the client also.

A licensed fencing contractor should be appointed to provide further advice and perform rectification works as necessary.

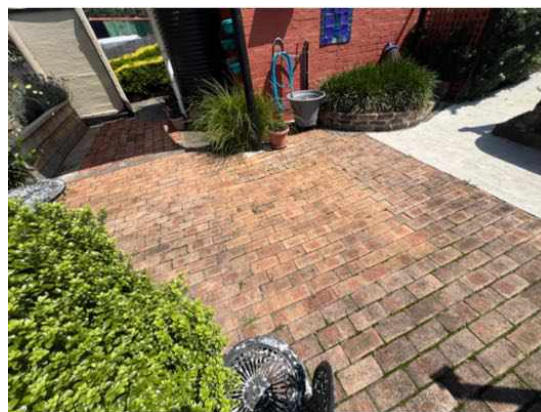
### Defects 3.16

Building:	Yard
Location:	Yard - Back
Finding:	Paving - Uneven
Information:	Sections of the external paved area are uneven, creating a potential trip hazard. It appears as though the area has been subject to rough installation, or that paving sections have lifted due to movements in the foundation of the property.

Where paving creates a trip hazard, personal injury may ensue if due caution is not taken by all persons within this area.

Re-paving of the area is required as soon as possible to remedy this situation. Further consultation with a specialist concreter is advised.

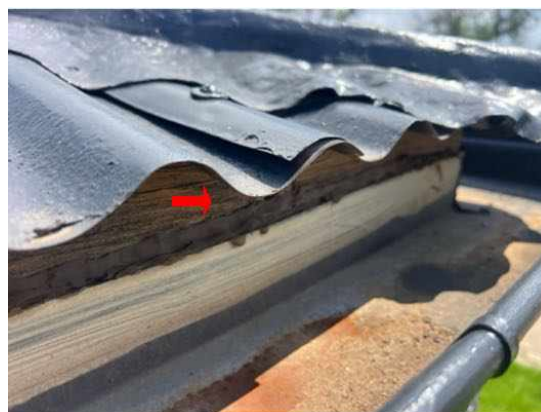
### Defects 3.17

Building:	Main Building
Location:	Roof Exterior - Verandah
Finding:	Timber - exposed to weather
Information:	External timbers that are frequently exposed to harsh weather conditions require adequate protection in order to maintain their condition. Where timbers have not been painted or treated adequately, general deterioration is likely to occur at an accelerated rate.

If left unattended, replacement of these timbers is likely to be necessary in the short-term future. Adequate treatment of these timbers is required as soon as possible by a painting contractor or general handyman.

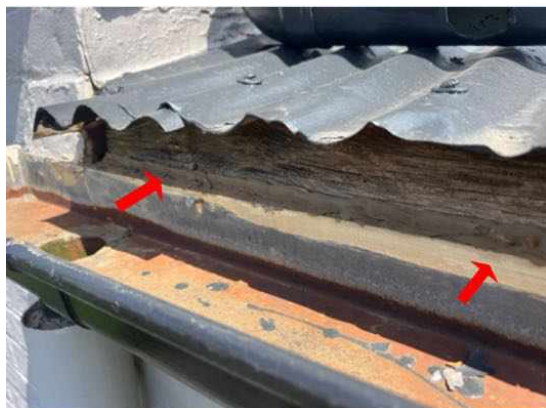
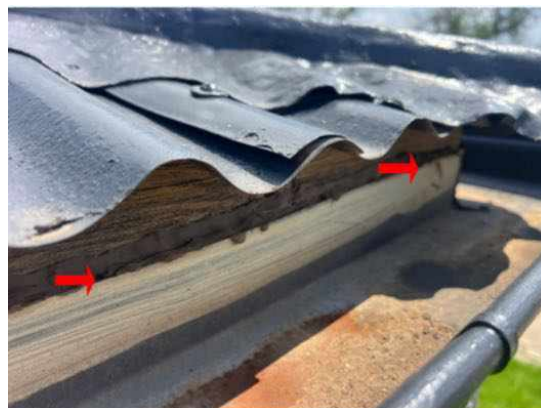
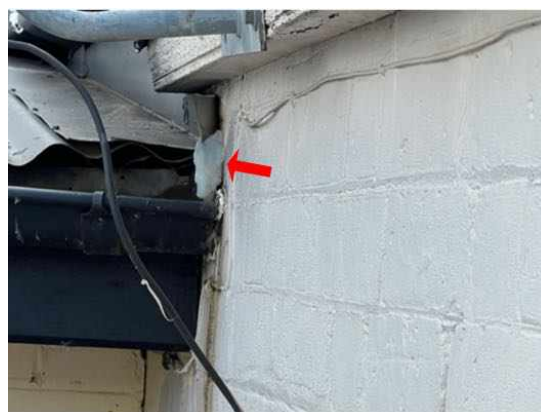
### Defects 3.18

Building:	Main Building
Location:	Roof Exterior - Verandah
Finding:	Exterior roof - Inadequate repairs
Information:	It appears that interim roof repairs have previously been undertaken, which have included application of silicone to address roof leakage.

Application of silicone should be viewed as a short-term solution to roof leakage, as it

does not provide adequate long-term protection against weather conditions and other causes of damage and deterioration. Any underlying structures that show signs of damage should be repaired and replaced to ensure the longevity of the roof covering and associated building elements.

Further consultation with a roof restoration company is highly advised. Inadequate roofing repairs are not likely to prevent roof leakage in the long-term future.

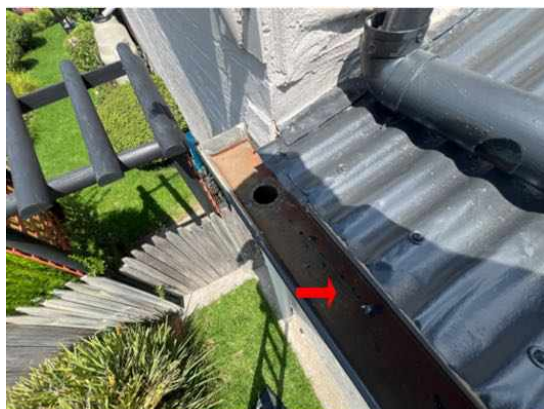
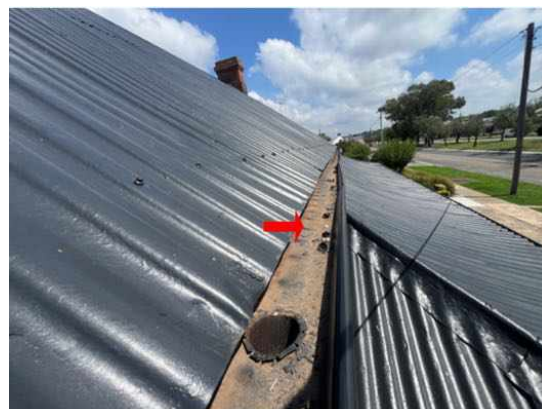
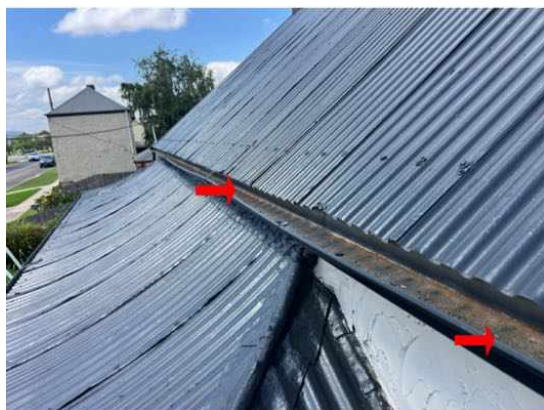
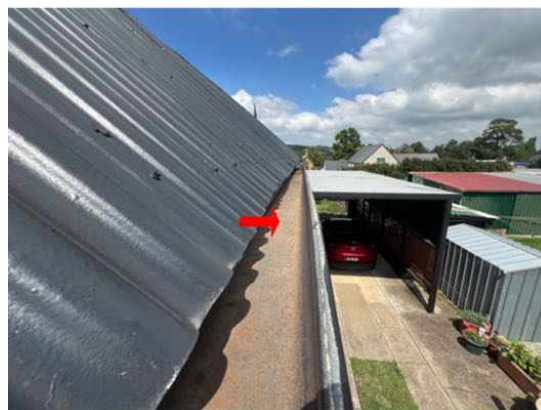
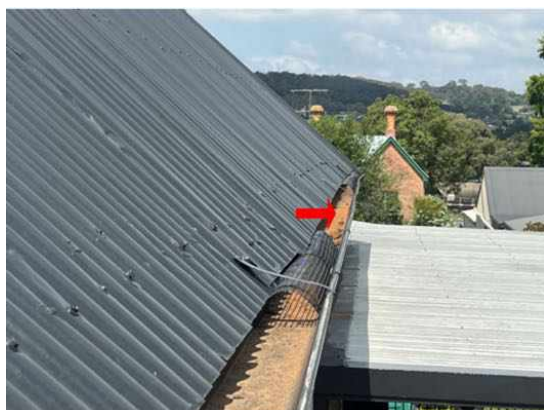
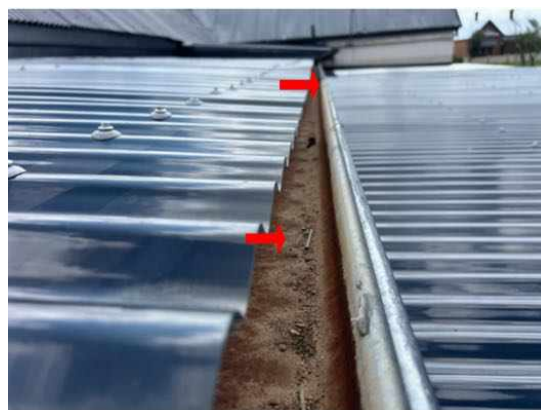
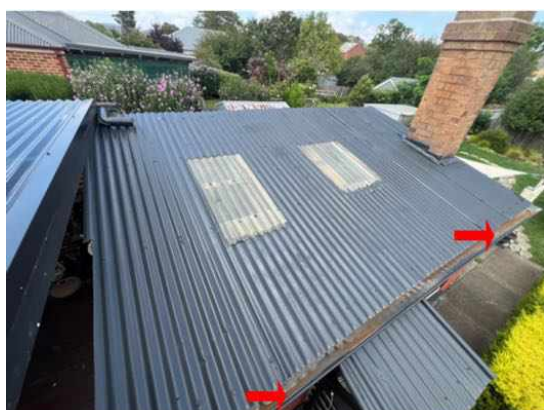
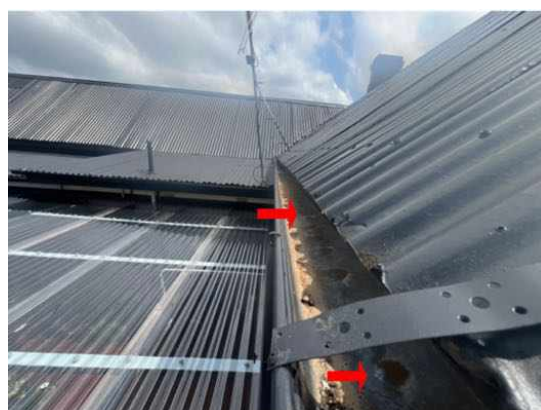
### Defects 3.20

Building:	Main Building
Location:	Roof Exterior
Finding:	Roof plumbing - Rusted or corroded
Information:	The roof plumbing has areas of rust and corrosion. It is suspected that this has been caused by blockages, resulting in pooling or standing water, that have prematurely rusted elements of the roof plumbing.

Rusted roof plumbing will generally develop holes and leaks that can affect other building elements with poor drainage of storm water. Poorly drained roof areas will also lead to damp conditions surrounding the base perimeter of the building which, if left unmanaged, can lead to a range of secondary building defects.

Repair and/or replacement of rusted roof plumbing is highly required in order to reinstate the roof drainage system to a fully operational level. To further maintain these areas, gutters should be cleaned frequently, allowing the avoidance of any partial blockages.

A licensed plumber or specialist roof restoration company should be appointed to undertake these works. It is advised that such works be completed as soon as possible to prevent any further damage and deterioration.

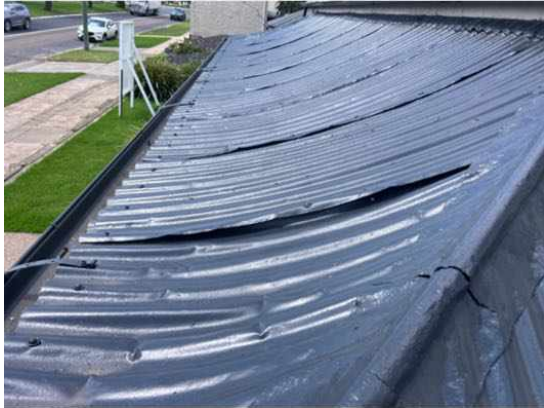
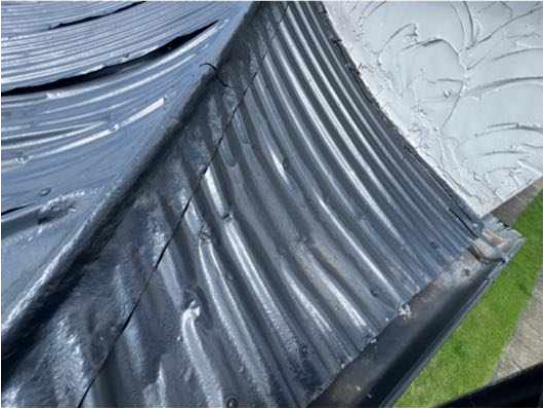
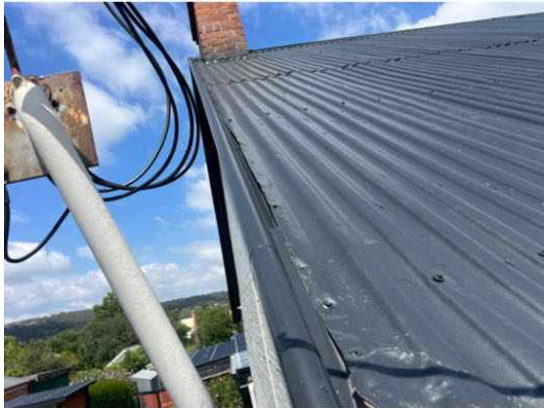
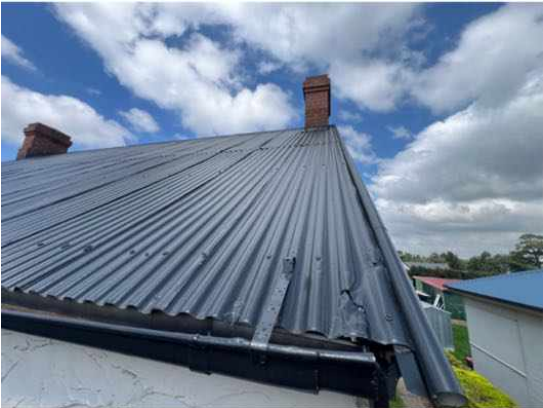
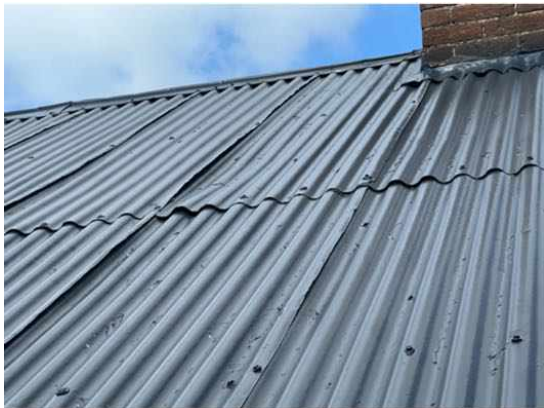
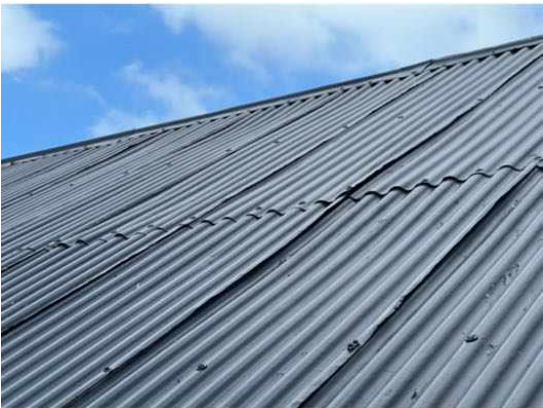
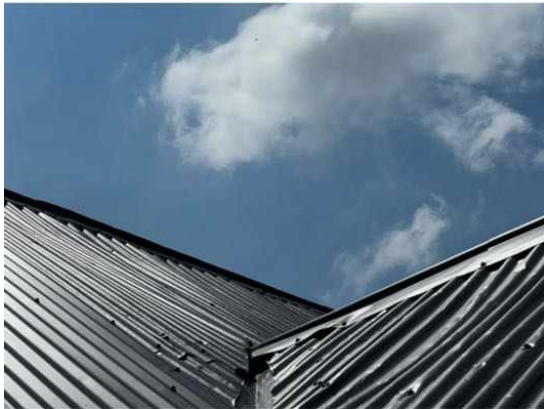
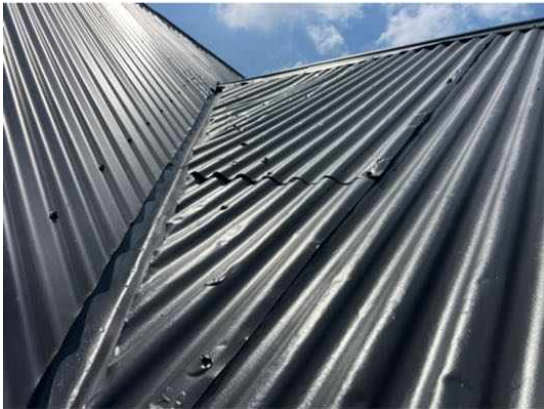
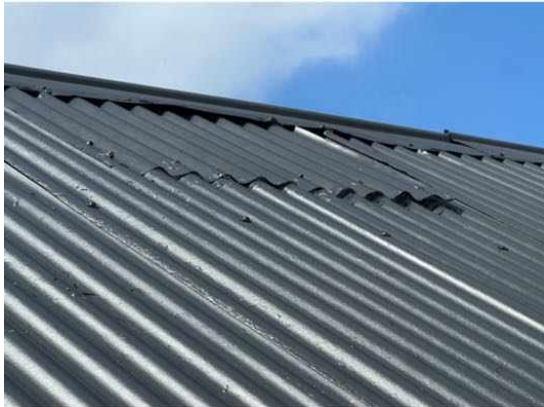
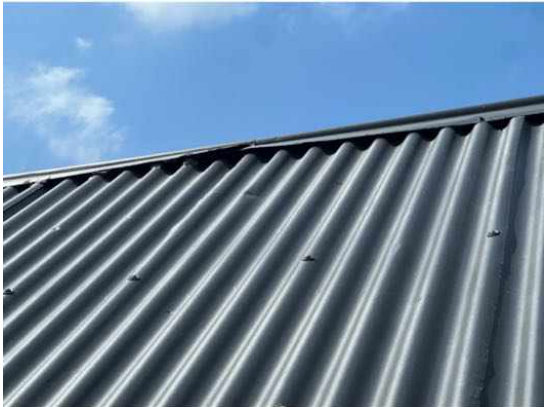
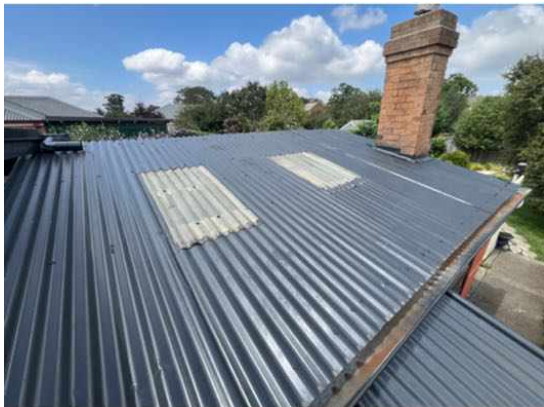
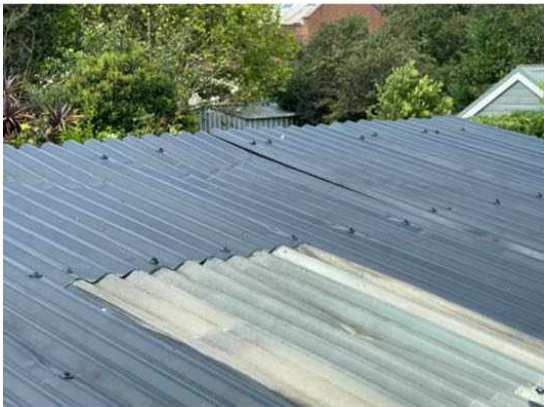
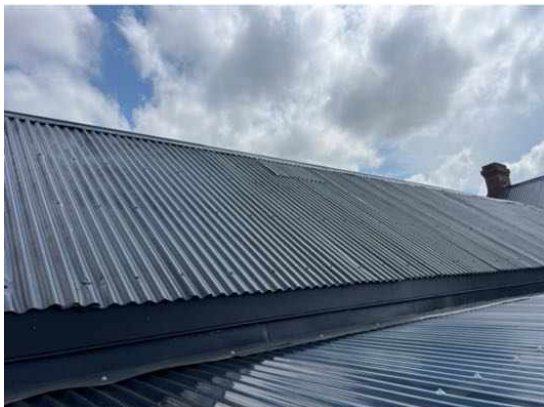
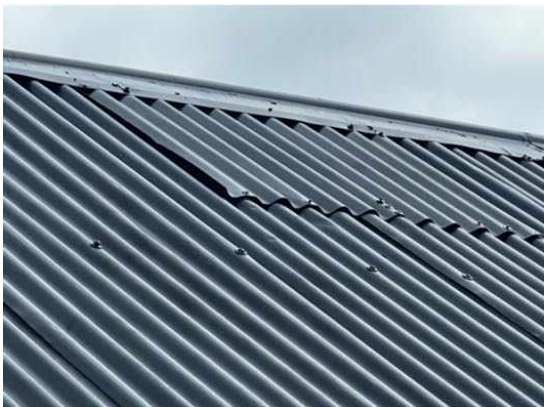
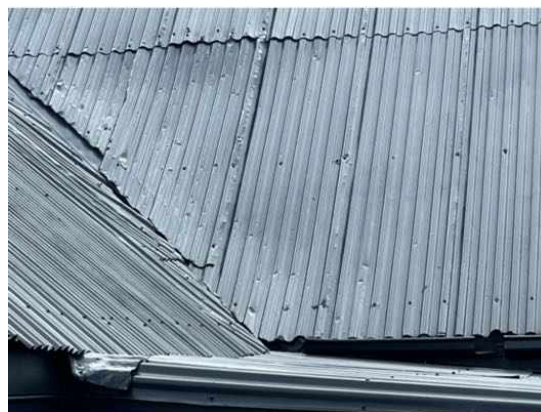
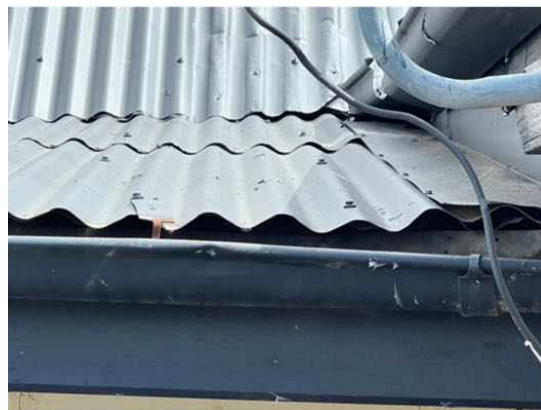
### Defects 3.21

Finding: Roof sheets - Deteriorated

Information: Upon inspection of the exterior roofing, it was found that the roof sheets show signs of deterioration, with some sheets having come loose from their original fixing. The roofing has sustained an array of issues due to the age of the materials and a lack of general maintenance over time, including loose sheeting, lifting and sagging of sheets, and deterioration of associated building elements.

Loose, deteriorated and damaged roof sheets are susceptible to water penetration, exposing the surrounding associated area to internal roof leaks and water damage.

Re-fixing of all loose roof sheets should be conducted as soon as possible to ensure that no further damage occurs. Depending on the extent of the damage, replacement of sections of roof sheets or associated materials may be required. Engagement of a roofing restoration contractor is highly advised to perform remedial works as necessary.

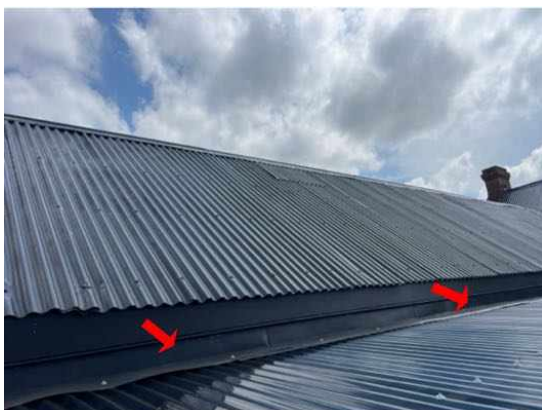
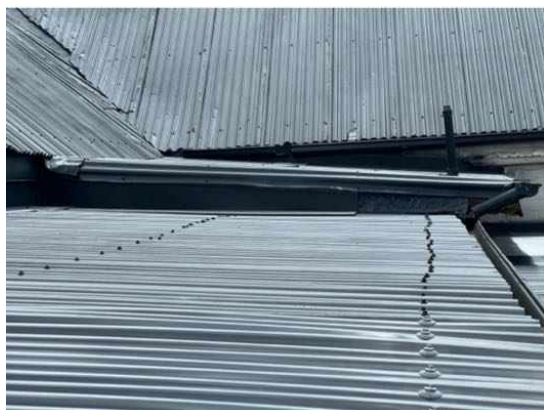
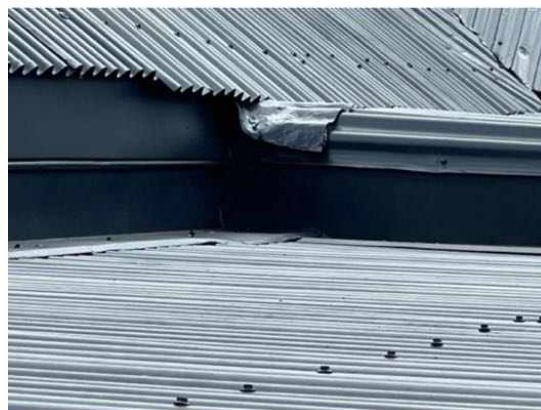
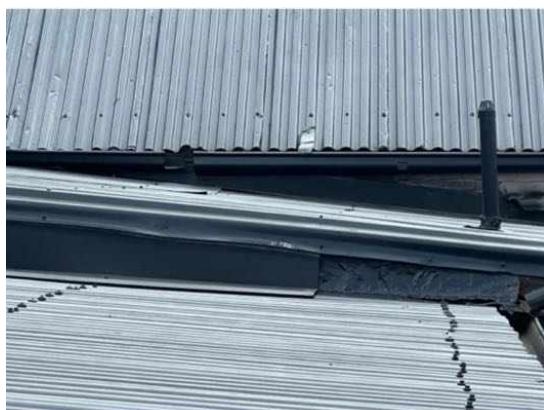
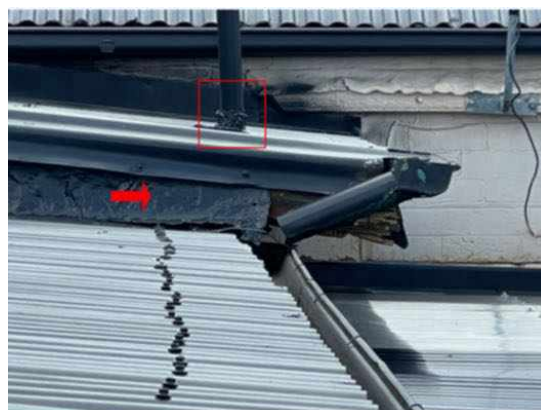
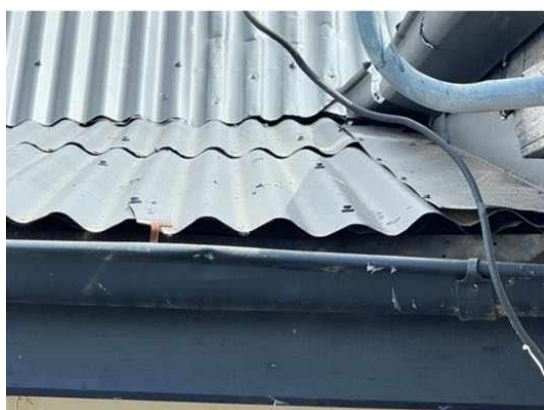
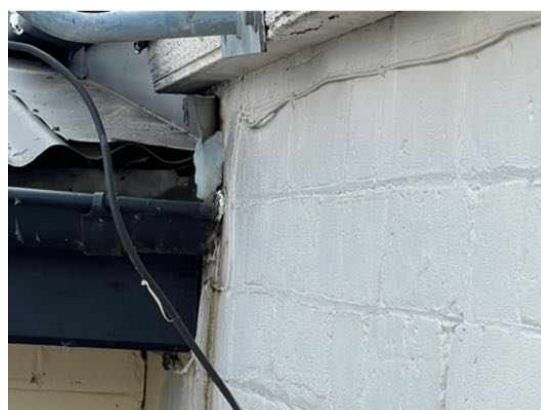
### Defects 3.23

Building:	Main Building
Location:	Roof Exterior
Finding:	Roof plumbing - Flashing inadequate
Information:	Some sections of the roof are missing or have inadequate roof flashings. Flashings are metal and other materials which are applied to seals and intersections between roof coverings and building elements. They are designed to aid in weatherproofing of roof joins.

Flashings that are not installed adequately or are missing are likely to result in water penetration to the interior of the property, as well as creating excessively damp conditions against the exterior surfaces and around the base perimeter of the building.

Premature ageing and secondary building defects are imminent where roof plumbing is missing or inadequately installed. Additionally, water pooling also creates an environment that is susceptible to termite and pest infestation.

A roofing plumber should be appointed as soon as possible to install relevant roof plumbing materials, ensuring that no further damage is sustained.

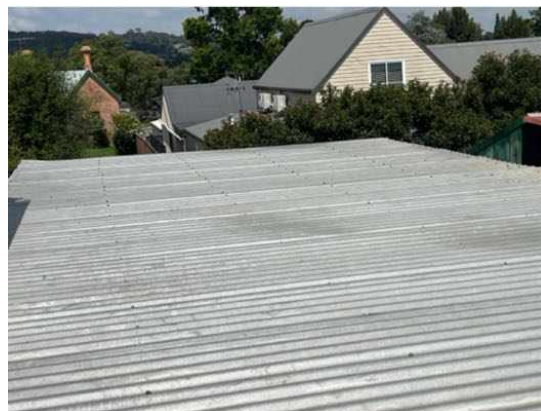
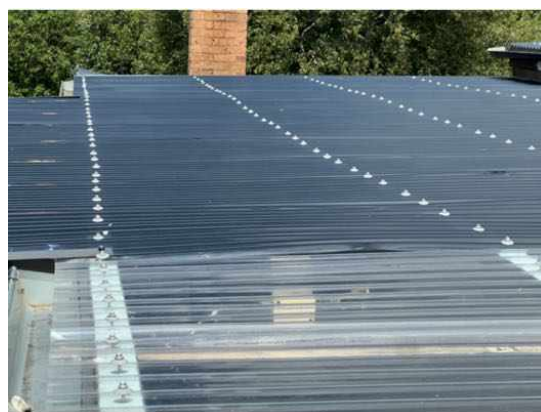
### Defects 3.24

Building:	Main Building
Location:	Roof Exterior - Carport, Pergola
Finding:	Exterior roof - Insufficient fall
Information:	It was identified that there is insufficient fall or angle in the roofing structure, which is leading to pooling of water and an array of secondary related building defects. Such defects are likely to include material deterioration, leaks and/or corrosion of associated building materials.

The angle of the roof is insufficient to facilitate the effective drainage of rain water to the roof plumbing systems. Over time, if this defect is not addressed (potentially including structural changes to the roof), further building defects will develop.

Consultation with a roofing plumber or roofing restoration contractor is required for quotations regarding these works. Where water pooling is quite significant, structural alterations to the roof may potentially be expensive and time-consuming.

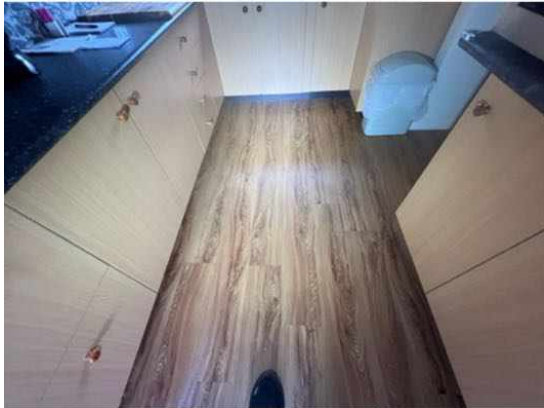
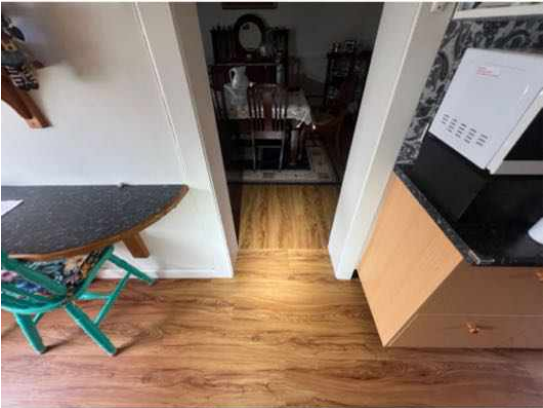
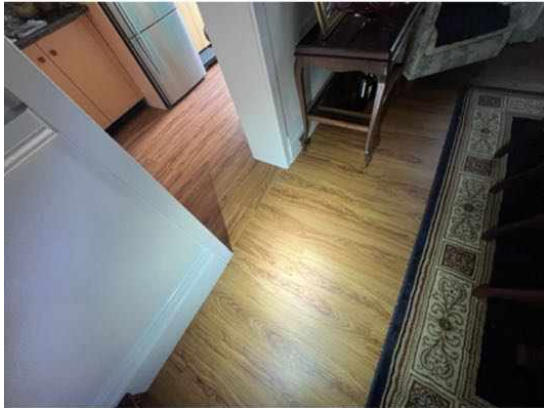
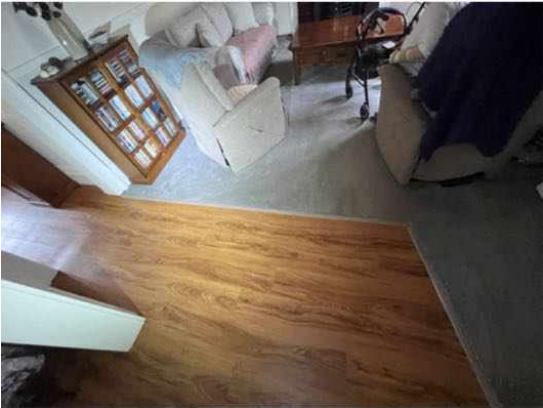
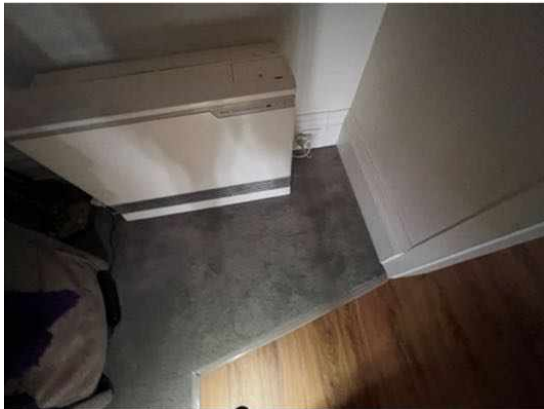
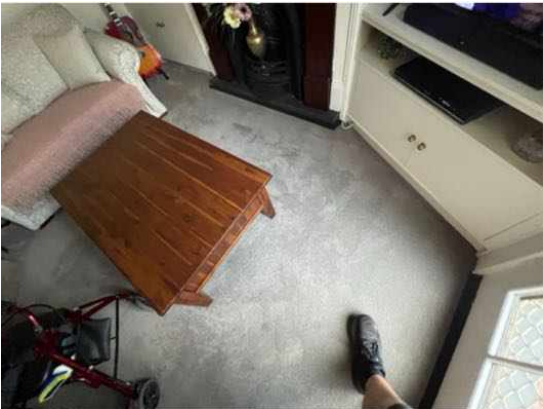
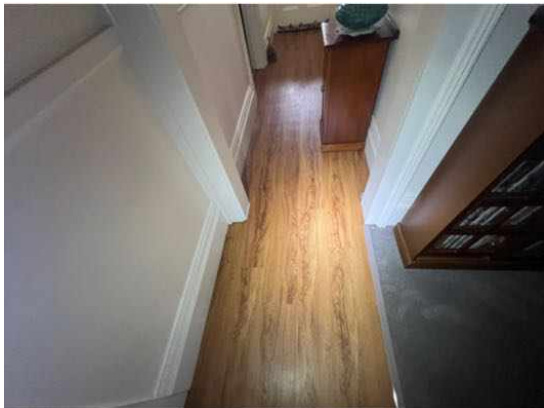
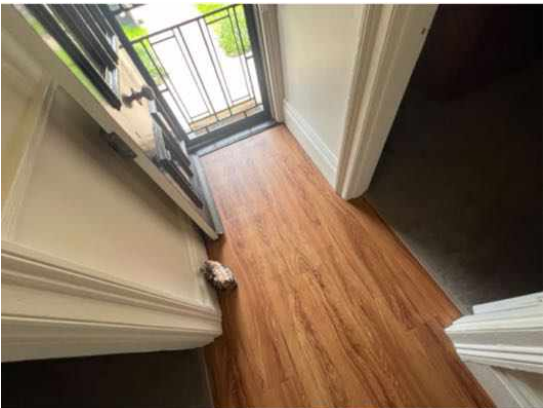
### Defects 3.25

Building:	Main Building
Location:	All Internal Areas
Finding:	Flooring - Uneven
Information:	The internal flooring in this area is out of level and uneven. Uneven flooring is likely to indicate minor defects such as expected movement of the foundations of the property, but may also indicate subsidence of the associated subfloor stumps.

It is advised that the flooring be closely monitored to identify any further movement. Where flooring remains relatively unchanged for an extended period of time (i.e. several months), it is likely that this defect has been caused by expected movement of the foundations of the property.

However, where flooring is uneven further, potentially invasive inspection of the subfloor structures and stumps in this area is required. In this case, works to repair are likely to be required, and would be carried out by a registered builder specialising in re-stumping.
