## Building Inspection Report

Inspection Date: Fri, 6 Mar 2026

Property Address: 47 Grafton St, Goulburn NSW 2580,  
Australia

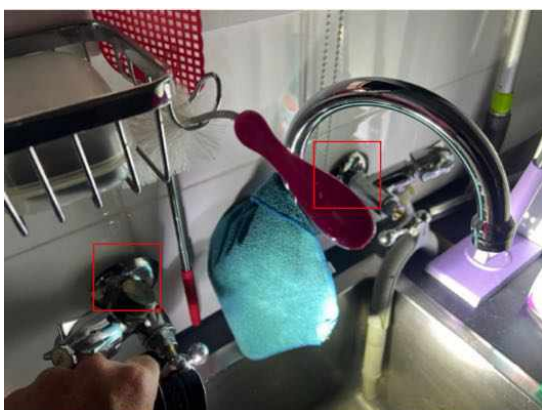
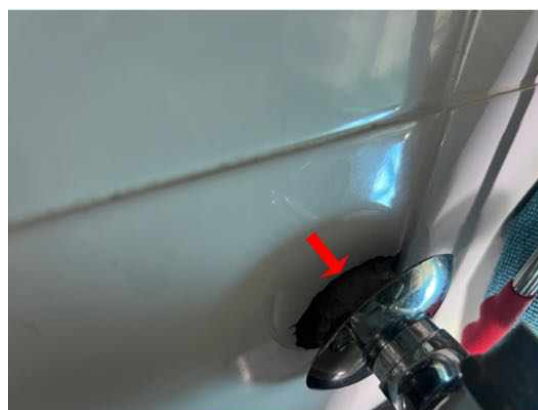
### Defects 3.27

Information: The tap set was observed to be severely loose and not securely fixed within the wall at the time of inspection. The fixture moves freely when operated, indicating it is not properly supported by the wall structure or mounting bracket.

Tap fittings that are not adequately secured may place stress on the connected plumbing pipework during use. Continued movement of the fixture may lead to loosening of pipe connections, potential water leaks, or damage to surrounding wall materials.

A licensed plumber should be appointed to assess the installation and secure the tap set to ensure the fixture is properly supported and operating as intended.

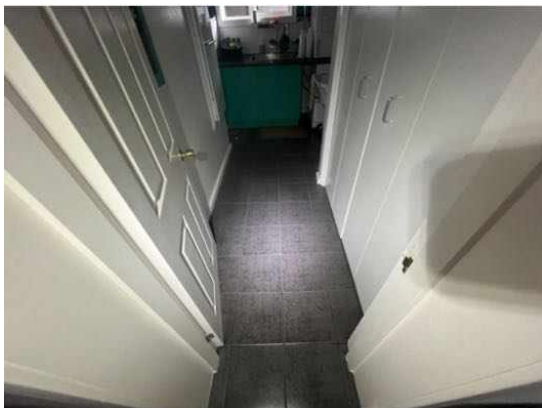
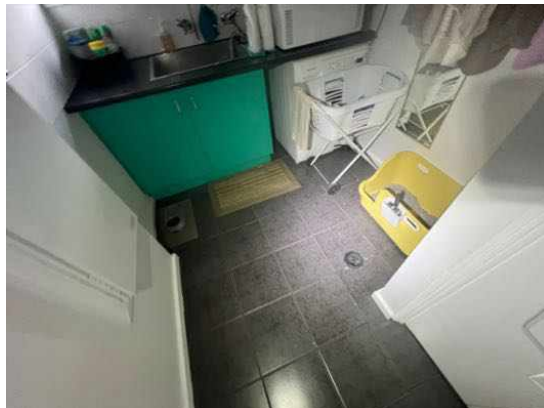
### Defects 3.29

Building:	Main Building
Location:	Laundry, Toilet (WC)
Finding:	Floor tiles - Uneven
Information:	The tiled flooring area appears to be uneven in this area. While this may indicate a failure of the subfloor structure, it is suspected, in this case, that the area has been subjected to poor tiling workmanship at the time of installation.

Where poor workmanship is the cause of uneven tiling, the tiled surface level is unlikely to decrease further. If unevenness does increase over time, this may indicate issues with the associated flooring structure.

Where uneven tiled flooring appears to be a result of poor tiling work, a tiling contractor should be appointed to re-instate the flooring at the discretion of the client. Where flooring remains uneven, further inspection of the flooring structure may be required.

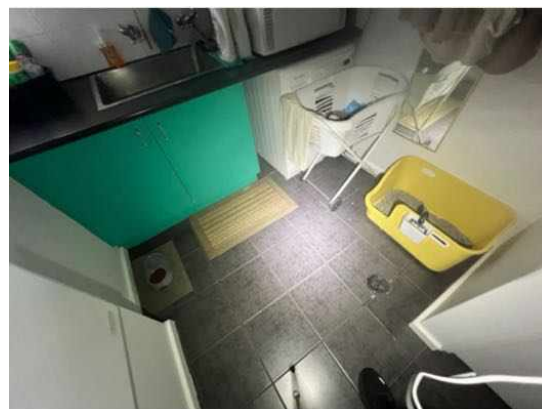
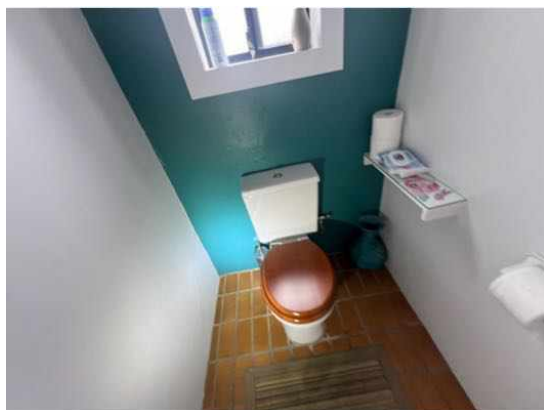
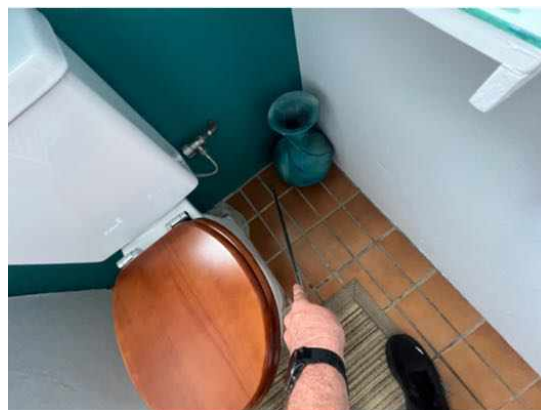
### Defects 3.30

Building:	Main Building
Location:	Laundry, Toilet (WC)
Finding:	Tiles - Drummy
Information:	Drummy tiled areas were identified at the time of inspection. The term 'drummy' refers to tiles that have become detached from their fixing, despite otherwise being in relatively good condition. Such defects are generally caused by physical or moisture damage to the area. Drummy tiled areas may also be a direct result of poor workmanship during the construction process.

Tiled areas may swell and shrink with changes in air humidity if the area has sustained moisture damage. Any exposure to moisture is capable of causing tiled areas to become drummy and/or cracked over a prolonged period of time. Drummy tiled areas generally require removal and replacement of affected tiles, with adequate sealant and grouting.

Specialist trades are available for these types of services. A registered builder may be required to undertake works if damage is extensive or if secondary building defects have resulted. Otherwise, it is advised that a tiling contractor be appointed to perform works as necessary. Immediate action is recommended to ensure that no further damage is sustained in the affected area.

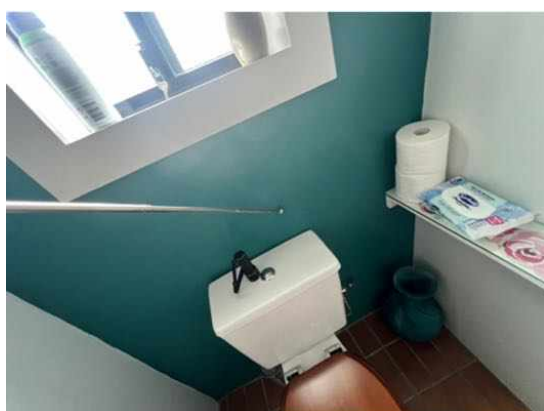
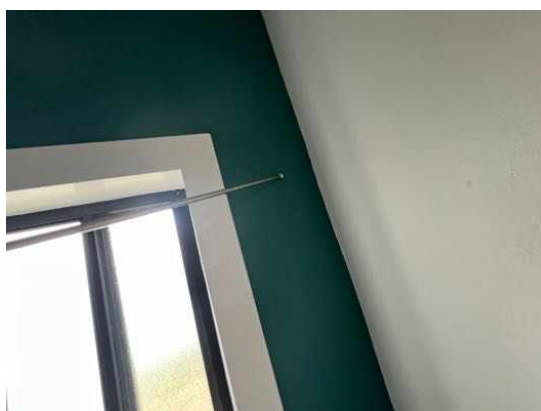
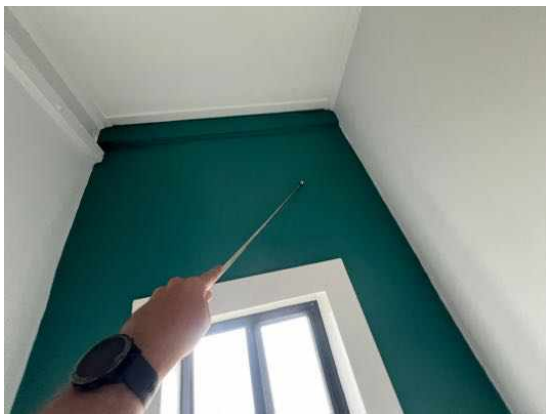
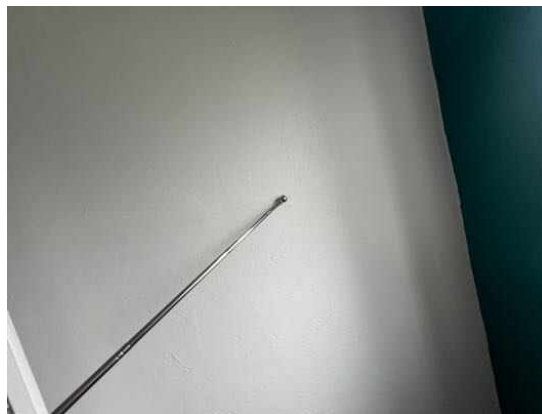
### Defects 3.31

Information: Drummy rendered areas were identified at the time of inspection. The term 'drummy' refers to render that has become detached from its fixing, despite it still being solid. Such defects are generally caused by physical or moisture damage to the area. Drummy render may also be a direct result of poor workmanship during the construction process.

Render may swell and shrink with changes in air humidity if the area has sustained moisture damage. Any exposure to moisture is capable of causing rendered areas to become drummy and/or cracked over a prolonged period of time. Drummy render generally requires chipping off and re-rendering or painting.

Specialist trades are available for these types of services. A registered builder may be required to undertake works if damage is extensive, or if secondary building defects have resulted. Immediate action is recommended to ensure that no further damage is sustained in the affected area.

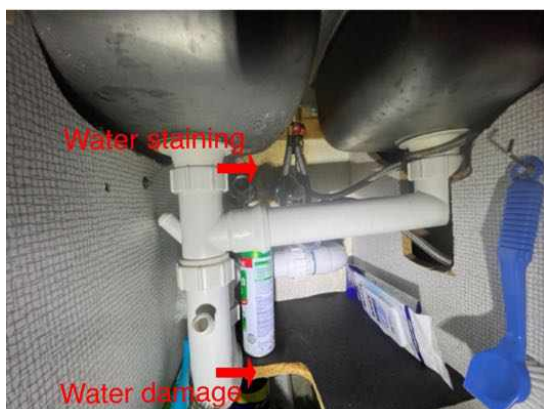
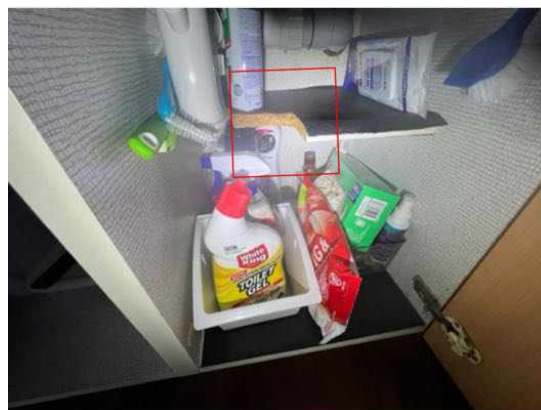
### Defects 3.32

Building:	Main Building
Location:	Kitchen
Finding:	Shelving - water damage
Information:	Water damage was observed to the shelving within the sink cabinet. This type of defect is typically caused by prolonged moisture exposure from minor plumbing leaks, condensation, or poor sealing around fixtures and fittings.

If left unmanaged, water ingress can lead to swelling, delamination, or deterioration of the joinery, potentially compromising its functionality and hygiene. Moist conditions in enclosed cabinetry may also create an environment conducive to mould or timber pest activity.

It is recommended that a licensed plumber be engaged to inspect the sink plumbing for leaks or seepage. A cabinetmaker or qualified joiner may also be required to replace the affected shelving or restore the unit where practical.

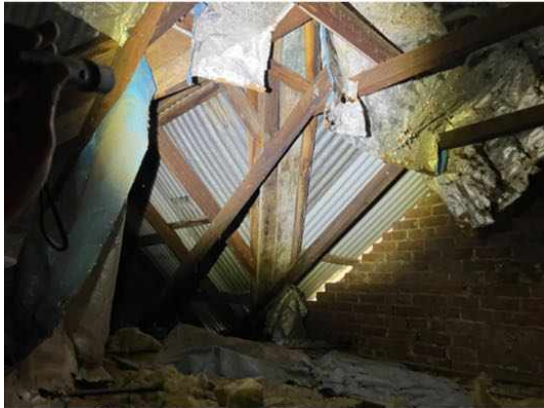
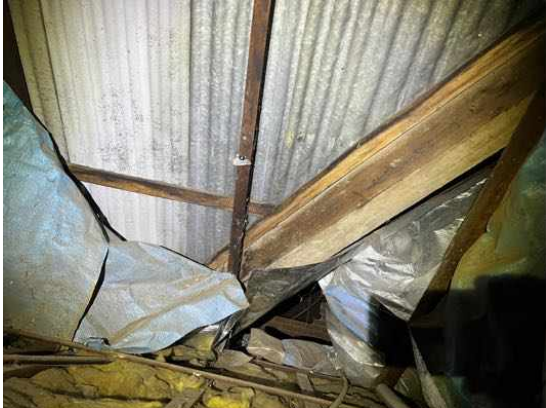
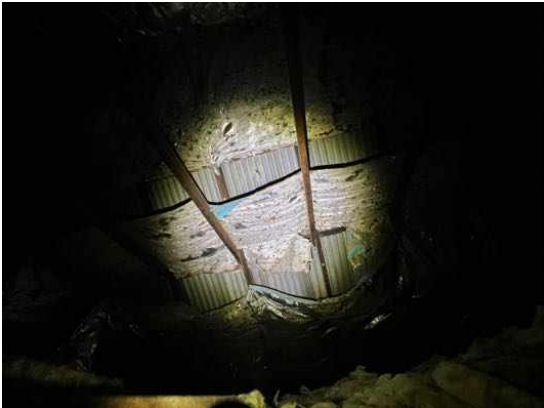
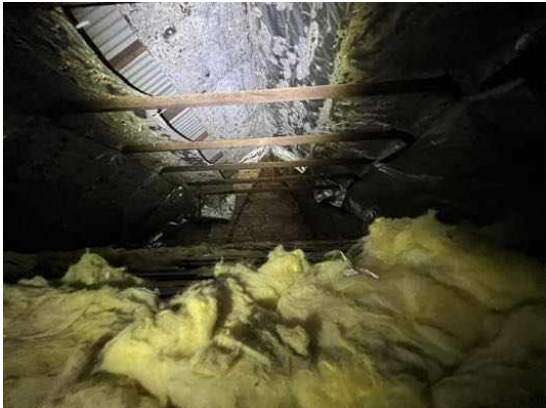
### Defects 3.36

Building:	Main Building
Location:	Roof Void
Finding:	Sarking - Damaged
Information:	Sarking, a laminated aluminium foil applied to the interior of the roof covering, assists in insulating the property and acting as a vapour-barrier to the roof void and, subsequently, to the household.

Where sarking is damaged, both insulation and moisture protection of the property are inhibited. This creates a loss of energy and thus negatively impacts the energy efficiency of the property, allowing potential for moisture ingress from condensation or leaking roof tiles.

It is important to repair any holes or damaged sections of sarking to ensure that the building material is fully functional. A registered builder or qualified carpenter should be consulted to provide further advice on this defect and to perform rectification works at client discretion.

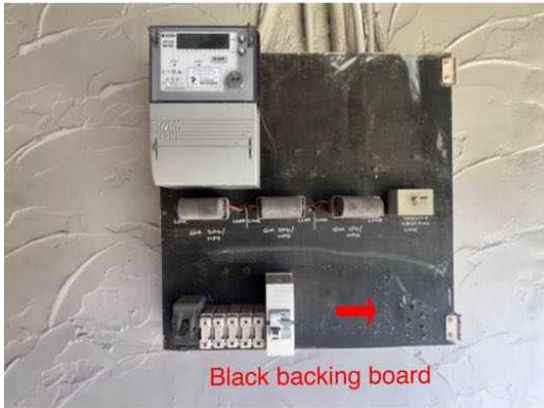
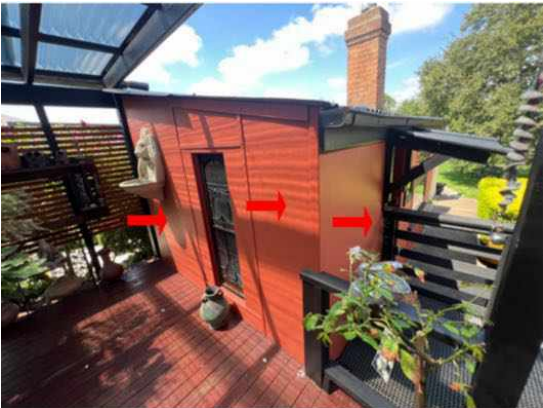
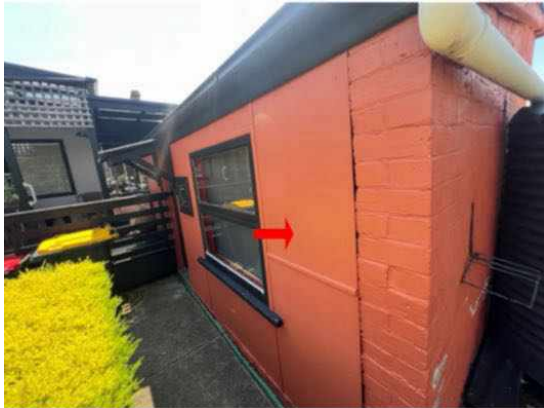
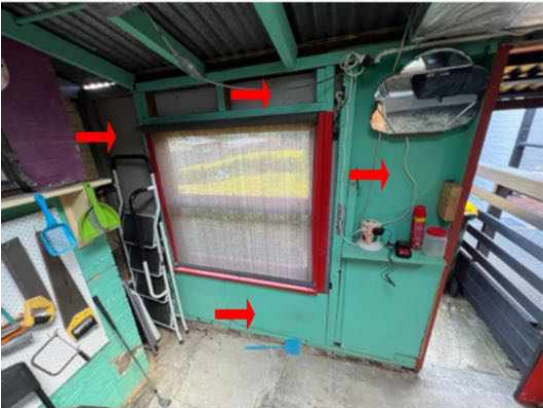
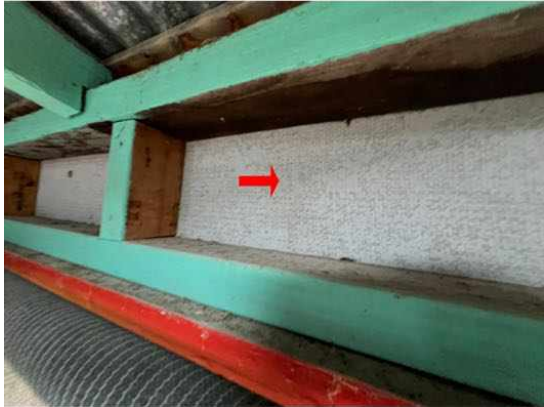
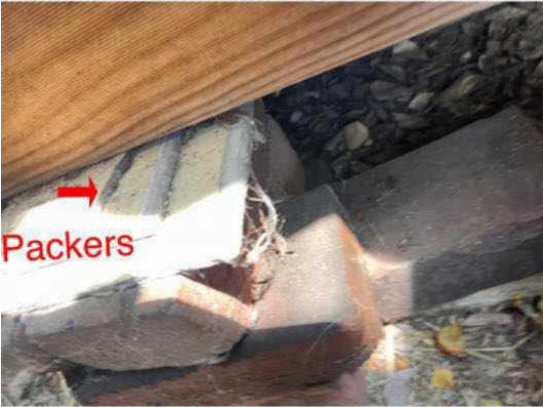
Building:  
 Location: Meterbox, Shed - Brick, Deck  
 Finding: Asbestos - Suspected ACM Identified on Site  
 Information: Reporting on Asbestos is outside the Scope of this Report. This suspected defect is

As Asbestos Reporting is outside the scope of this report, we advise that you consider a separate Asbestos Inspection and Condition Audit, which can include the taking of samples for definitive confirmation of the presence of Asbestos.

In the interim, the client is advised to act with caution, especially when considering any damage to building materials general wear and tear renovations extensions demolition and general maintenance activities due to the suspected presence of Asbestos.

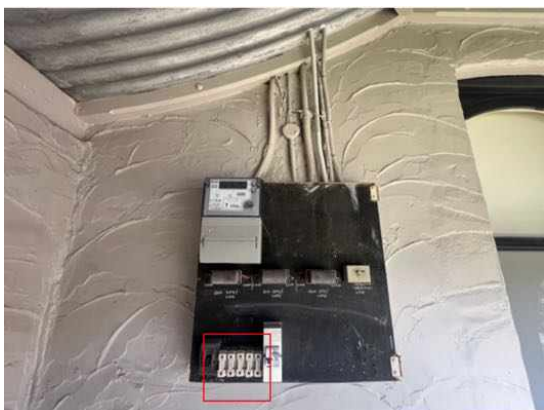
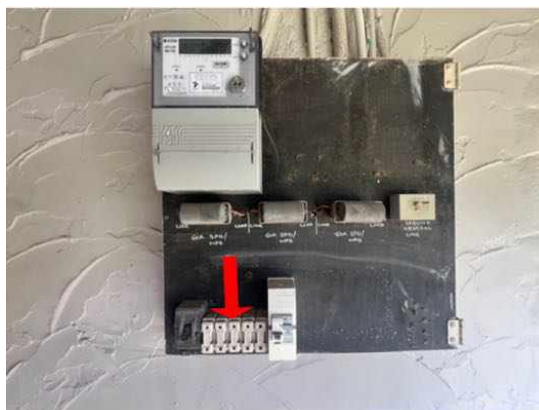
Building: Main Building  
 Location: Exterior walls - front  
 Finding: Electrical switchboard - Old ceramic fuses  
 Information: The electrical switchboard while appearing to have adequate safety switches installed has old ceramic fuses in place.

While this on its own on is not considered a defect it is noted for the clients consideration that a switchboard upgrade may be required in the short to mid term to improve the functionality of the electrical system. A licensed electrician could be appointed to provide quotation for the works at the client's discretion which may in turn expose other required works to bring the system up to a compliant state.

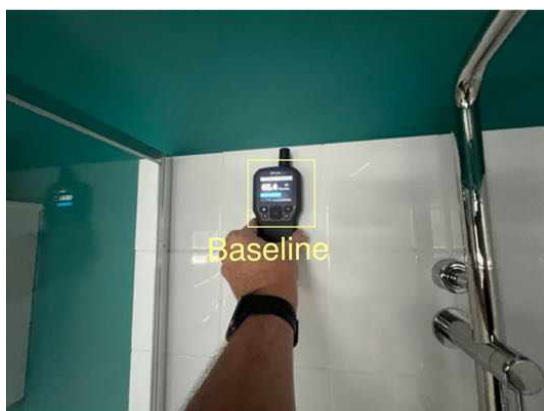
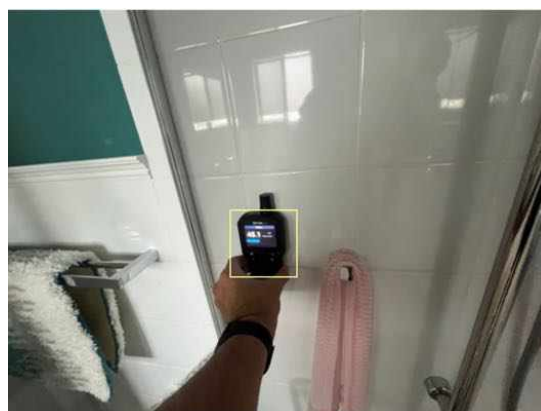
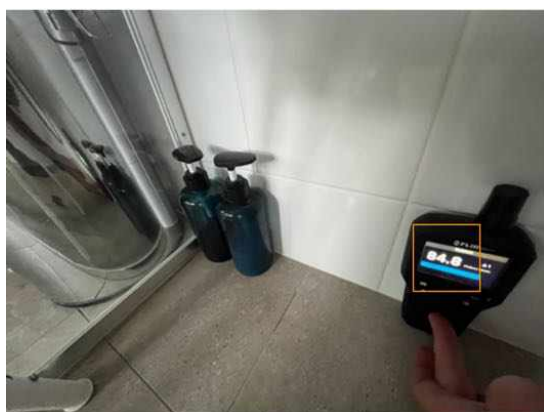
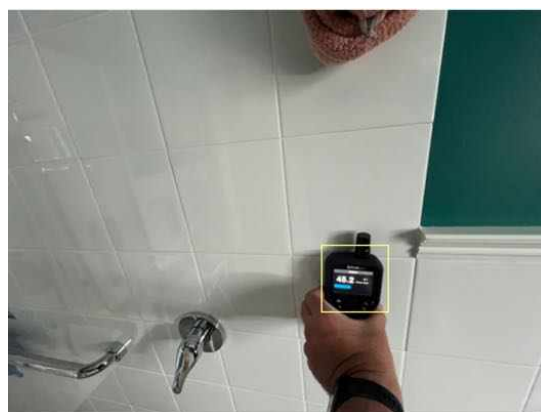
Building: Main Building

Location: Bathroom  
 Finding: Moisture in shower - No action required  
 Information: Moisture is evident behind the tiles to the shower alcove. This defect is quite common, and is suspected to have been caused by moisture permeating through the grouting in this area.

Given that no moisture was detected around plumbing and at the other side of the wall, no action is required on this defect.

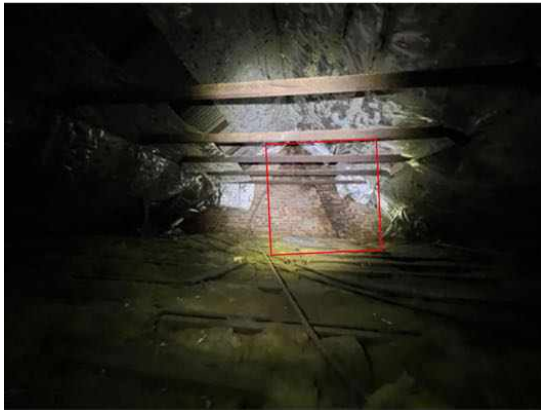
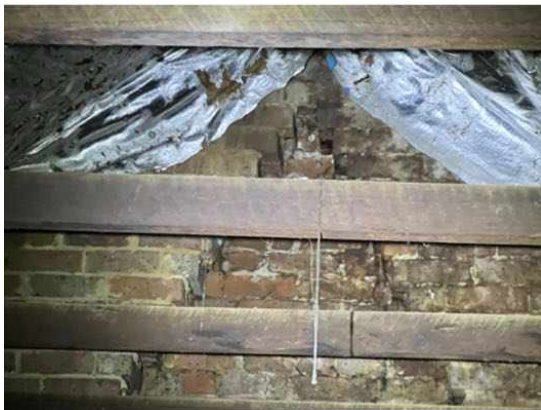
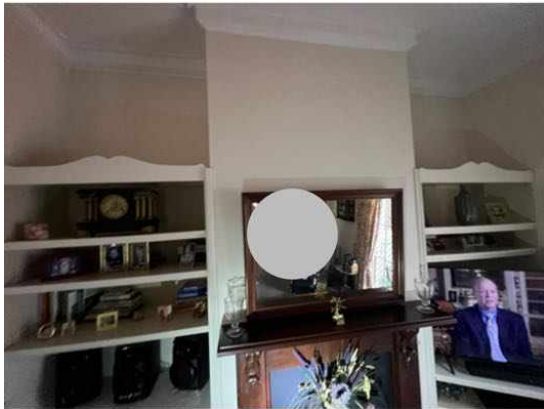
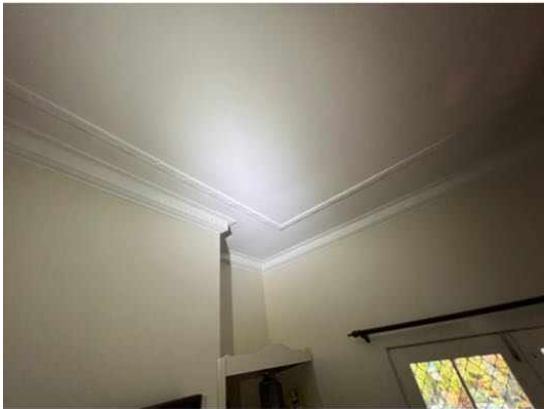
Building: Main Building  
 Location: Roof Void

Finding: Brickwork - Evidence of Past Moisture Staining

Information: Sections of the masonry within the roof space exhibited localised staining and discolouration consistent with past moisture exposure. Such staining may occur from historical roof leaks, condensation, or prior moisture migration through masonry.

At the time of inspection, no active moisture, damp insulation, or visible deterioration to adjacent timber framing was identified in the immediate area. Additionally, no corresponding staining or moisture damage was observed to the ceiling lining below the affected location.

While the staining appears historic in nature, the area should be monitored for any future signs of moisture ingress. If staining progresses or moisture becomes evident, further assessment by a licensed roofing contractor may be required to identify the source.

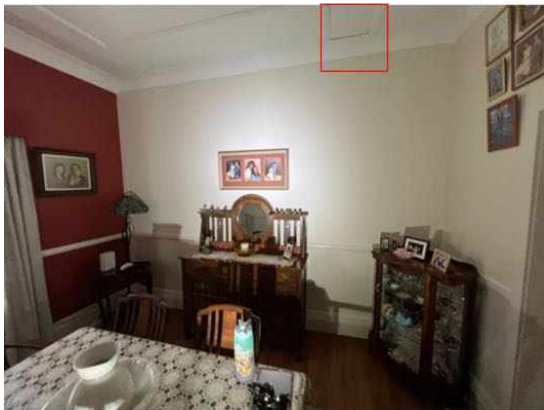
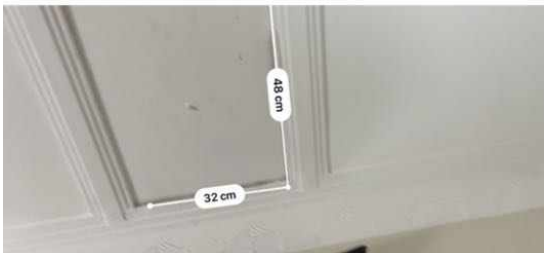
Building: Main Building  
Location: Roof Void  
Finding: Roof void access limitations  
Information: Limited access to the roof void was present due to facts including but not limited to access hatch size or placement, for this reason access to the roof void was minimal.

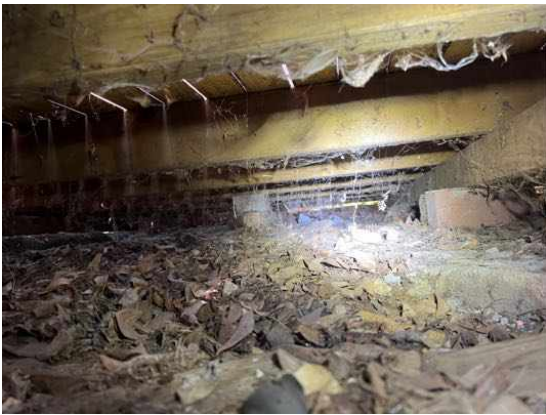
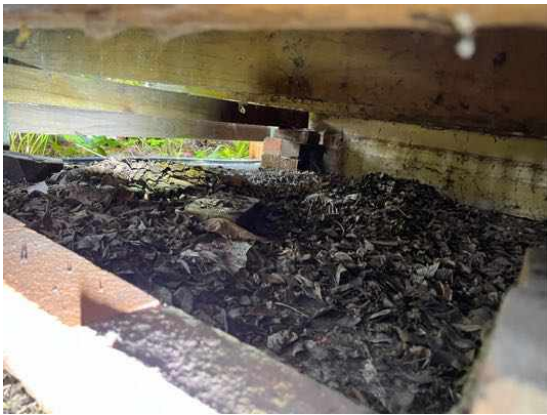
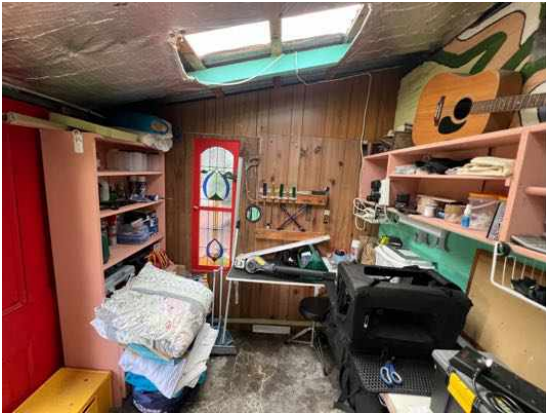
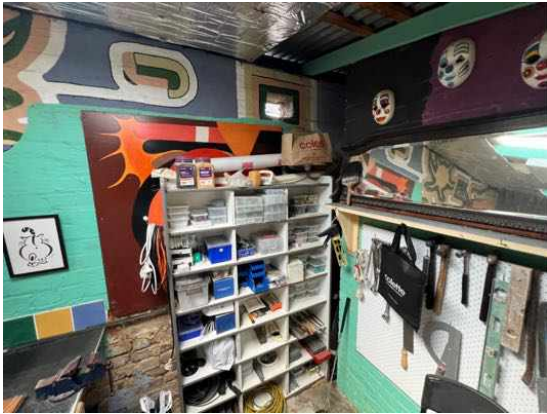
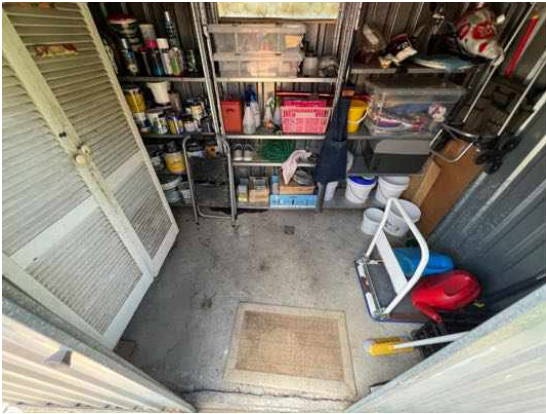
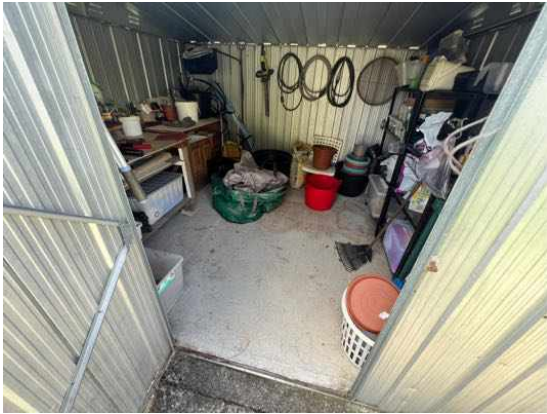
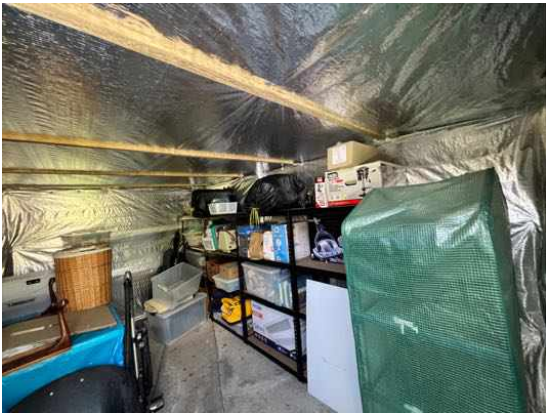
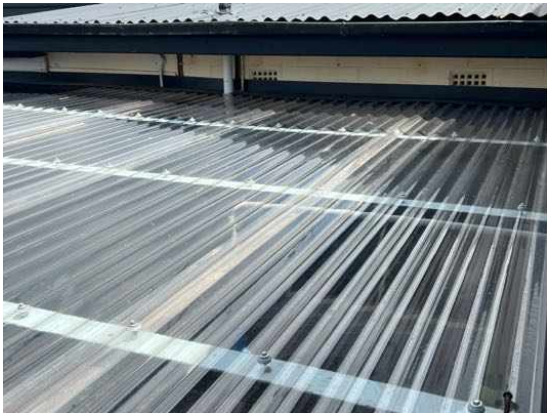
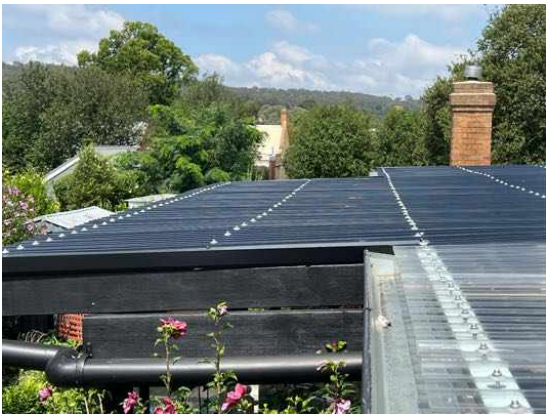
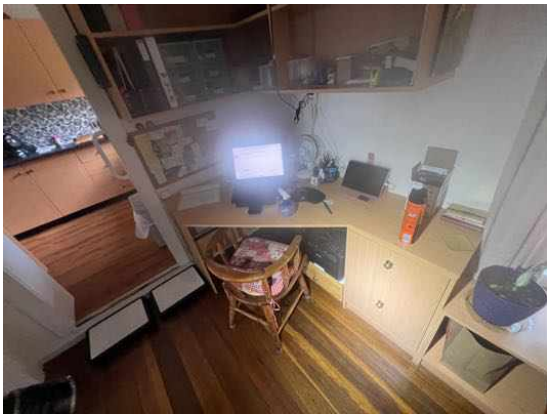
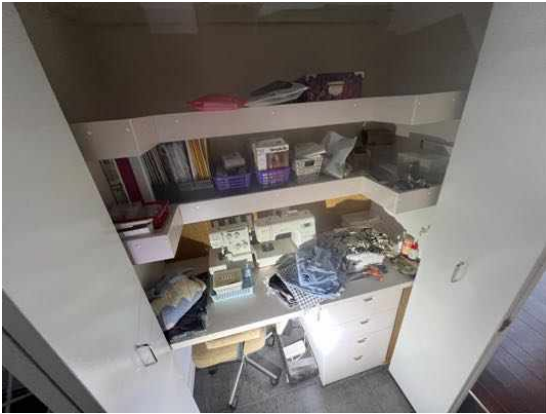
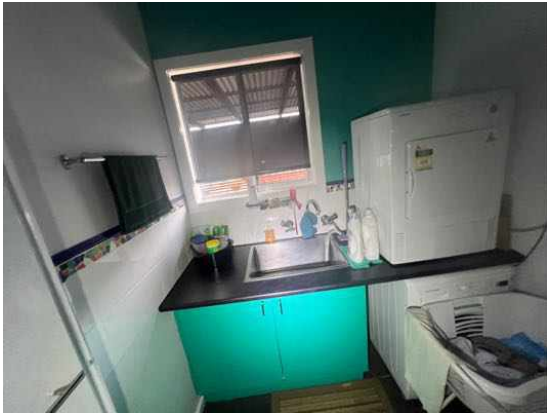
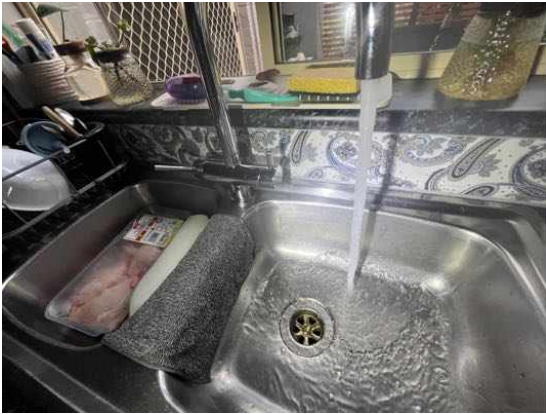
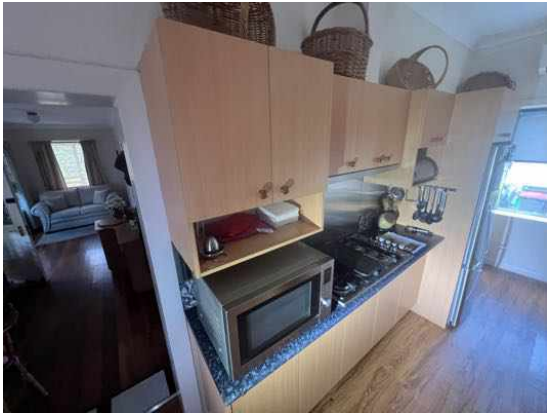
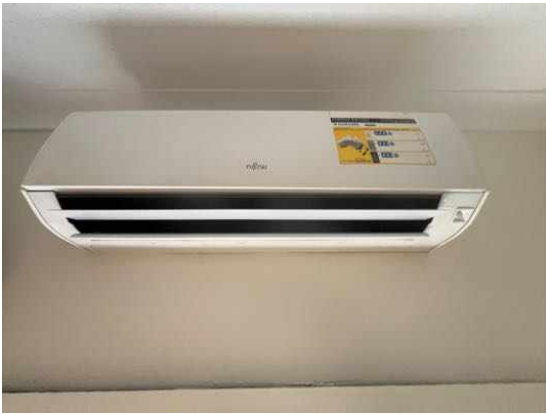
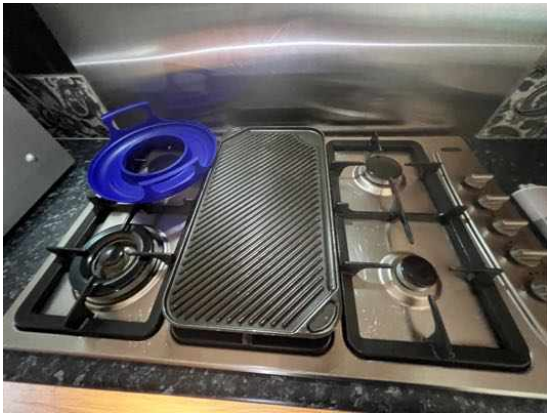
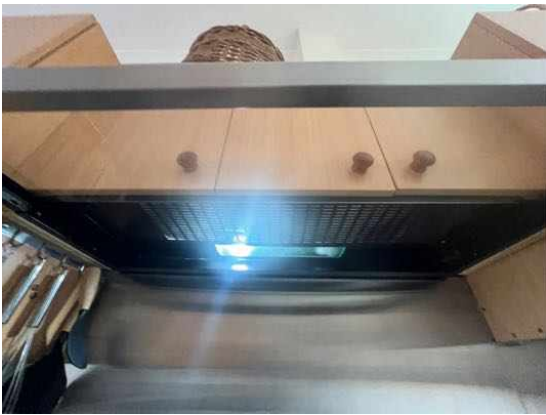
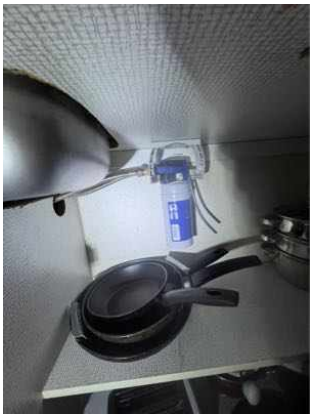
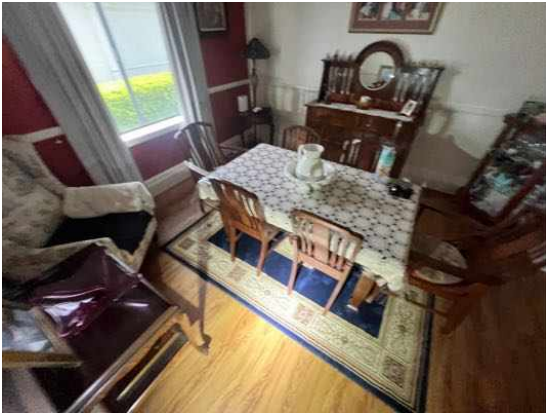
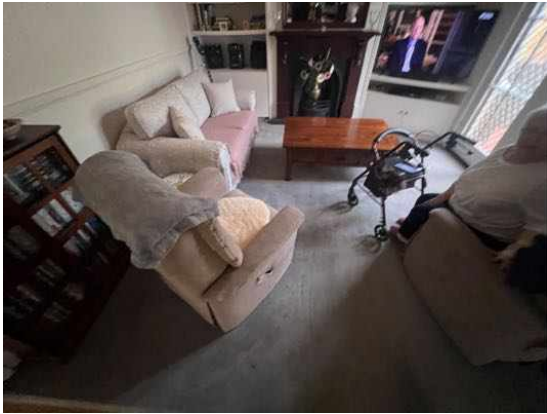
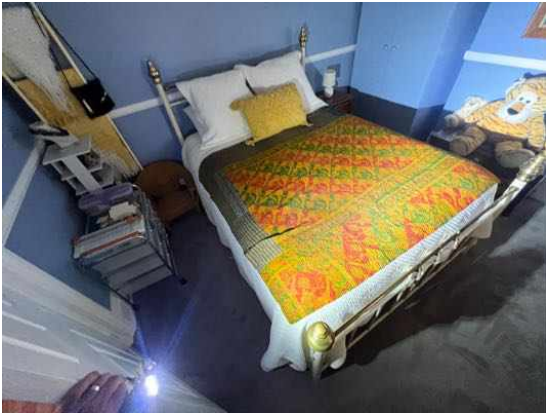
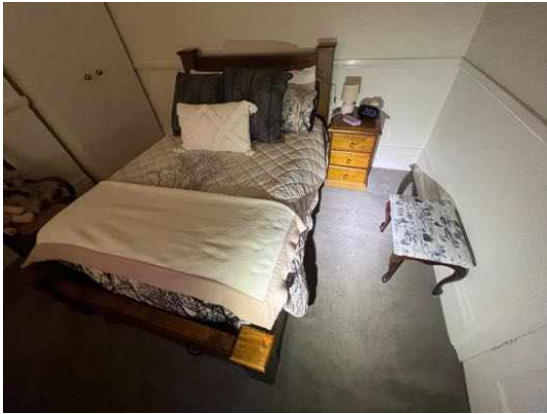
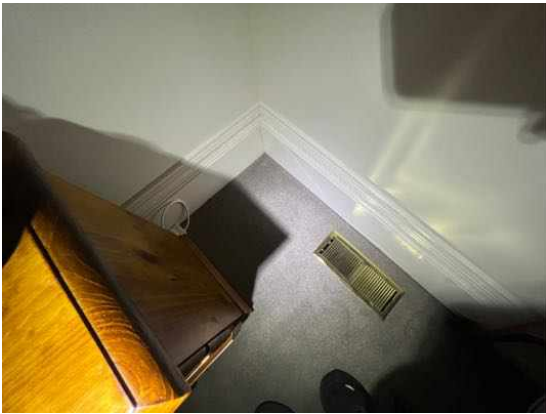
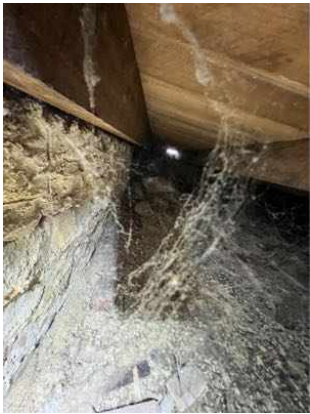
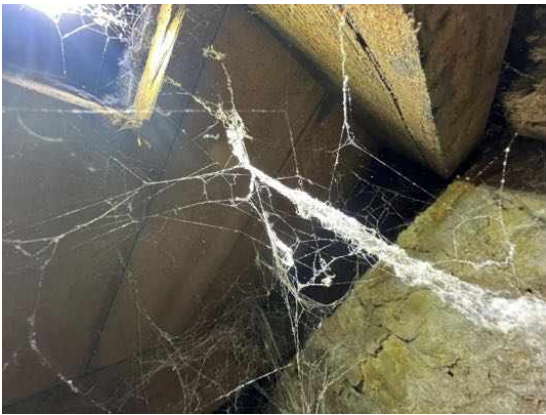
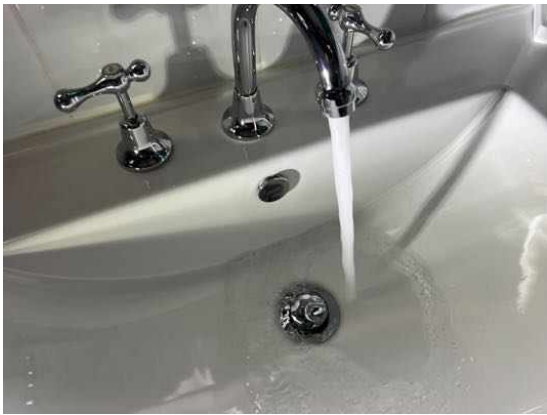
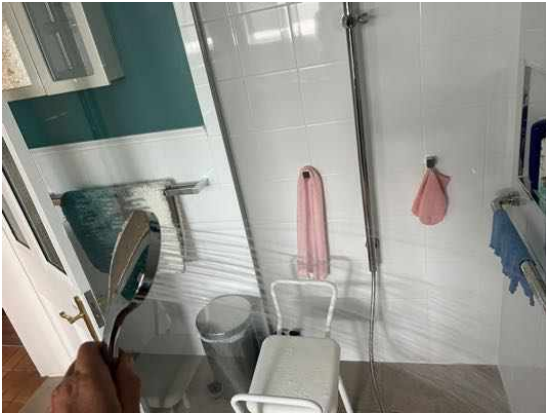
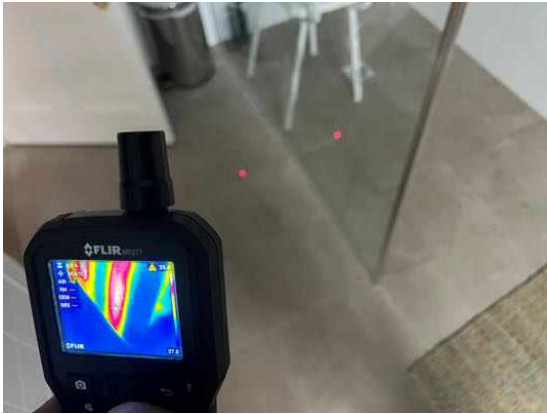
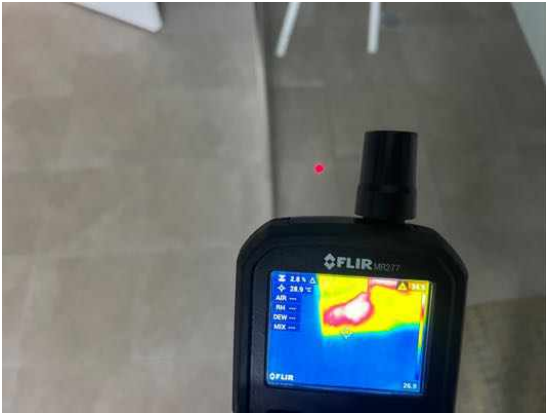
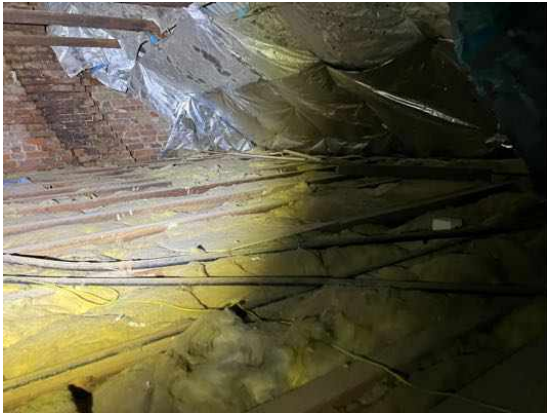
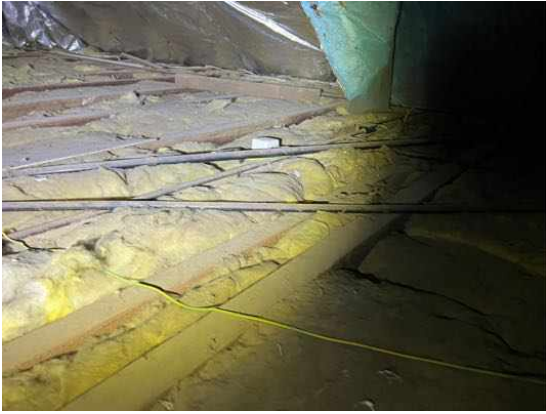
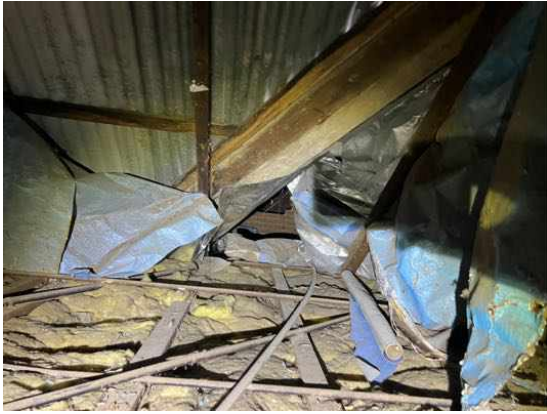
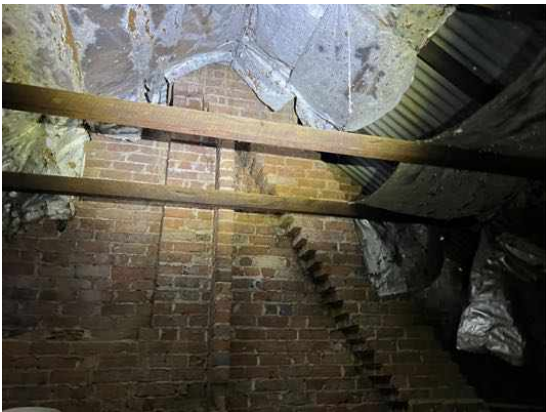
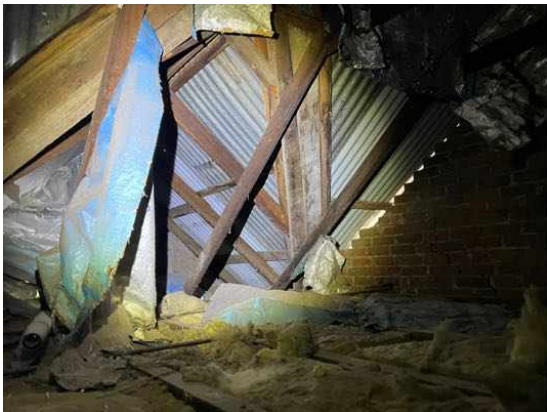
Building: Main Building  
Location:  
Finding: FYI - Additional Photos  
Information: Additional photos are provided for your general reference and may include obstructions, testing of water & windows, moisture readings or minor maintenance items.
