BEFORE YOU BUY
BEFORE YOU BUILD

Building and Timber Pest Inspection Report

Inspection Date: Tue, 10 Feb 2026

Property Address: 358 Great Western Hwy Service Rd,
Warrimoo NSW 2774, Australia

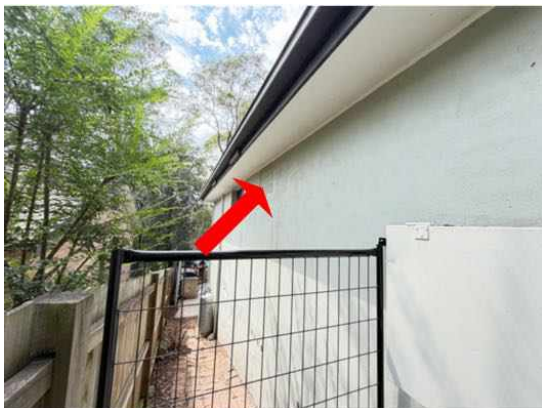
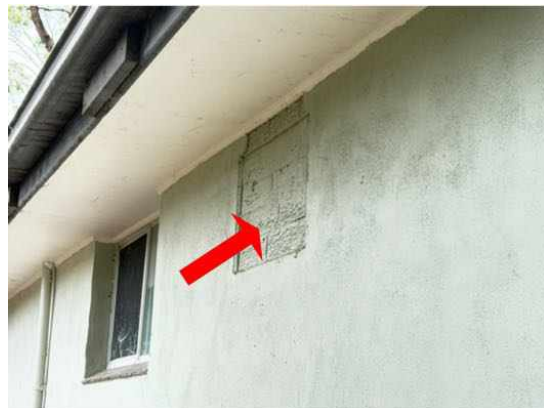
Information: A section of the external wall shows evidence of a previous penetration, likely from a removed air conditioning unit. While the brickwork has been patched, the cement render has not been reinstated to match the surrounding wall finish. As a result, the repaired area remains exposed and unfinished.

This defect is primarily cosmetic in nature and does not appear to be affecting the structural integrity or weatherproofing performance of the wall at the time of inspection. However, the incomplete render application detracts from the overall appearance of the façade.

It is recommended that the area be properly rendered to match the existing finish and subsequently painted to provide a consistent and uniform appearance.

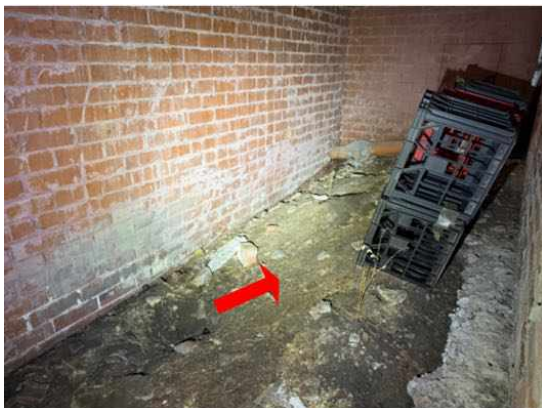
Finding 6.04

Building:	Main Building
Location:	Subfloor
Finding:	Subfloor - Lack of ventilation
Information:	It was noted at the time of inspection that the subfloor area lacks adequate ventilation. Ventilation can be restricted by a variety of minor defects, including obstructions in the subfloor space, a lack of vents or a low clearance.

A well ventilated subfloor aids in maintaining dry conditions, preventing secondary damage such as wood rot and pest activity, as well as preventing the development of mould and mildew (which can lead to respiratory safety hazards for occupants).

The initial step in improving ventilation is to ensure that the subfloor area is free of any debris or stored items. Where ventilation is still inadequate, it is advised to ensure that all vents are clear of blockages, and additional vents may be installed.

The client may also consider mechanical ventilation (powered fans) to improve subfloor airflow. Remedial works should be conducted as a matter of urgency to protect against the development of potentially harmful subfloor conditions.

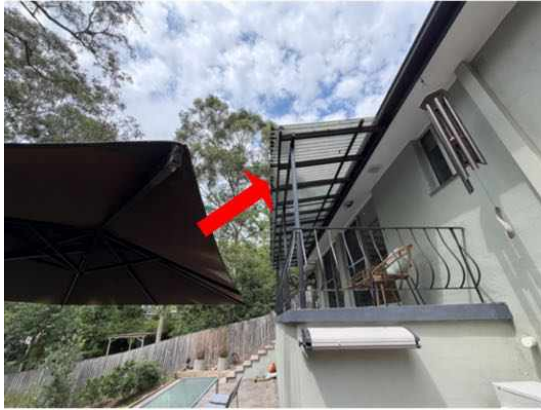
While this may be a design choice, the absence of gutters can lead to uncontrolled water runoff, which may cause surface ponding, staining to adjacent walls, increased splash-back onto external cladding, and potential moisture ingress over time. Concentrated water discharge may also contribute to movement or deterioration of paving and footings in the immediate area.

It is recommended that the area below the roof edge be monitored for signs of erosion or moisture-related issues. Consideration may be given to the installation of an appropriate guttering and stormwater disposal system to better control roof water runoff and minimise potential long-term impacts.

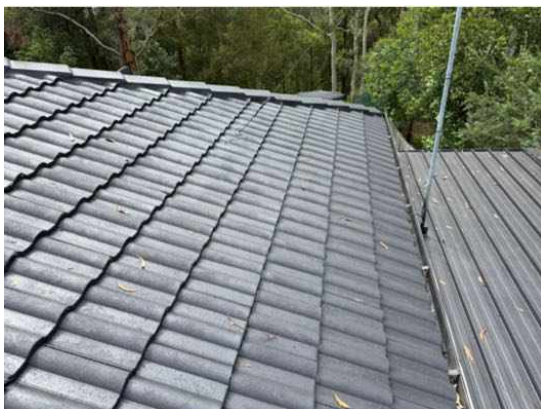
Minor amounts of debris were observed within the guttering system. While this is not uncommon, gutters should be kept clean and free of debris to ensure proper stormwater flow and to prevent blockages, overflow, and potential moisture-related issues to the building fabric.

Regular maintenance and periodic cleaning of the gutters is recommended to maintain effective roof drainage and prolong the lifespan of the roofing components.

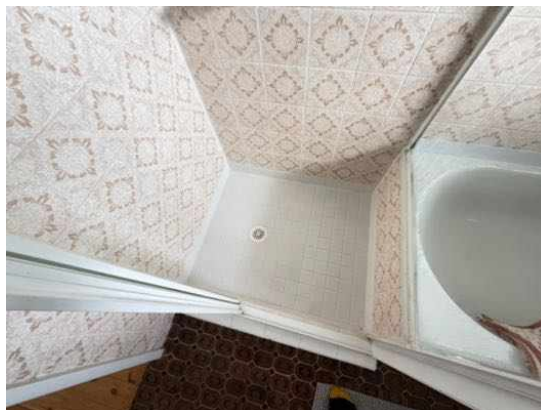
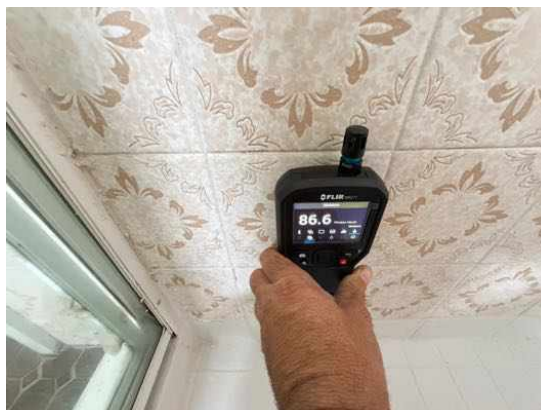
Building: Main Building
 Location: All Areas
 Finding: FYI-Moisture Readings
 Information: Moisture readings taken during the inspection were recorded using a FLIR MR277 moisture meter, which provides numerical values rather than direct percentage readings. These values are not expressed as a percentage of moisture content but rather as relative indicators of moisture presence within building materials. Each material-such as plasterboard, timber, tile or concrete wall surfaces -has its own baseline range of ambient moisture, and the meter's readings reflect deviations from that baseline.

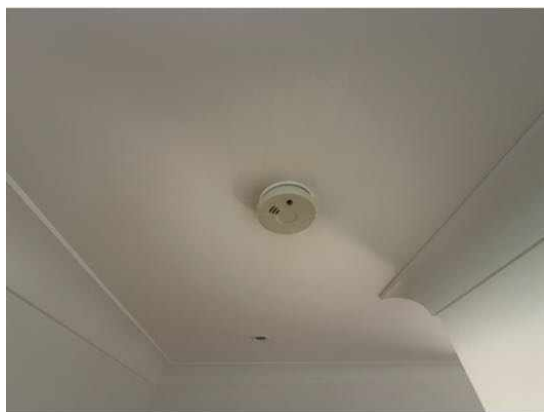
Building: Main Building
 Location: Smoke Detectors
 Finding: FYI-Smoke Detectors and Alarms
 Information: Reporting on Smoke Detectors or Alarms, including hard wired smoke detection systems and their legislative requirements, is outside the Scope of this Report.

Please note that this defect is highlighted as a caution only. We suspect, based on our experience in the building industry, that the absence of smoke detectors, or their poor condition, should be addressed as a matter of urgency to improve occupant safety.

Always ensure sufficient working and suitable smoke detectors are installed prior to occupying any building. Additionally, it is advised that all smoke detectors be tested by the homeowner on a monthly basis.

Please refer to AS3786 and state based legislation, which may also apply.

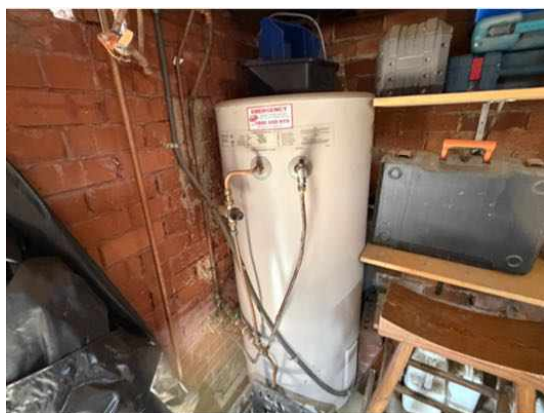
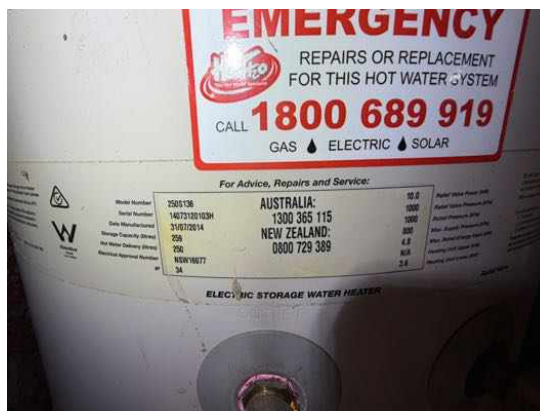
Building: Main Building
 Location: Hot Water System
 Finding: FYI-Hot Water Unit
 Information: The HWS appeared to be in good condition at the time of inspection. For the date of manufacture - (see attached photo)

Water pressure appears to be normal, however, this is not an opinion of a licensed plumber. No water hammer was noted when taps are turned off fast.

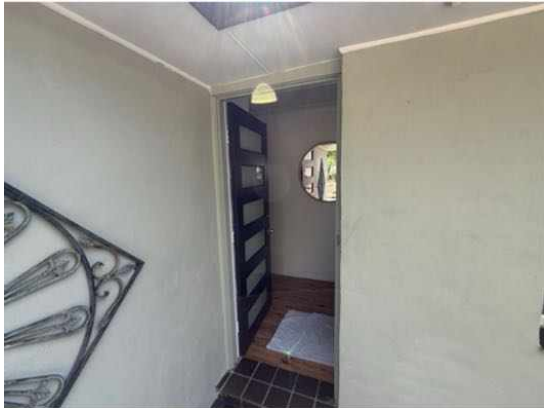
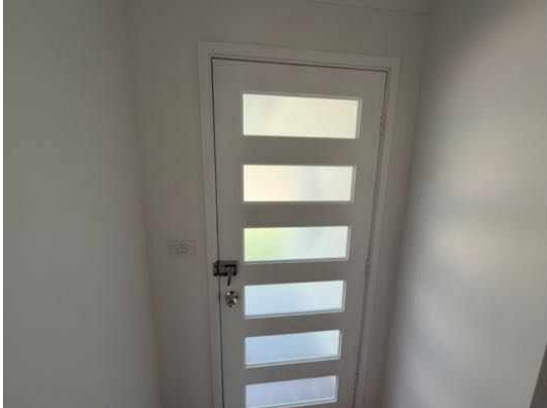
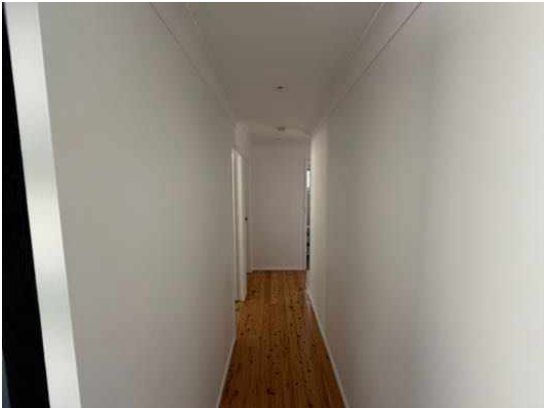
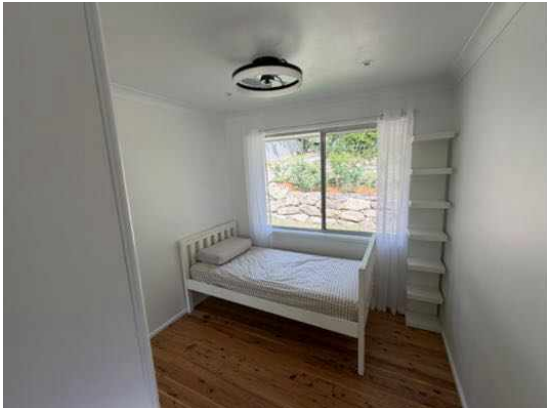
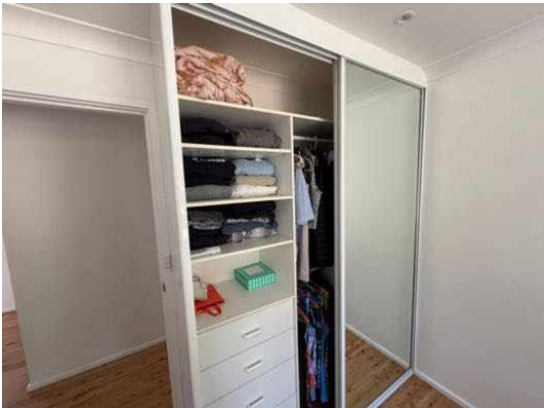
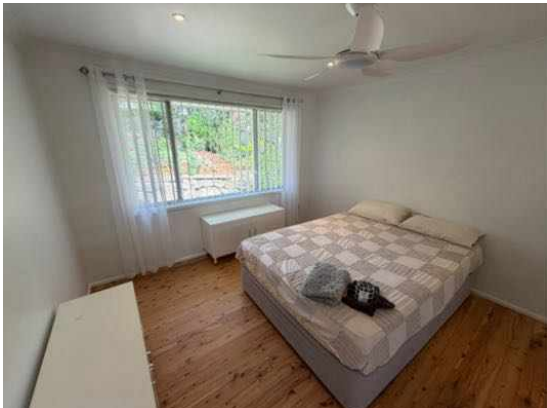
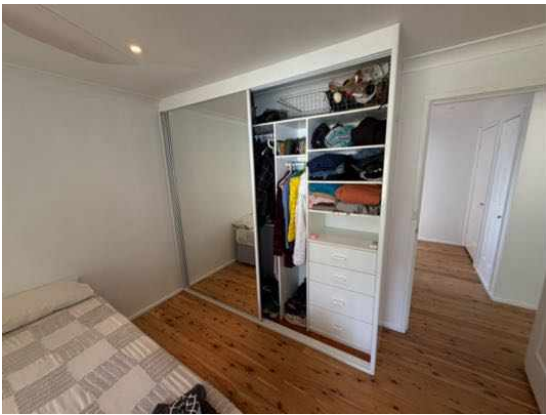
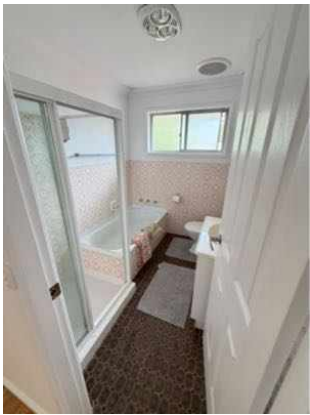
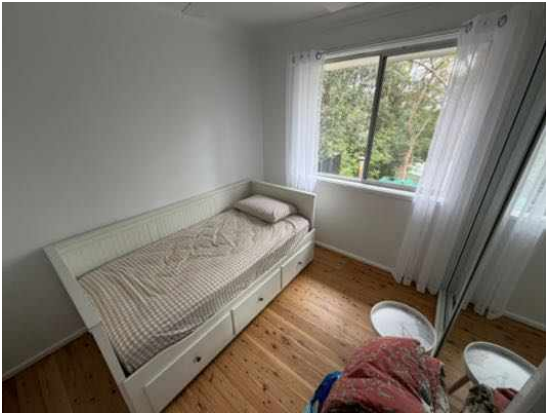
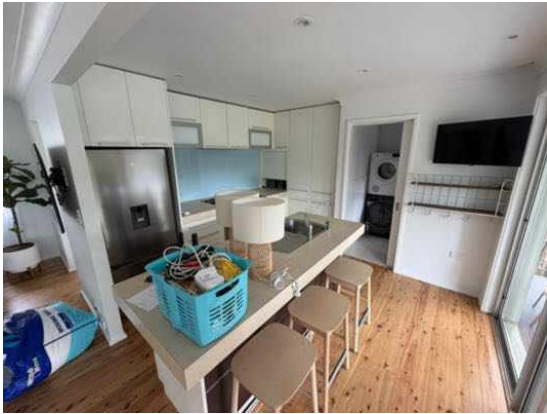
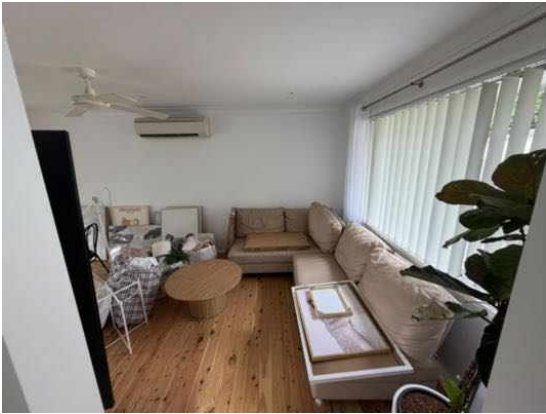
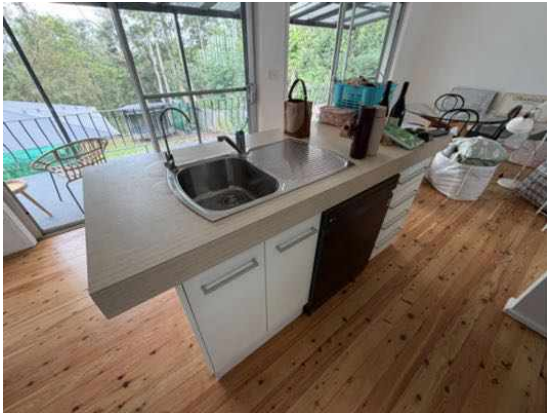
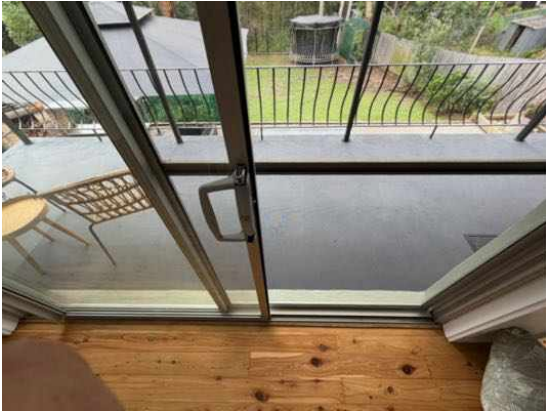
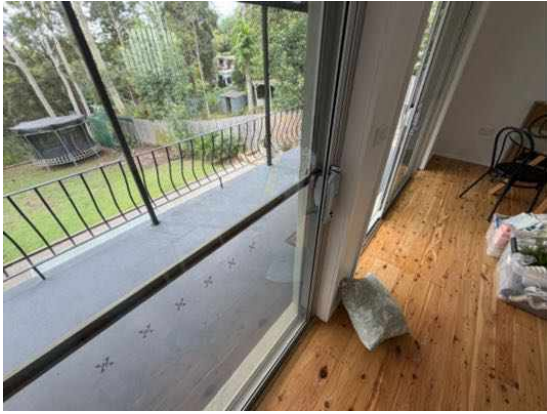
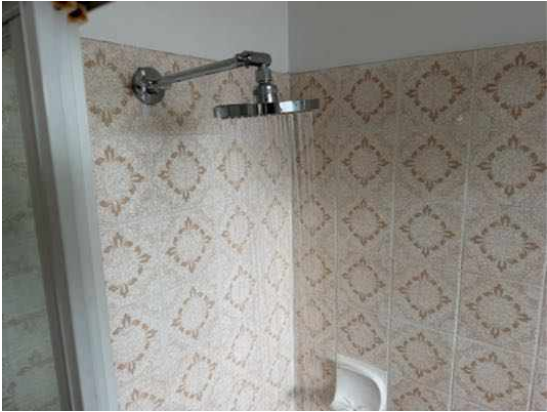
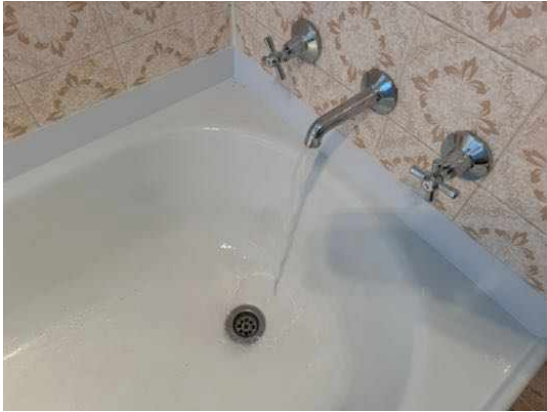
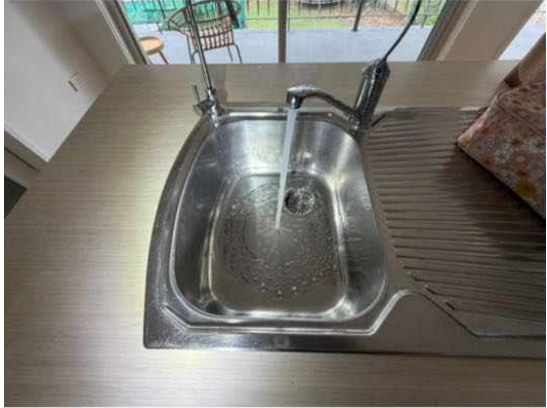
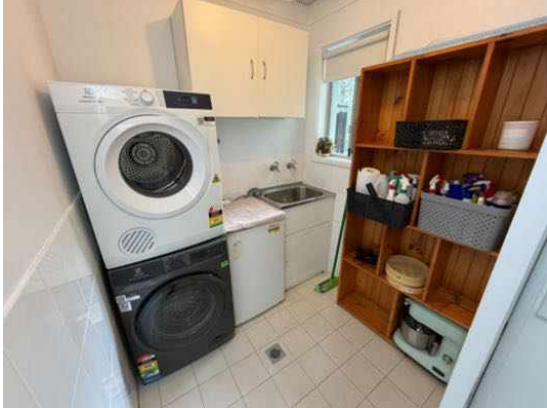
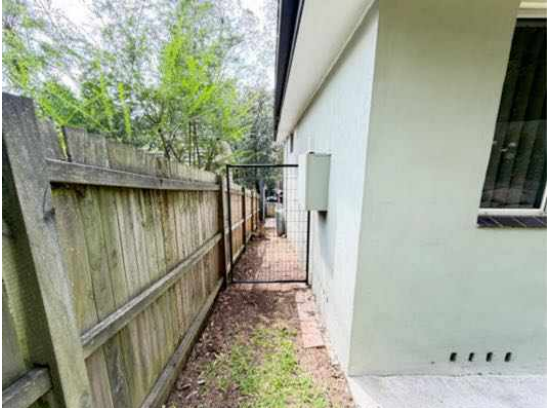
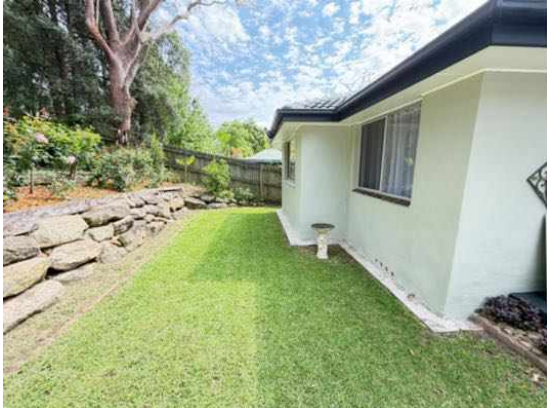
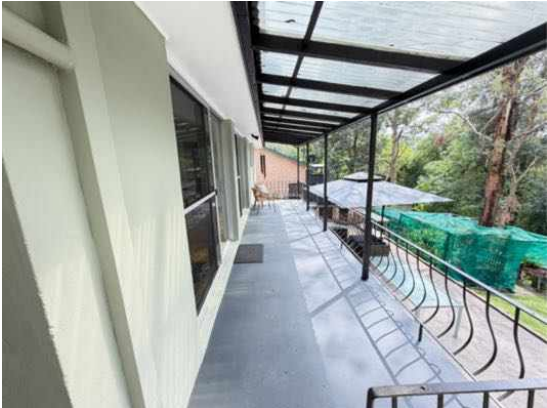
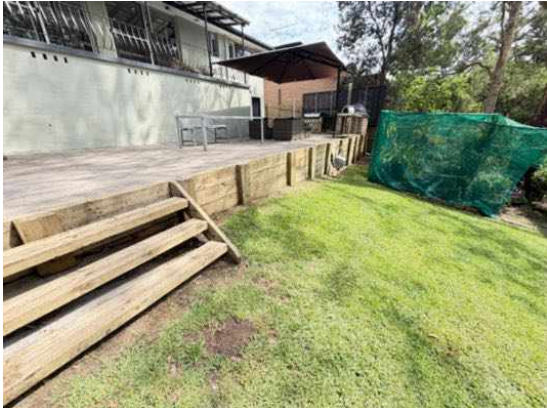
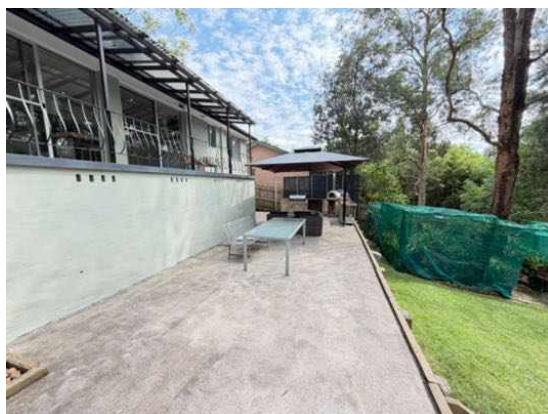
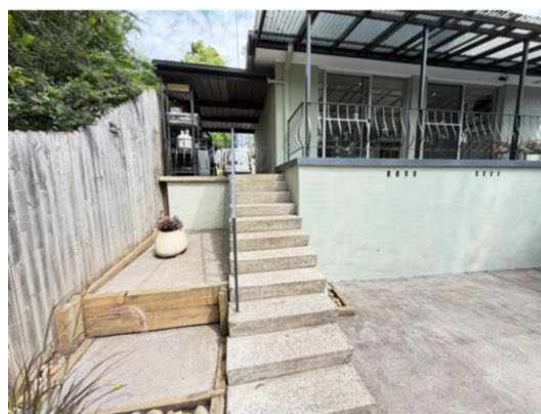
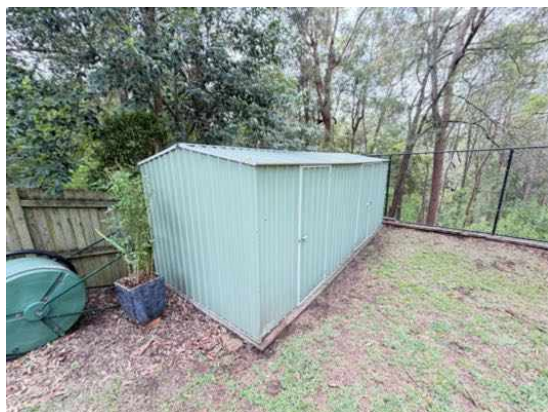
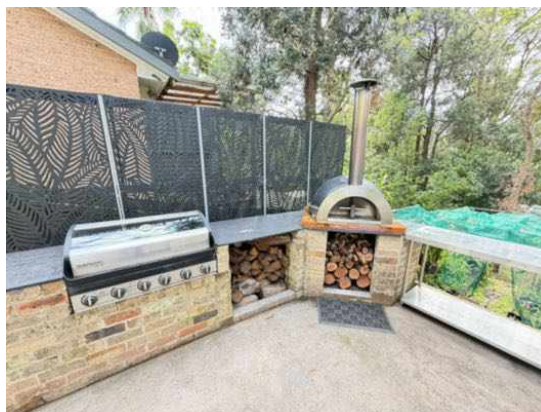
Building: Main Building
Location: All Areas
Finding: FYI-Additional Photos
Information: Additional photos are provided for your general reference and may include obstructions, testing of water and windows, moisture readings or minor maintenance items.

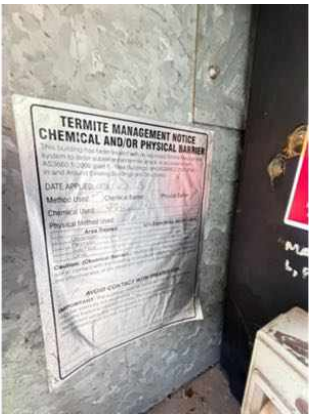
The following items were noted as - Evidence of a previous termite management program

Where a Termite Management System has been identified you should refer to the type of barrier date of installation warranty conditions and any documentation provided by a builder or past owner. Consult the company who installed the barrier to confirm whether the system is still under warranty.

Most chemical termite management systems expire and require replenishment and all physical systems are primarily designed to prevent concealed entry.
