# Building and Timber Pest Inspection Report VR

Inspection Date: Fri, 13 Mar 2026

Property Address: 11 Sayers St, Lawson NSW 2783, Australia

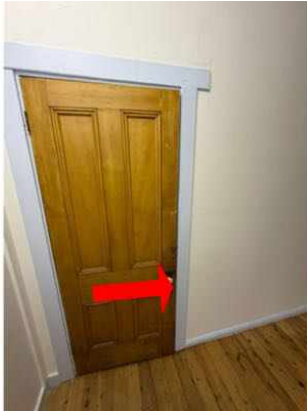
Information: Binding and/or jamming of several doors throughout the property were evident during standard operation. This defect inhibits the functionality of affected doors as well as creating potential for secondary defects to associated building elements, such as damage to the floor covering.

A door that binds to flooring or to the associated door frame may have several causes, ranging from minor defects, such as poor installation of the door or deteriorated hinges, through to major structural issues, such as damage to subfloor structures.

For minor causes, a qualified carpenter or general handyperson should be appointed to perform minor rectification works at client discretion.

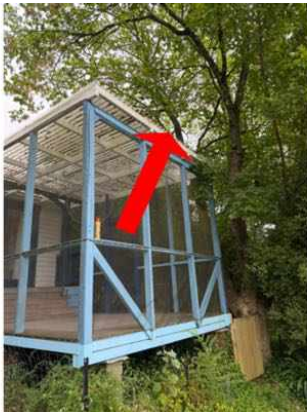
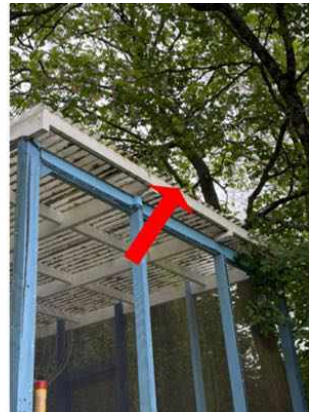
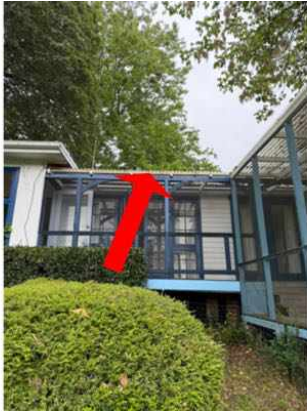
### Finding 3.03

Finding: Gutters-Missing

Information: A section of roof at the rear of the dwelling was observed to have no guttering installed. As a result, rainwater is currently discharging directly from the roof onto the ground adjacent to the building. This can lead to excessive moisture around the footings, potential soil erosion, and an increased risk of water ingress or damage to the building over time.

It is recommended that suitable guttering and downpipe connections be installed to this section of roof to ensure effective collection and discharge of roof water away from the dwelling. Installation should be carried out by a suitably qualified contractor.

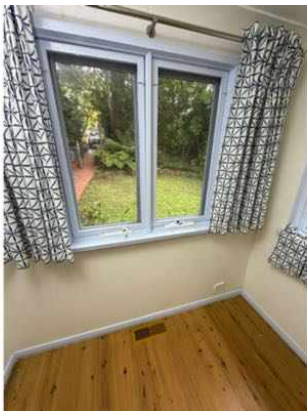
### Finding 3.04

Information: The window in the bedroom was difficult to operate at the time of the inspection. Windows provide ventilation to the adjoining area and should be at a fully operational level to ensure user comfort. Restricted function of the window may also pose as a potential safety hazard if required for emergency egress from the building.

Generally, factors such as general age of the building element and a lack of maintenance are the usual causes for this type of defect.

Replacement of window hardware or frame may be required, as well as minor repairs and cleaning. A registered builder or general handy person will be required to repair the window at the owners discretion.

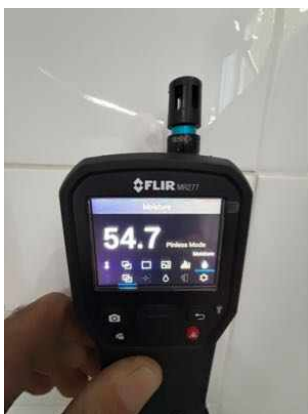
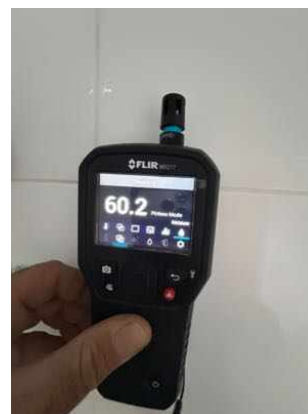
Finding: Bathroom-Cracked tile

Information: One cracked tile was observed in the lower corner of the shower recess. Cracked tiles can allow moisture to penetrate behind the tiled surface over time, which may lead to deterioration of the underlying materials if left unaddressed.

The shower was flood tested at the time of inspection and no leaks were identified. Moisture readings were also taken from the walls and were found to be within acceptable parameters, indicating that no significant moisture issues were present at the time of inspection.

No sign of recent water damage was evident upon a visual inspection of the surrounding walls, where the visual nature of the inspection was possible. Consequently, there is no conclusive evidence of any current shower recess leakage and it is reasonable to assume the shower waterproofing is sound.

Apart from the cracked tile noted, the shower and bathroom were generally found to be in acceptable condition.

It is recommended that the cracked tile be repaired or replaced and the area appropriately sealed to help prevent potential water ingress in the future. Work should be carried out by a suitably qualified person.

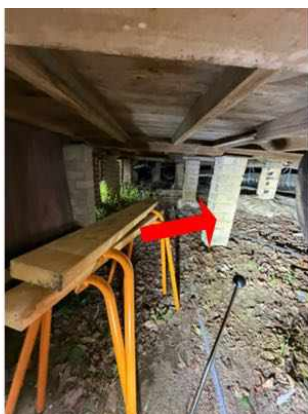
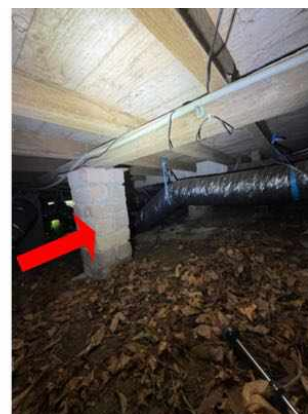
### Finding 3.07

Building:	Main Building
Location:	Subfloor
Finding:	Isolated piers subfloor-leaning
Information:	Some of the isolated brick piers in the sub-floor area are leaning slightly. Whilst this is common among homes of this age it should be monitored for further movement over time.

A builder could be engaged to make repairs if movement continues.

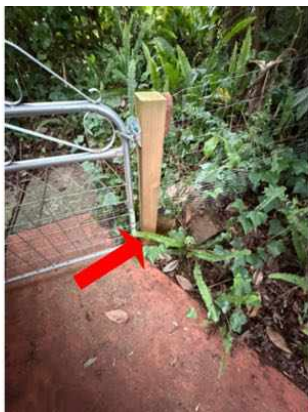
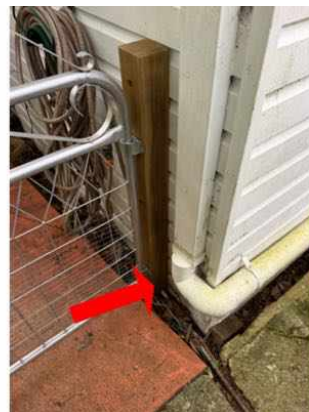
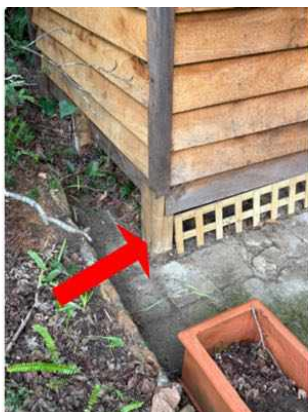
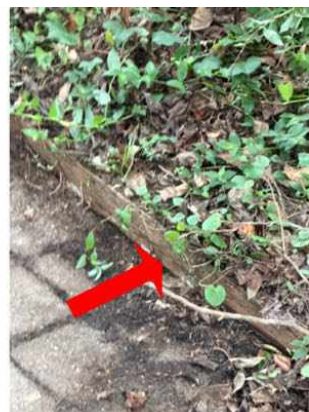
Building:	Yard
Location:	Yard
Finding:	In ground contact
Information:	Any timbers in direct ground contact provide opportunity for concealed termite entry and are likely to be subject to premature rot and decay as the soil retains moisture or damp conditions against the timbers.

Treated Timbers can decay or be poorly treated at manufacturing and as they degrade overtime can allow for termite attack.

Remove any timber that is in direct contact with external grounds. Consider replacement with more durable materials i.e. non timber elements. Frequent pest inspections are advised to readily identify any termite activity in these areas.

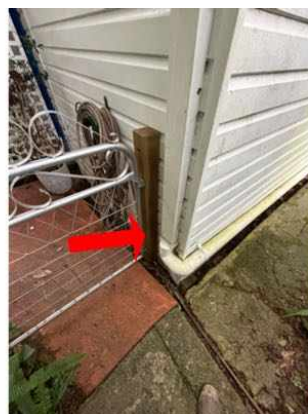
Where any part of an attachment to a building is not isolated and is not provided with a clear gap of at least 25mm from the building, bridging occurs.

The client should consider obtaining further advise from a timber pest technician regarding treatments required in this area. It is recommended that obtaining such advice be a short-term priority.

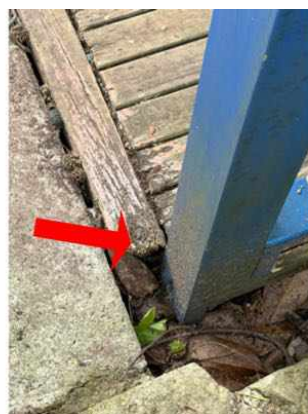
### Finding 7.01

Building: Main Building  
Location: All Areas  
Finding: Fungal decay - present at the time of inspection  
Information: Fungal decay also known as wood decay or wood rot occurs when timbers and other cellulose building materials are exposed to damp conditions on an ongoing basis. This could be the result of exposure to weathering in the long term or the pooling of water or absorbed moisture from other abutting building materials or a shower leak. It is advisable to remove these affected timbers to prevent any chance of termite attack in the future.

Wood decay is more susceptible to termite attack and these timbers should be replaced to limit termite attack.

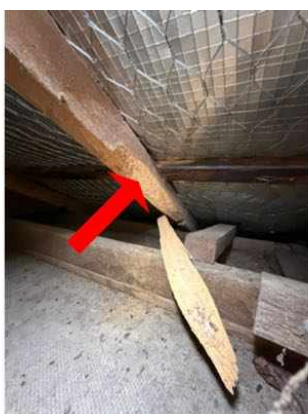
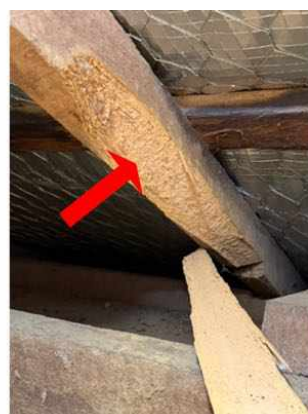
### Finding 8.01

The other commonly known borer the Anobium borer is more likely to attack floorboards and may cause severe structural damage to flooring areas.

As no live wood borer activity was identified treatment is not required at this time. Replacement of affected timbers may be considered by the client for superficial reasons.

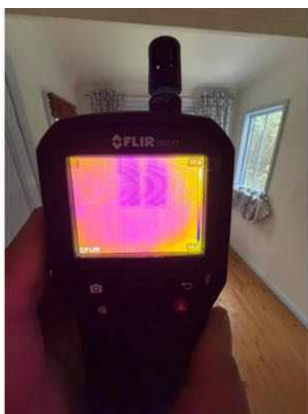
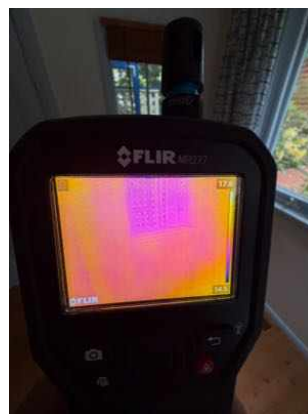
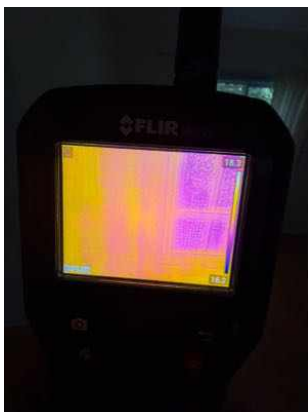
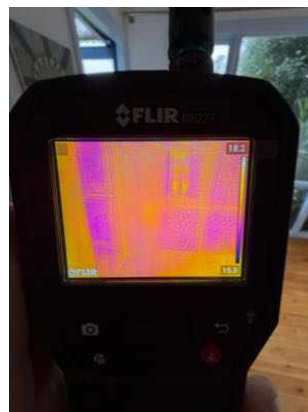
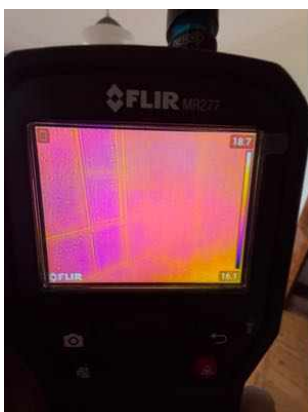
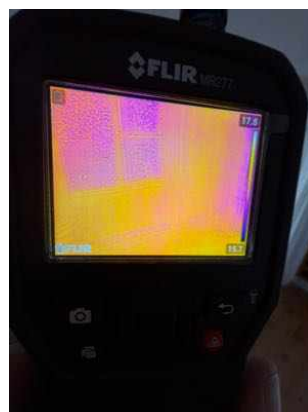
Building: Main Building  
 Location: All Internal Areas  
 Finding: For your information-Thermal camera  
 Information: AS 3660.2:2017 is the recommendation for the carrying out of 'Additional Tests' using specialist non-destructive tools:

A thermal imaging inspection was carried out throughout the interior of the house using a Flir MR277 thermal camera. No thermal anomalies were noted that would be consistent with any current termite activity, however various factors must be taken into effect which may hamper or impede the reading obtainable by the imager. These factors include obstructions, ambient temperature, wall material and thickness etc. If any surface is restricted visually or otherwise, a proper thermal reading is not possible and is not within the scope of this inspection. Any findings or otherwise is reported on at the time of the inspection only.

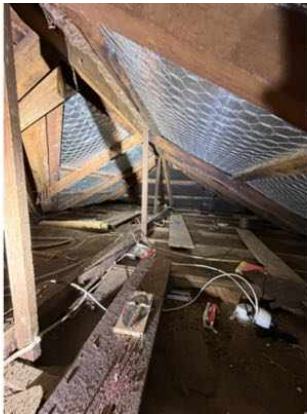
Building:	Main Building
Location:	Roof Void
Finding:	Obstructions and Limitations-Roof Void
Information:	These photographs are an indication of the obstructions and limitations that impeded the full inspection of the roof cavity at the time of inspection. Note that the insulation covered nearly all the ceiling joists, which are a major structural element of the ceiling; the inspection was also limited to areas with an allowable crawl space of 600mm x 600mm, in particular towards the external walls where the roof line diminishes, it was not accessible. These obstructions and limitations can hide an array of defects and should be removed to allow a full inspection to be carried out. A re-inspection is

recommended once areas are made accessible.

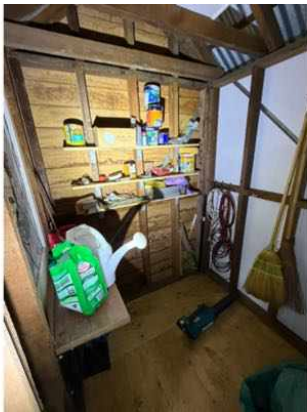
Building: Main Building  
Location: Internal Areas  
Finding: Obstructions and Limitations-Internal areas  
Information: These photographs are an indication of the obstructions and limitations which impeded full inspection of the internal areas at the time of inspection. These obstructions can hide an array of defects and should be removed to allow a full inspection to be carried out. A re-inspection is recommended once the areas are made accessible.

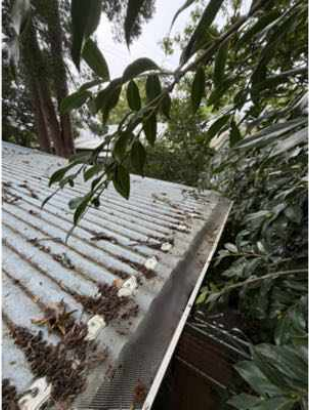
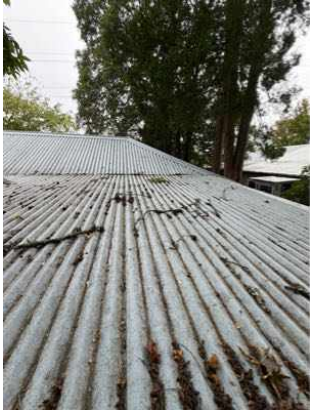
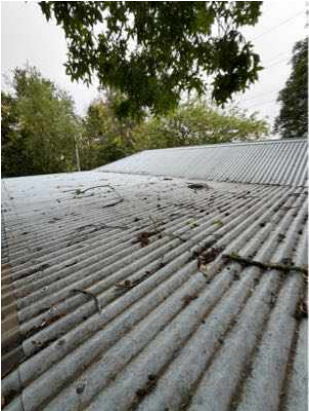
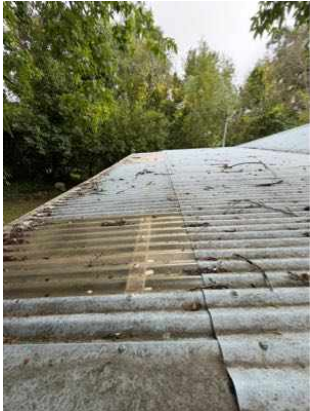
Building: Main Building  
Location: Roof Exterior  
Finding: FYI-Roof Maintenance Required  
Information: The corrugated metal roofing to the dwelling was observed to be quite weathered and had a build-up of leaves and organic debris across several areas at the time of inspection. Accumulated debris on roof surfaces can trap moisture and accelerate the deterioration of roofing materials. It can also contribute to blocked gutters and downpipes, which may lead to water overflow and potential water ingress issues.

Regular cleaning and maintenance of the roof surface and associated drainage systems is recommended to remove debris and help prolong the service life of the roofing materials. Ongoing maintenance should be carried out as required to keep the roof in good working condition.

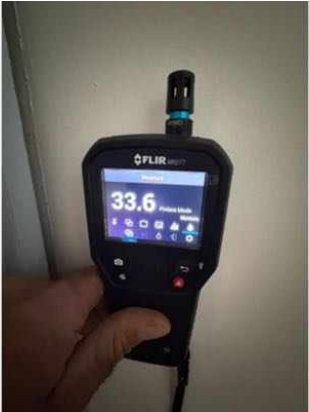
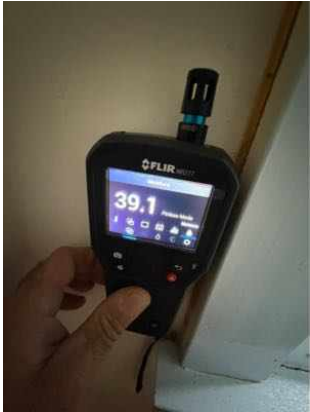
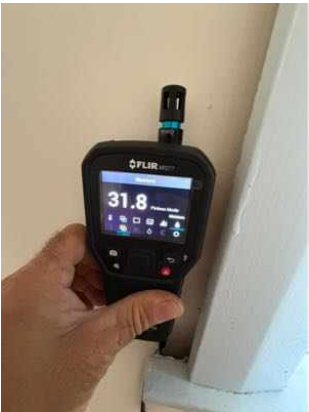
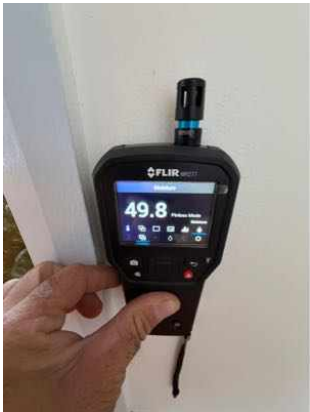
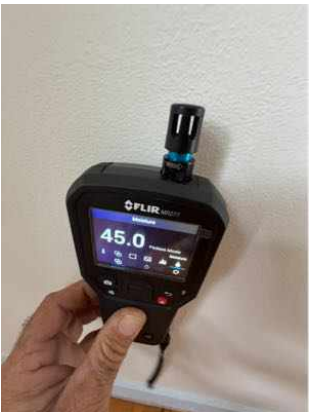
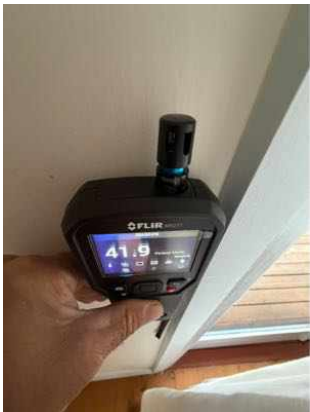
Building: Main Building  
 Location: All Areas  
 Finding: FYI-Moisture Readings  
 Information: Moisture readings taken during the inspection were recorded using a FLIR MR277 moisture meter, which provides numerical values rather than direct percentage readings. These values are not expressed as a percentage of moisture content but rather as relative indicators of moisture presence within building materials. Each material-such as plasterboard, timber, tile or concrete wall surfaces -has its own baseline range of ambient moisture, and the meter's readings reflect deviations from that baseline.

For example, plasterboard in dry, internal areas may typically register between 10-30 points, while ceramic tiles in bathrooms may show 30-50 points due to their density and surface retention. These numbers are used comparatively in critical areas (e.g, near windows, wall bases, or wet zones) and are assessed against these baselines to identify elevated moisture ingress.

The FLIR MR277 uses both pin and pinless sensors, along with thermal imaging, to detect hidden moisture anomalies. Its readings are designed to highlight relative changes rather than provide absolute moisture percentages. This approach is particularly effective in building diagnostics, as it allows for non-invasive detection of moisture trends across different substrates.

In short, while percentages are familiar, the meters numeric scale offers a more nuanced and material - sensitive method of identifying moisture issues. Elevated readings – especially those exceeding baseline values by around 20 points or more – are flagged for further investigation, even if no visible damage is present.

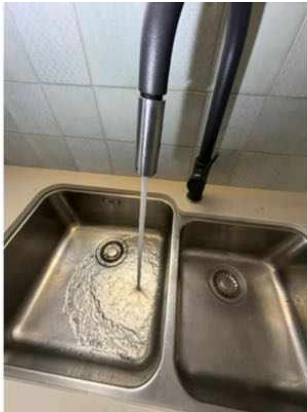
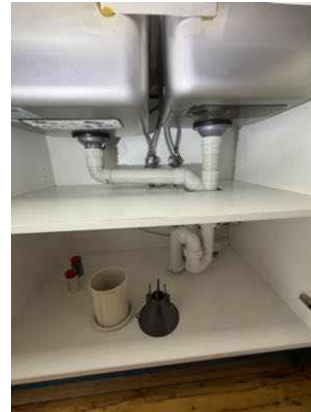
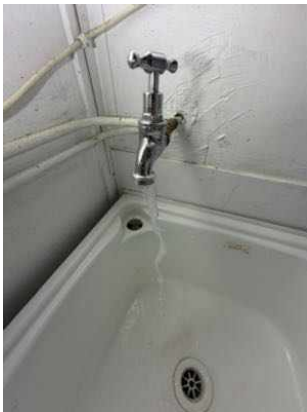
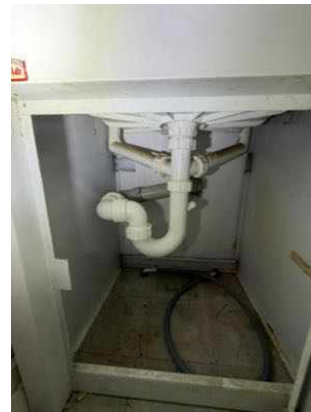
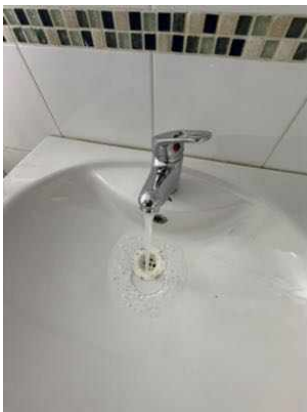
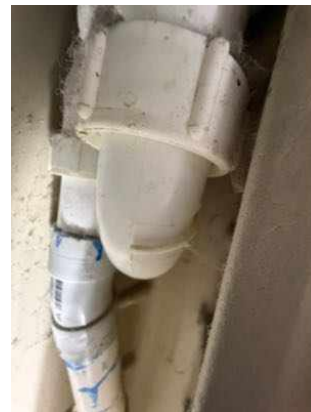
Building: Main Building  
Location: Cabinetry Plumbing  
Finding: FYI-Cabinetry Plumbing  
Information: All cupboards where sinks and basins with drainage plumbing were inspected no evidence of leaks were present at the time of inspection.

If damp or wet conditions do occur there are many consequences including the development of fungal decay and/or wood rot, swelling or damage to building materials.

For your information only no remedial works are required at the time of inspection.

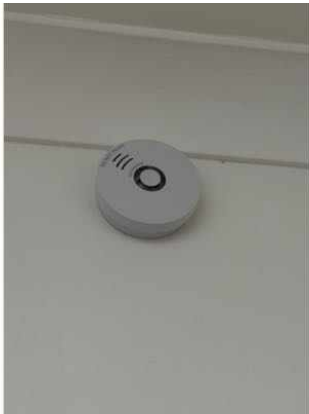
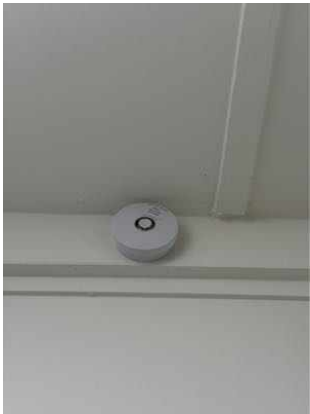
Building: Main Building  
 Location: Smoke Detectors  
 Finding: FYI-Smoke Detectors and Alarms  
 Information: Reporting on Smoke Detectors or Alarms, including hard wired smoke detection systems and their legislative requirements, is outside the Scope of this Report.

Please note that this defect is highlighted as a caution only. We suspect, based on our experience in the building industry, that the absence of smoke detectors, or their poor condition, should be addressed as a matter of urgency to improve occupant safety.

Always ensure sufficient working and suitable smoke detectors are installed prior to occupying any building. Additionally, it is advised that all smoke detectors be tested by the homeowner on a monthly basis.

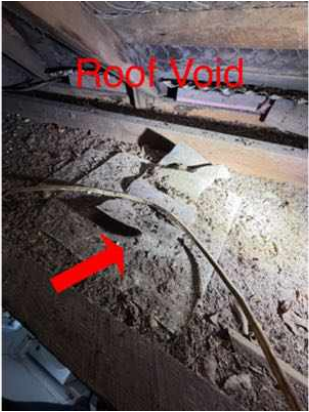
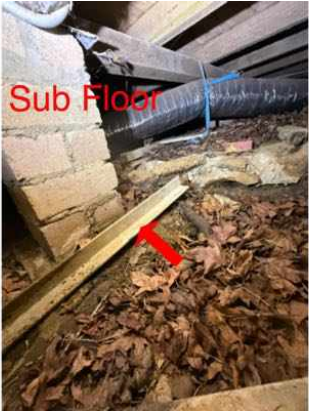
Building: Main Building  
 Location: Suspected ACM  
 Finding: FYI-Asbestos - Suspected ACM Identified on Site  
 Information: Reporting on Asbestos is outside the Scope of this Report. This suspected defect is highlighted as a caution only. We suspect, based on our experience in the building industry, that there is a higher risk of the identified building element containing asbestos.

As Asbestos Reporting is outside the scope of this report, we advise that you consider a separate Asbestos Inspection and Condition Audit, which can include the taking of samples for definitive confirmation of the presence of Asbestos.

In the interim, the client is advised to act with caution, especially when considering any damage to building materials general wear and tear renovations extensions demolition and general maintenance activities due to the suspected presence of Asbestos.

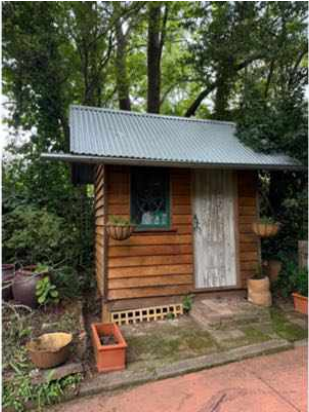
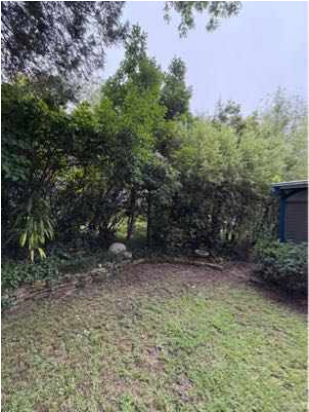
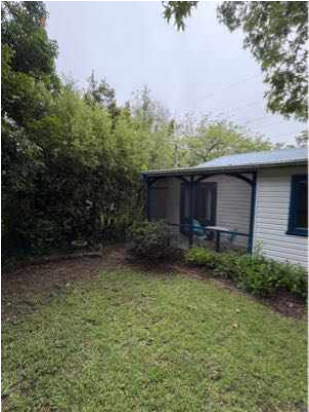
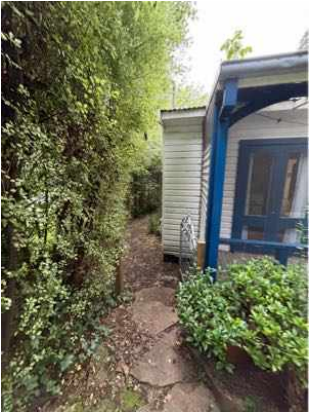
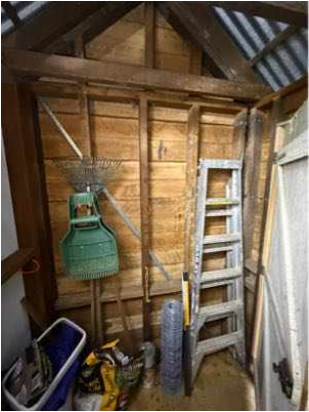
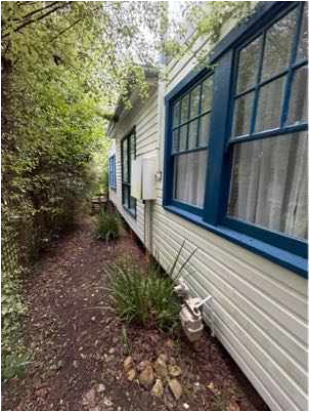
Building: Main Building  
 Location: All Areas  
 Finding: FYI-Additional Photos  
 Information: Additional photos are provided for your general reference and may include obstructions, testing of water and windows, moisture readings or minor maintenance items.
