Building and Timber Pest Inspection Report

Inspection Date: Fri, 6 Feb 2026

Property Address: 14 Varna St, Mount Colah NSW 2079,
Australia

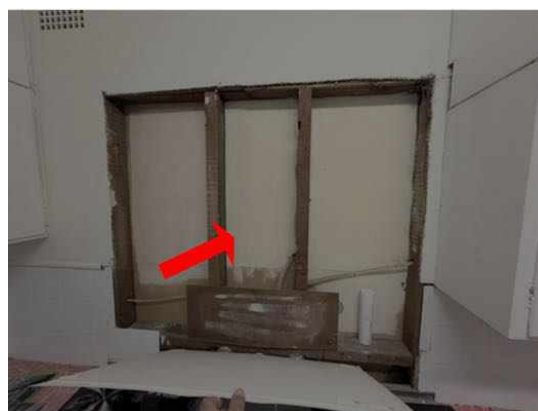
Finding 2.01

Building:	Main Building
Location:	Studio
Finding:	Plasterboard - incomplete
Information:	A section of plasterboard is missing from the wall, likely resulting from previous plumbing or remedial works. The wall lining has not been reinstated, leaving the timber framework exposed. This is considered incomplete workmanship. The plasterboard is required to be reinstated, properly fixed, set and finished, and the affected area painted to match the surrounding wall surfaces to achieve an acceptable standard of finish.

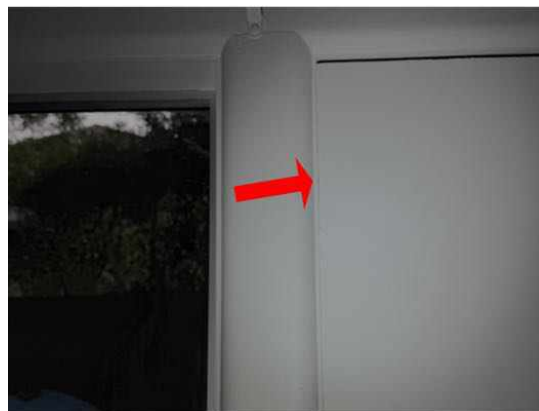
Finding 3.01

Building:	Main Building
Location:	Laundry
Finding:	Door - Binding/jamming
Information:	Binding and/or jamming of this door is evident during standard operation. This defect inhibits the functionality of the affected door as well as creating potential for secondary defects to associated building elements, such as damage to the door and jamb.

A door that binds to flooring or to the associated door frame may have several causes, ranging from minor defects, such as poor installation of the door or

deteriorated hinges, through to minor building movement.

For minor causes, a qualified carpenter or general handyperson should be appointed to perform minor rectification works at client discretion.

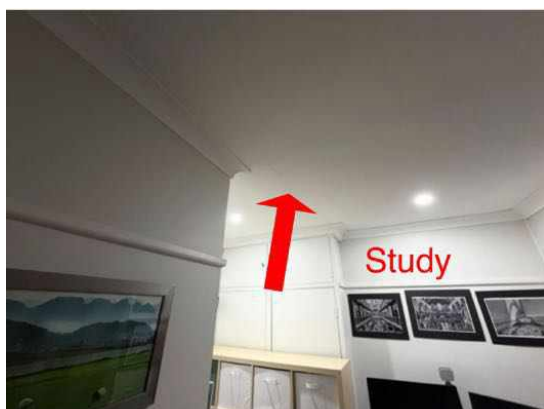
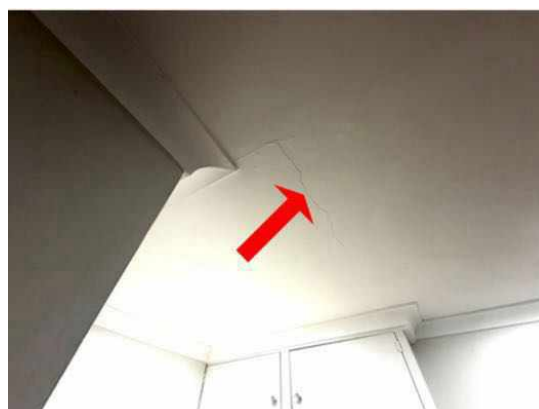
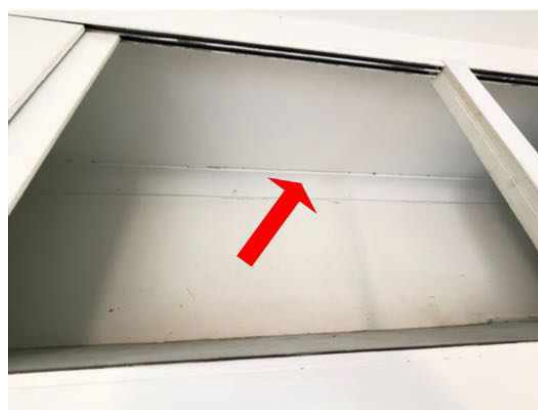
Finding 3.02

Building:	Main Building
Location:	Study/bedroom
Finding:	Cracking - Damage Category 1 - Fine (up to 1mm)
Information:	Although fine cracks are quite noticeable, they are often only considered to be an appearance defect, and usually do not indicate any structural damage. Generally, the cause of a fine crack is indicative of a separation between building materials and finishes (e.g. paint, plaster, etc.) along joins.

Cracking of this nature can generally be repaired with minor sanding, filling and/or repainting. Such works should be performed by a qualified painter or a general handyman.

Monitoring of all cracking should be conducted frequently. Always contact a building inspector should cracks widen, lengthen, or become more numerous.

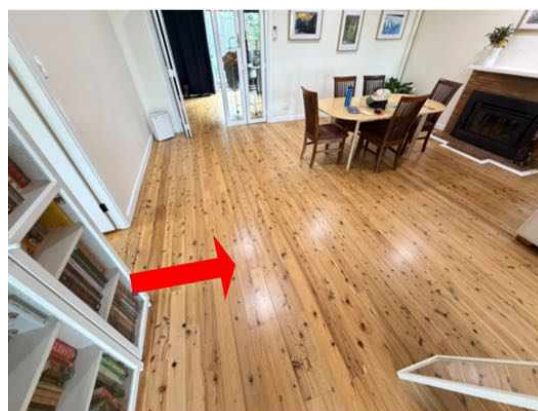
Finding 3.03

Building:	Main Building
Location:	Lounge Room
Finding:	Floors - Squeaking
Information:	Minor squeaking is evident to the timber flooring when walked across in the affected area. This indicates movement within the flooring system, potentially due to inadequate fixing, substrate movement, or installation tolerances. While not considered a major defect, remedial works are recommended to investigate the cause and rectify the issue to minimise noise, improve performance, and ensure the flooring is fixed and performing in accordance with acceptable building standards.

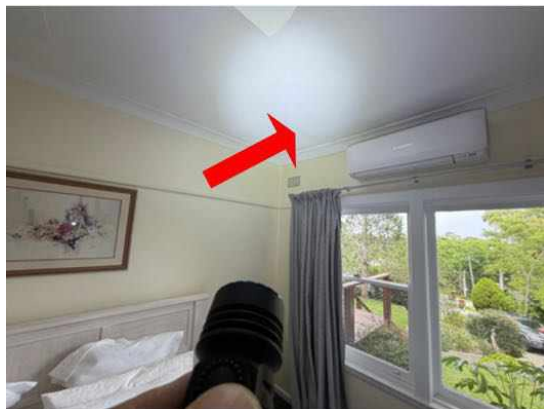
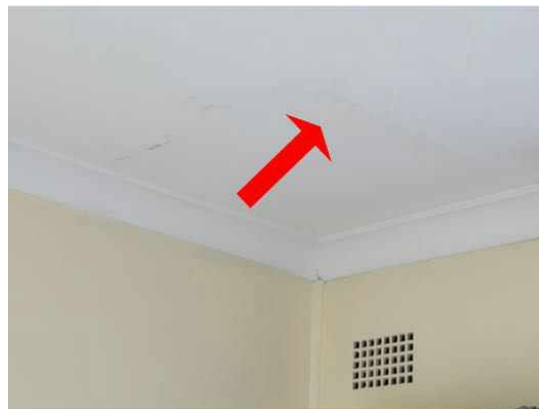
Finding 3.04

Building:	Main Building
Location:	Bedroom
Finding:	Ceiling – Staining from Previous Water Leak
Information:	Staining is present to the ceiling consistent with a past water leak. Moisture readings were taken at the time of inspection and no elevated moisture levels were recorded, the roof void in that area was inspected also and no signs of an ongoing issues were noted, indicating the leak is not currently active. While no ongoing moisture issues were identified, the staining remains visible. The affected area requires preparation and repainting to restore an acceptable finish and appearance.

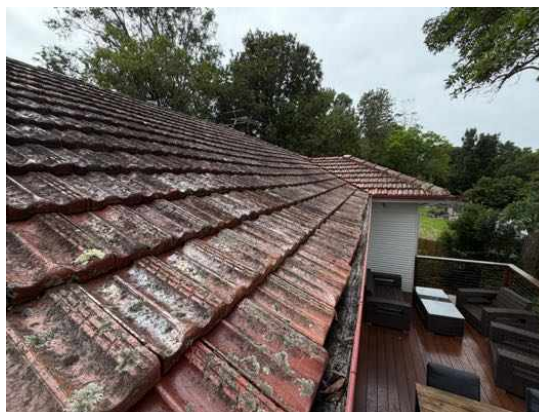
Finding 3.05

Building:	Main Building
Location:	Roof Exterior
Finding:	Lichen present on roof tiles
Information:	<p>Upon inspection of the exterior roofing, the majority of roof tiles were considered to be in a fair condition. While weathering of the tiles is consistent with the age of the property, maintenance works are required. Concrete roof tiles are typically cleaned to have the visible moss and lichen removed. Moss and lichen is attracted to the roof tiles surface, and if left will continue to grow and most likely restrict the flow of rain water over the tiles surface, into the roofs gutters. An application of an environmentally friendly anti-fungal solution should be applied to all moss and lichen, prior to undertaking the roof cleaning process.</p> <p>A roof restoration company can be contacted for further advice.</p>

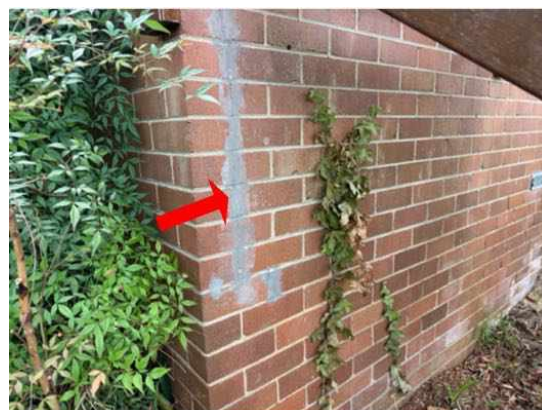
Finding 3.06

Building:	Main Building
Location:	Front Left Decking
Finding:	Brickwork - Cracking [Fine]
Information:	Although fine cracks are quite noticeable, they are often only considered to be an appearance defect and usually do not indicate any structural damage. Generally, the cause of a fine crack is indicative of a separation between brickwork and mortar throughout the structure, but single bricks may also show cracks of this nature.

Cracking of this nature can generally be repaired with minor filling and should be conducted by a qualified bricklayer.

Always contact a building inspector should cracks widen lengthen or become more numerous.

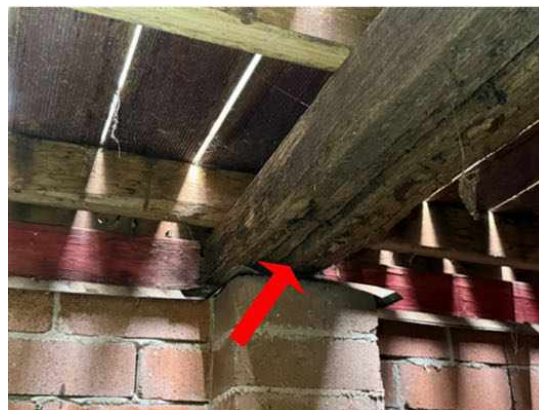
Finding 3.07

Building:	Main Building
Location:	Front Deck lhs
Finding:	Wood Rot - Decking bearers
Information:	One area of structural timber bearers located beneath the front timber decking shows visible signs of wood rot and deterioration. This condition indicates prolonged

exposure to moisture and may compromise the long-term structural integrity of the decking if it continues to deteriorate. While immediate replacement may not be required at this stage, the affected bearers should be regularly monitored, and allowance made for repair or replacement in due course to prevent further degradation and potential structural issues.

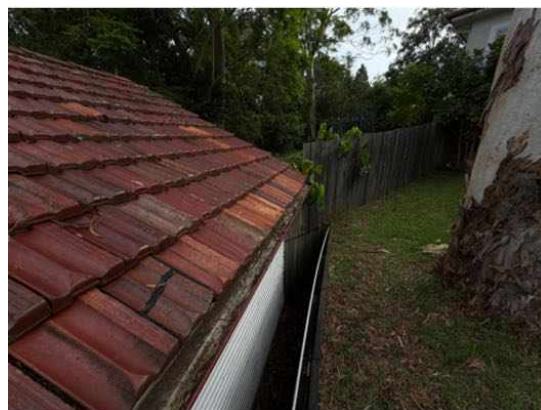
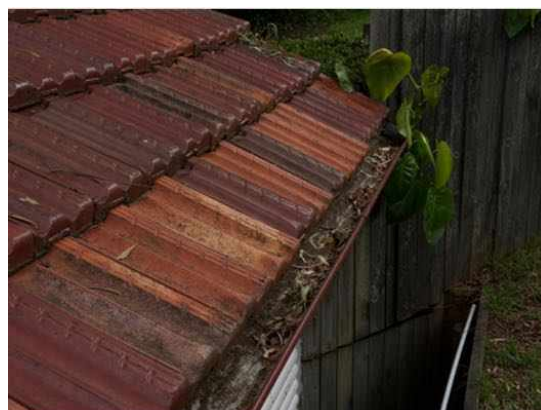
Finding 3.08

Information: At the time of inspection it was found that this gutter was completely blocked with debris, leaves and silt.

The area was checked for high readings of moisture in the area and no high levels were recorded.

Blocked gutters are likely to lead to high levels of moisture in the affected areas. Such moisture will not only cause rust and decay of the associated building materials, but can also provide conditions that are conducive to termite and timber pest activity.

Blockages in gutters should therefore be removed immediately to ensure dry conditions are maintained.

Consult a Licensed Plumber for further specific advice on remedial works that may be required. In the interim, it is highly advised that blocked gutters be removed by the homeowner or a general handyperson as a matter of urgency.

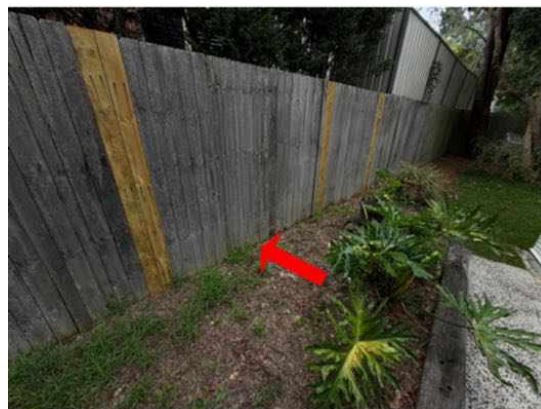
Building:	Yard
Location:	Yard
Finding:	In ground contact
Information:	Any timbers in direct ground contact provide opportunity for concealed termite entry and are likely to be subject to premature rot and decay as the soil retains moisture or damp conditions against the timbers.

Treated Timbers can decay or be poorly treated at manufacturing and as they degrade overtime can allow for termite attack.

Remove any timber that is in direct contact with external grounds. Consider replacement with more durable materials i.e. non timber elements. Frequent pest inspections are advised to readily identify any termite activity in these areas.

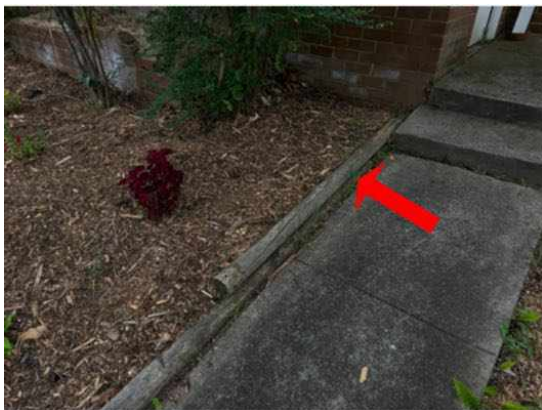
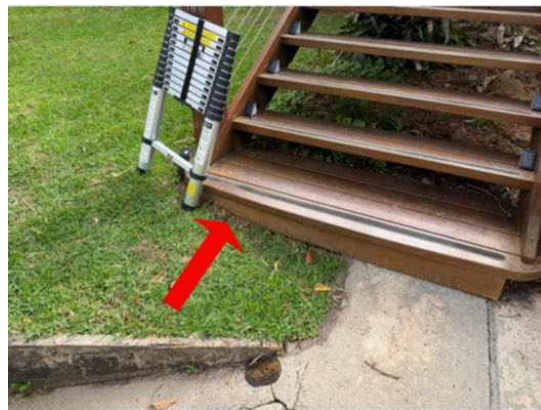
Finding 6.03

Building:	Main Building
Location:	All Areas
Finding:	Stored timbers - subfloor space or external area
Information:	The storing of timbers in the subfloor space or around the external property (including bark mulch) increases the risk of termite activity being present. As they are likely to come into contact with weather conditions or excessive moisture wood rot is likely to develop on timbers that are not treated.

It is highly recommended that any stored timbers be immediately removed from areas in which they may attract any termite / timber pest attack. Minimisation of risk / prevention of termite attack is far more adequate than dealing with the presence of termite activity.

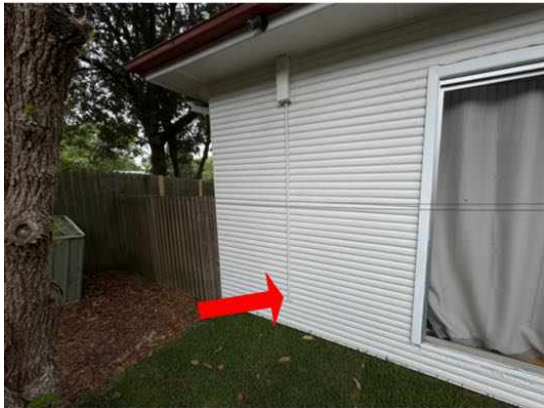
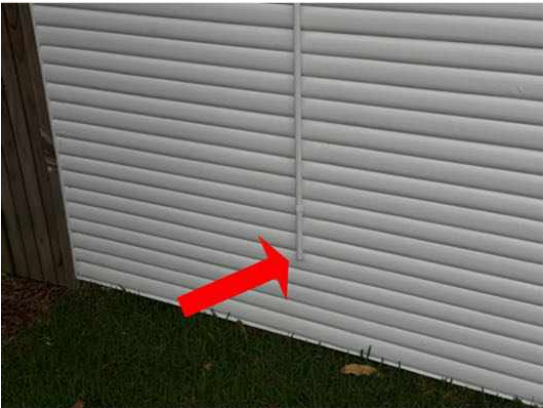
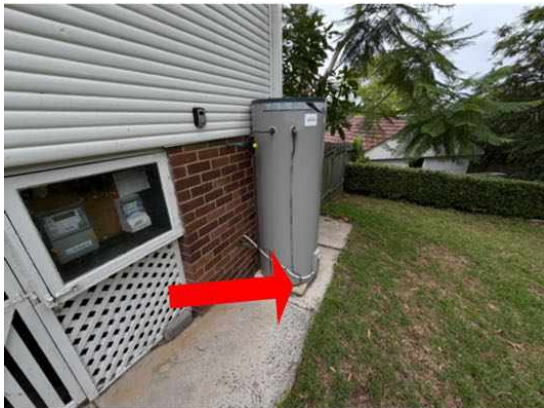
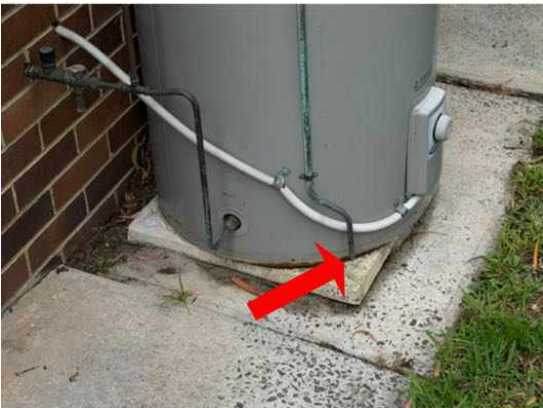
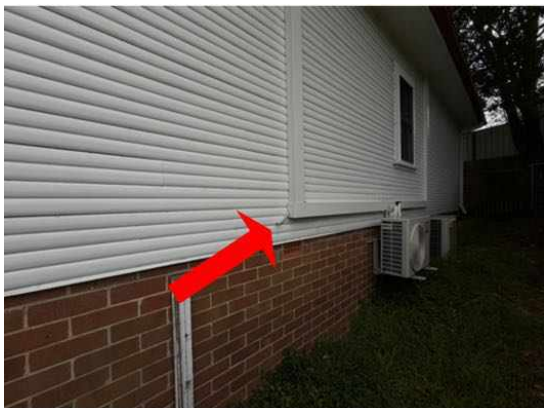
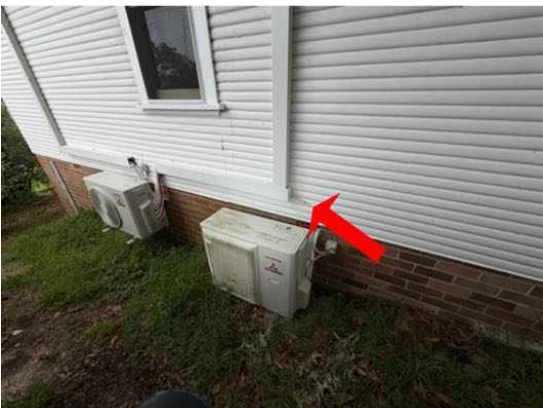
These damp conditions can lead to secondary defects such as rot, rust or corrosion of associated building elements, the formation of fungal decay, or even the creation of potential slip hazards. When coupled with poor site drainage, pooling of water may also attract termite activity to this area.

It is highly recommended that a qualified plumber be appointed to install adequate drainage to the overflow. These works will ensure that the area remains dry and free of any secondary defects.

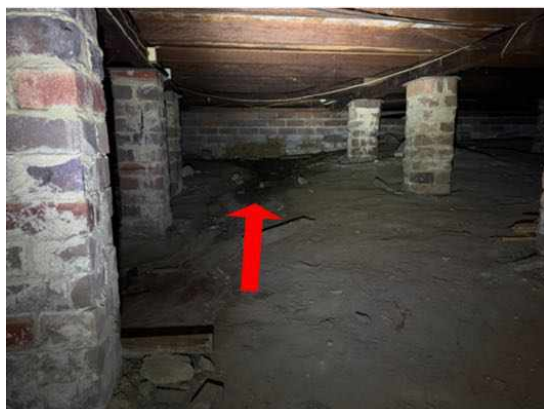
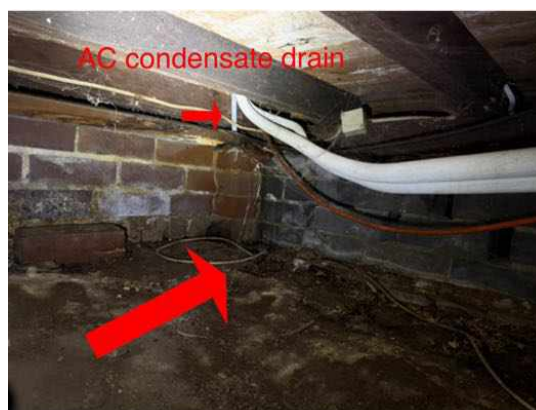
Finding 6.06

Building:	Main Building
Location:	Subfloor
Finding:	Excessive subfloor moisture
Information:	Excessive moisture can attract termites and produce conditions that promote termite attack fungal growth and wood decay.

Excessive moisture is generally caused by inadequate subfloor ventilation and poor site drainage.

There appear to be inadequate vents installed to the perimeter of the building and I would suggest that further solar powered fans or the like be installed to improve cross flow ventilation and aid in keeping the subfloor area relatively dry.

The installation of additional surface drainage to the rear of the property would also be beneficial to keeping the subfloor dry.

It is highly recommended that both subfloor ventilation and site drainage be improved and maintained regularly in order to prevent excessive moisture being present in the external / internal property.

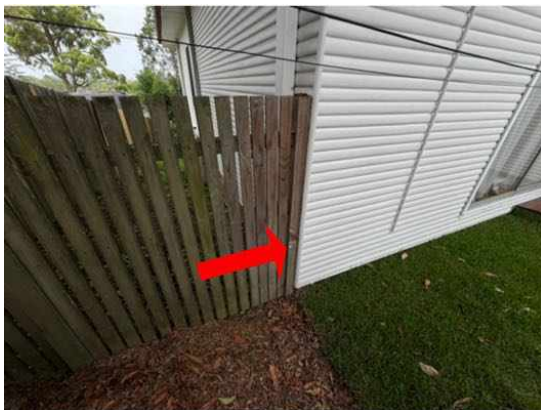
Finding 6.07

Building:	Main Building
Location:	All Areas
Finding:	Bridging or breaching of termite barriers - weep holes
Information:	Bridging is the spanning of a termite barrier or inspection zone so that subterranean termites are provided with passage over or around that barrier.

Additionally build-up of moisture is likely to occur if weep holes are covered further attracting termite activity to these areas.

It is highly recommended that weep holes are left exposed in all areas throughout the external property. Therefore if any termite activity leading into weep holes becomes easily detectable during frequent pest inspections.

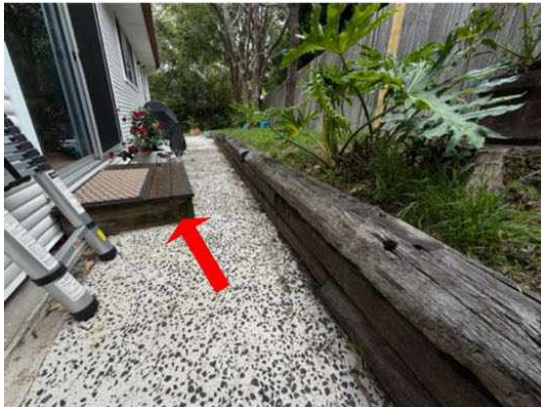
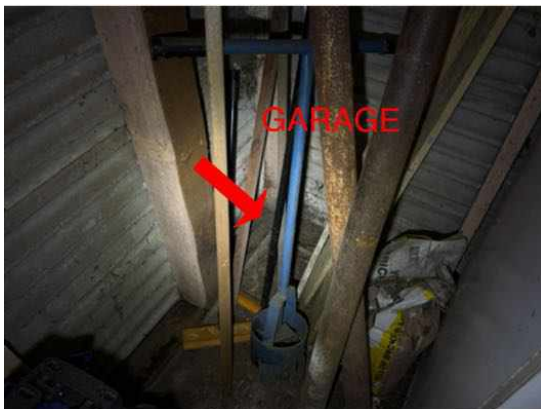
Finding 7.01

Building:	Main Building
Location:	Rear steps/detached Garage
Finding:	Fungal decay - present at the time of inspection
Information:	Fungal decay also known as wood decay or wood rot occurs when timbers and other

cellulose building materials are exposed to damp conditions on an ongoing basis. This could be the result of exposure to weathering in the long term or the pooling of water or absorbed moisture from other abutting building materials or a shower leak. It is advisable to remove these affected timbers to prevent any chance of attack in the future.

Wood decay is more susceptible to termite attack and these timbers should be replaced to limit termite attack.

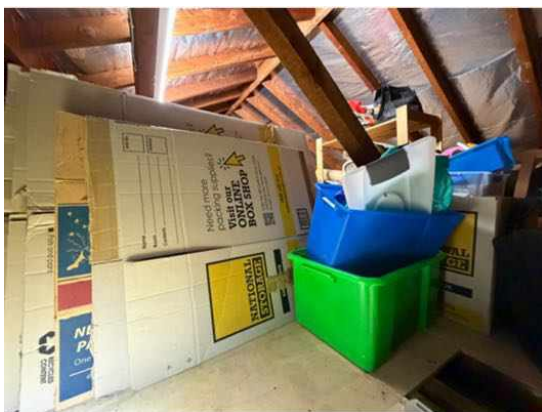
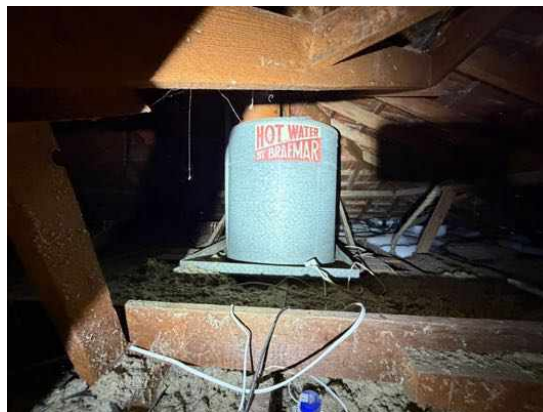
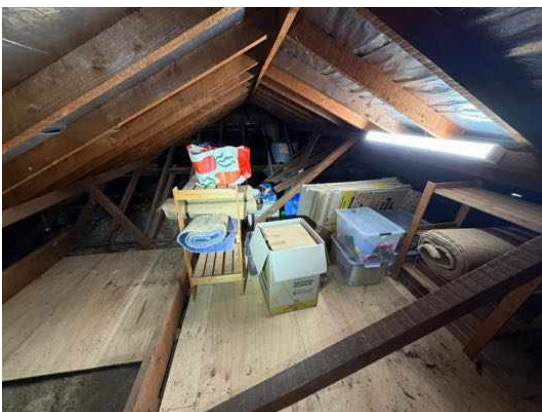
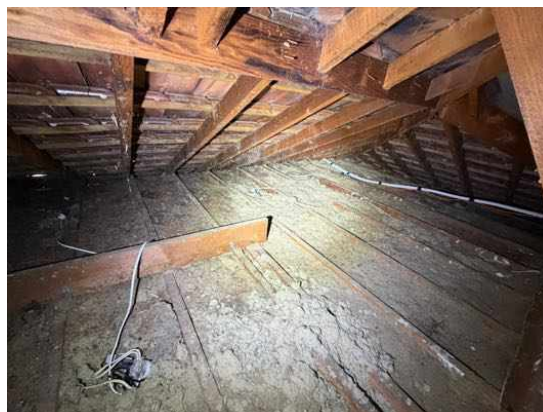
Building:	Main Building
Location:	Roof Void
Finding:	Obstructions and Limitations-Roof Void
Information:	<p>These photographs are an indication of the obstructions and limitations that impeded the full inspection of the roof cavity at the time of inspection. Note that the insulation covered nearly all the ceiling joists, which are a major structural element of the ceiling; the inspection was also limited to areas with an allowable crawl space of 600mm x 600mm, in particular towards the external walls where the roof line diminishes, it was not accessible. These obstructions and limitations can hide an array of defects and should be removed to allow a full inspection to be carried out. A re-inspection is recommended once areas are made accessible.</p>

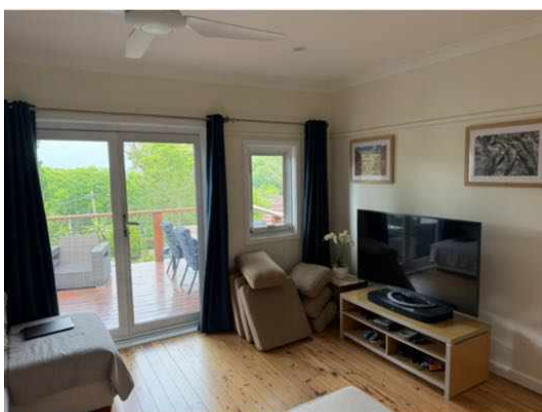
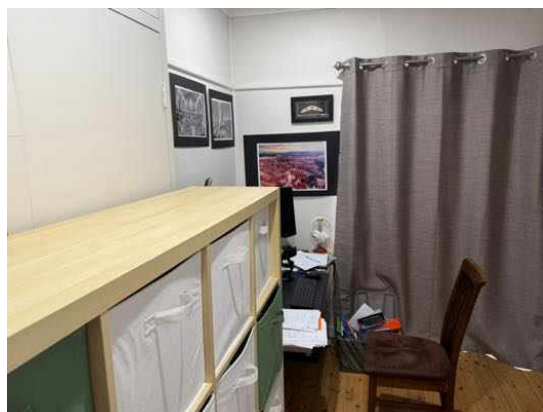
Building: Main Building
 Location: Internal Areas
 Finding: Obstructions and Limitations-Internal areas
 Information: These photographs are an indication of the obstructions and limitations which impeded full inspection of the internal areas at the time of inspection. These obstructions can hide an array of defects and should be removed to allow a full inspection to be carried out. A re-inspection is recommended once the areas are made accessible.

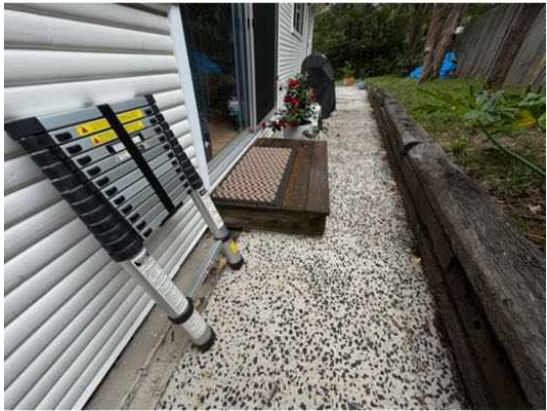
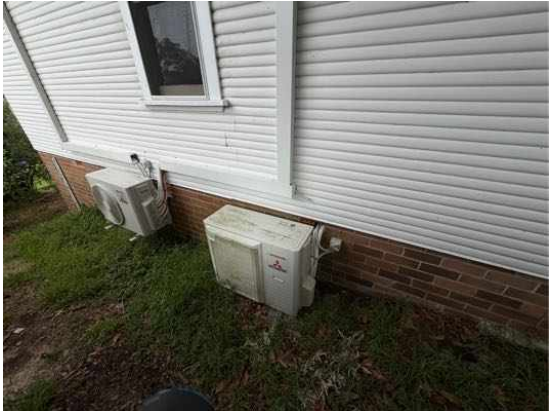
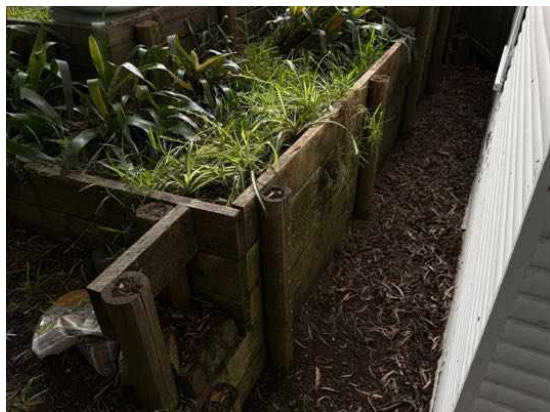
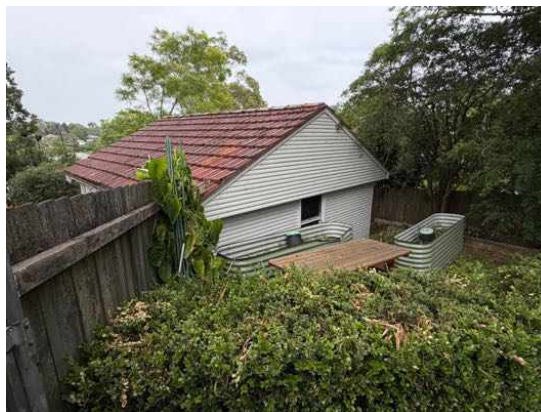
Building: Main Building
 Location: All External Areas
 Finding: Obstructions and Limitations-External Areas
 Information: These photographs are an indication of the obstructions and limitations which impeded full inspection of the external areas at the time of inspection. These obstructions can hide an array of defects and should be removed to allow full inspection to be carried out. A re-inspection is recommended once the areas are made accessible.

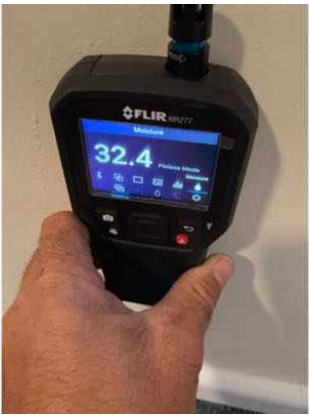
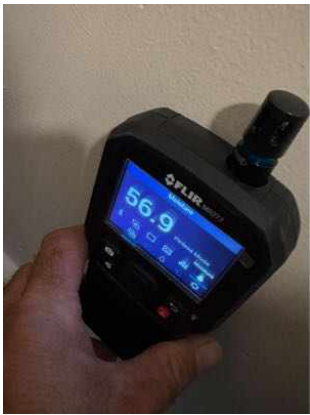
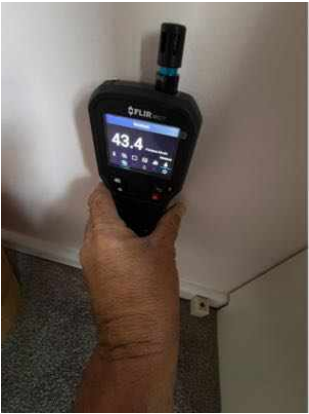
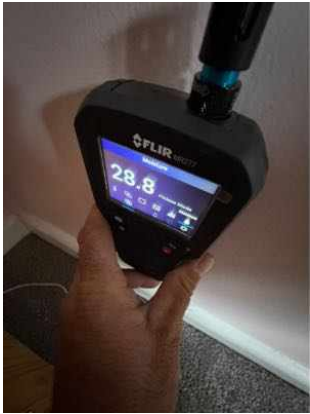
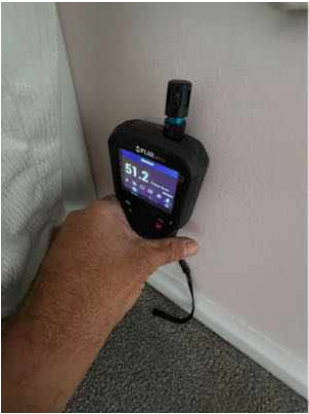
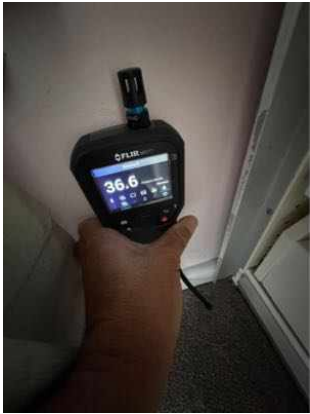
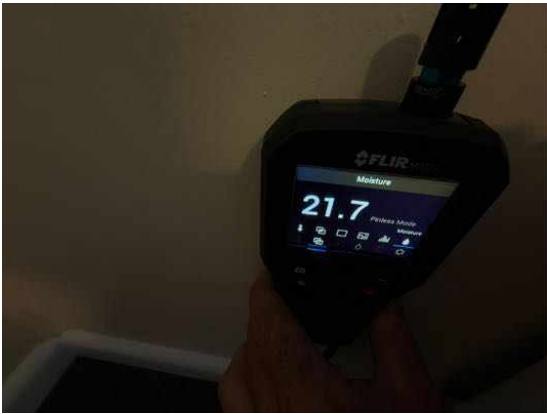
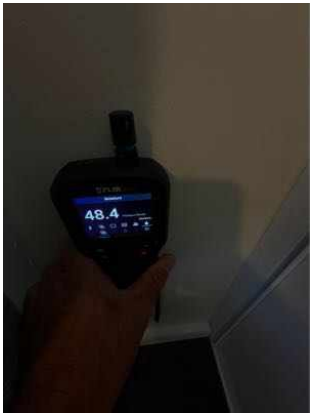
Building:	Main Building
Location:	All Areas
Finding:	FYI-Moisture Readings
Information:	Moisture readings taken during the inspection were recorded using a FLIR MR277 moisture meter, which provides numerical values rather than direct percentage readings. These values are not expressed as a percentage of moisture content but rather as relative indicators of moisture presence within building materials. Each material-such as plasterboard, timber, tile or concrete wall surfaces -has its own baseline range of ambient moisture, and the meter's readings reflect deviations from that baseline.

In short, while percentages are familiar, the meters numeric scale offers a more nuanced and material - sensitive method of identifying moisture issues. Elevated readings – especially those exceeding baseline values by around 20 points or more – are flagged for further investigation, even if no visible damage is present.

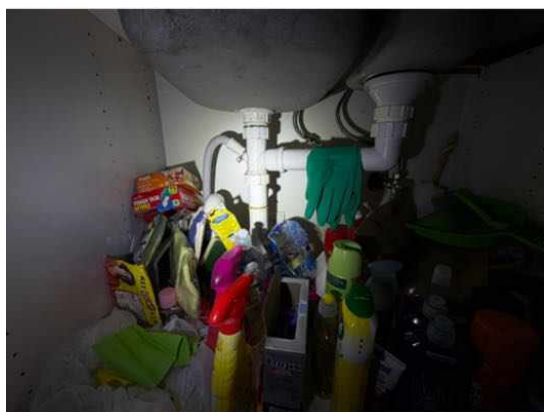
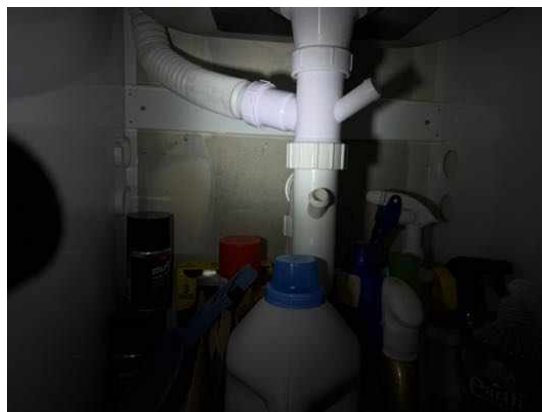
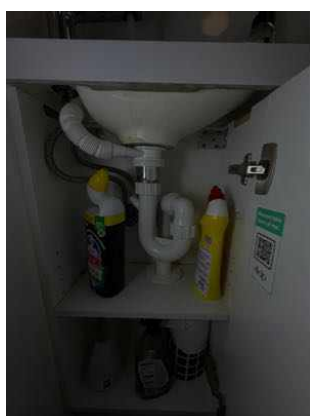
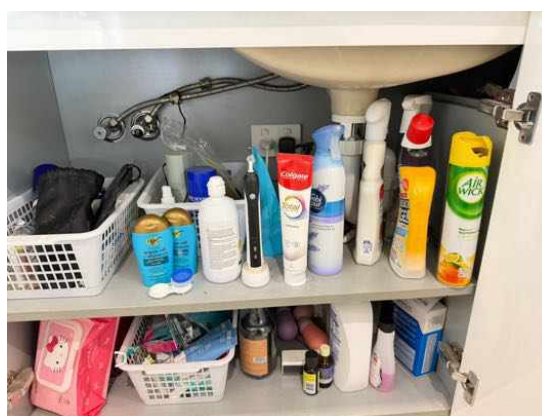
Building: Main Building
 Location: Cabinetry Plumbing
 Finding: FYI-Cabinetry Plumbing
 Information: All cupboards where sinks and basins with drainage plumbing were inspected no evidence of leaks were present at the time of inspection.

For your information only no remedial works are required at the time of inspection.

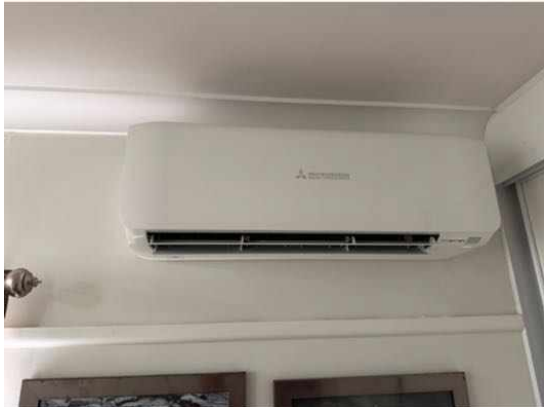
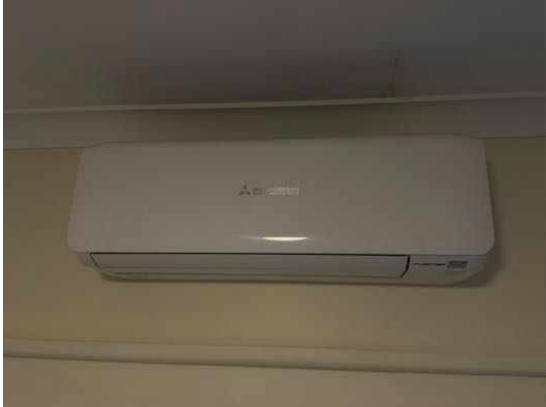
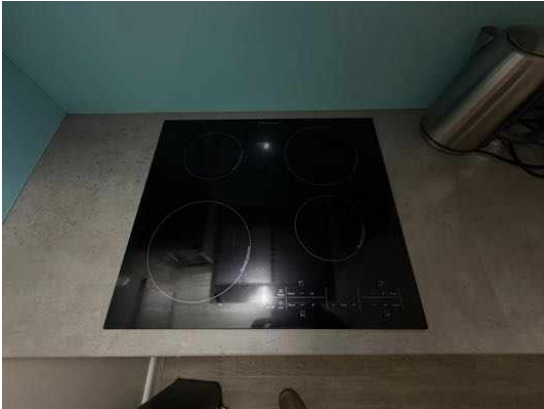
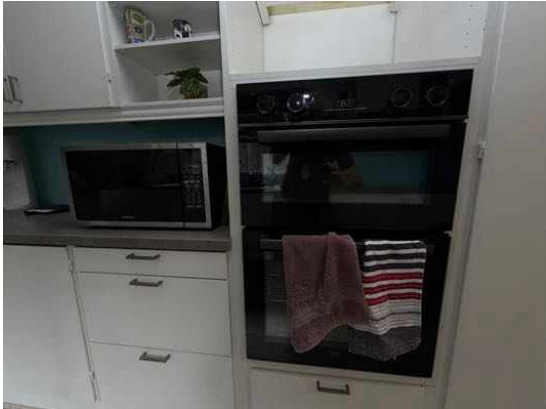
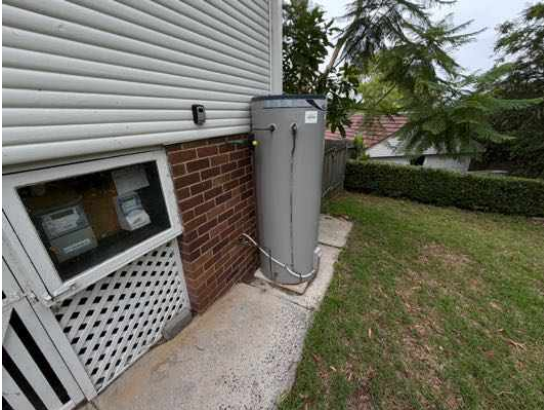
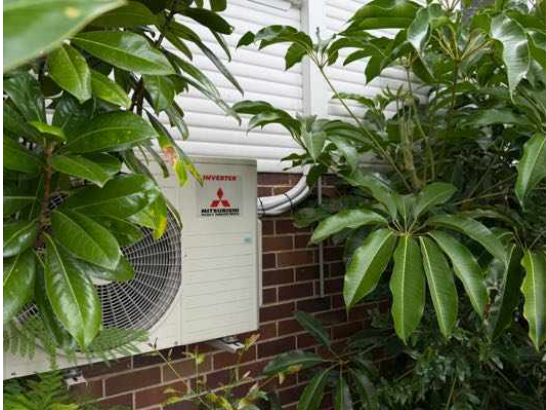
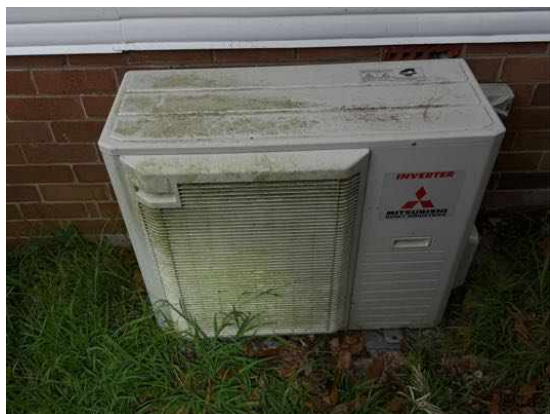
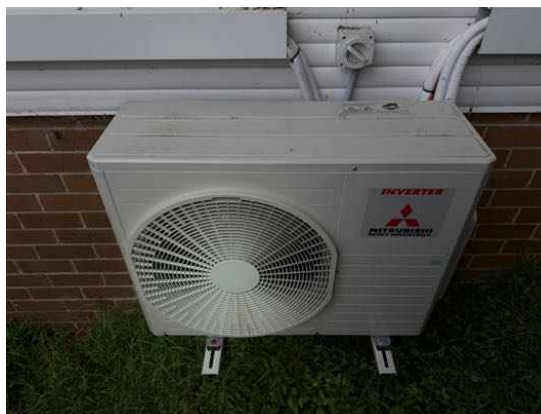
Building: Main Building
 Location: Plumbing/electrical/gas/aircon/pool equipment etc
 Finding: FYI-Plumbing and Electrical
 Information: Plumbing and Electrical inspections are outside the scope of the building inspection

It is highly recommended that the client makes immediate arrangements to have the gas appliances checked by a licensed gas plumber to ensure that the appliances are working safely and efficiently.

We recommend all other installations be checked also.

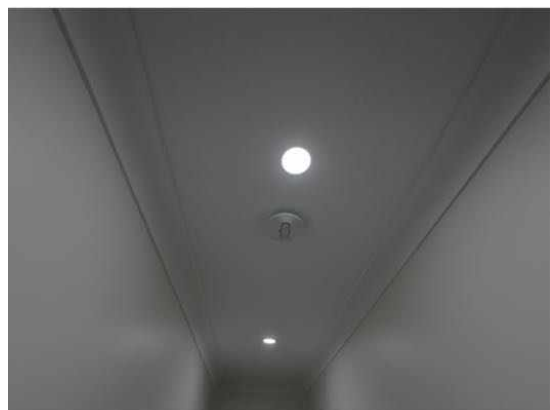
Building:	Main Building
Location:	Smoke Detectors
Finding:	FYI-Smoke Detectors and Alarms
Information:	Reporting on Smoke Detectors or Alarms, including hard wired smoke detection systems and their legislative requirements, is outside the Scope of this Report.

Please note that this defect is highlighted as a caution only. We suspect, based on our experience in the building industry, that the absence of smoke detectors, or their poor condition, should be addressed as a matter of urgency to improve occupant safety.

Always ensure sufficient working and suitable smoke detectors are installed prior to occupying any building. Additionally, it is advised that all smoke detectors be tested by the homeowner on a monthly basis.

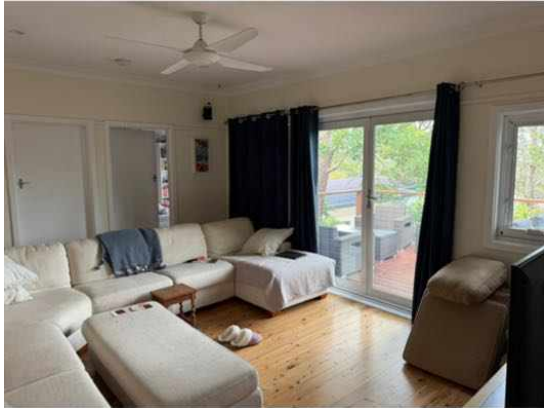
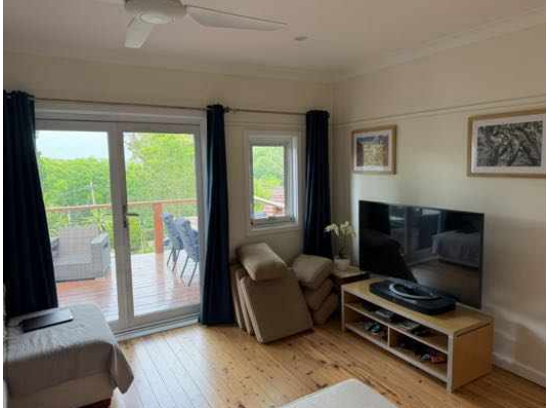
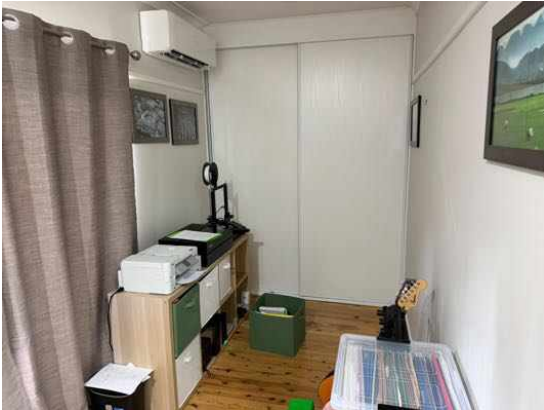
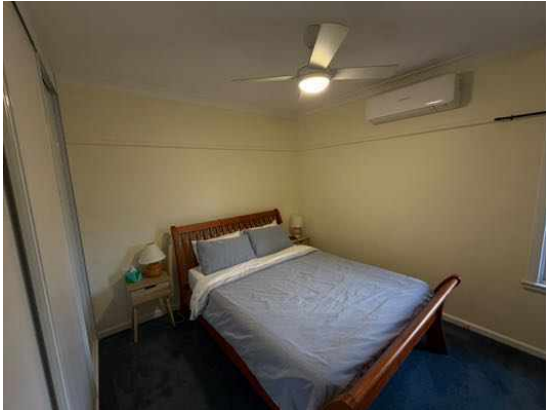
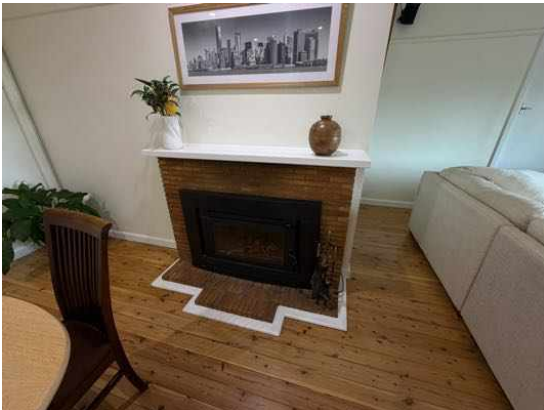
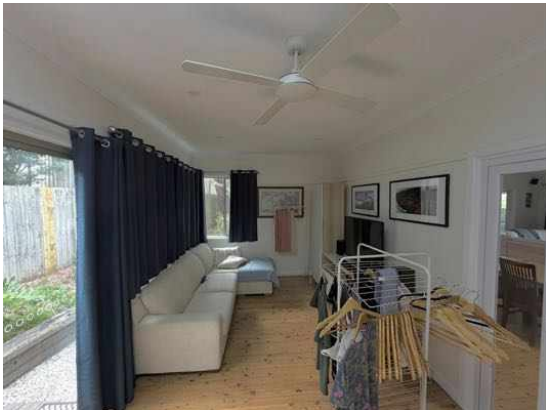
Building: Main Building
Location: All Areas
Finding: FYI-Additional Photos
Information: Additional photos are provided for your general reference and may include obstructions, testing of water and windows, moisture readings or minor maintenance items.
