Building and Timber Pest Inspection Report

Inspection Date: Fri, 6 Feb 2026

Property Address: 14 Varna St, Mount Colah NSW 2079,
Australia

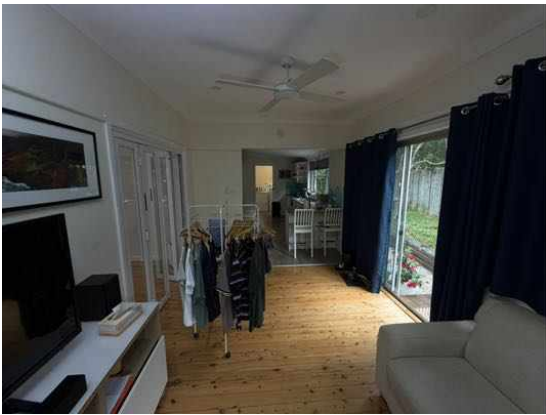
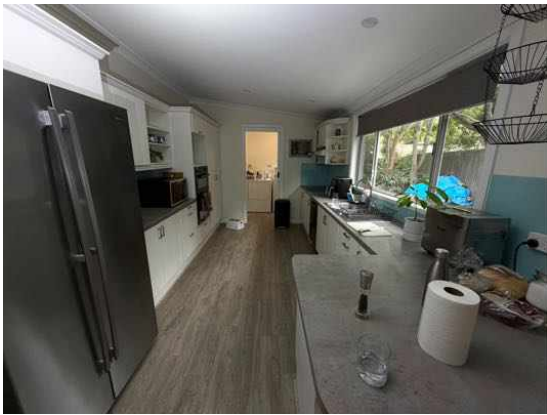
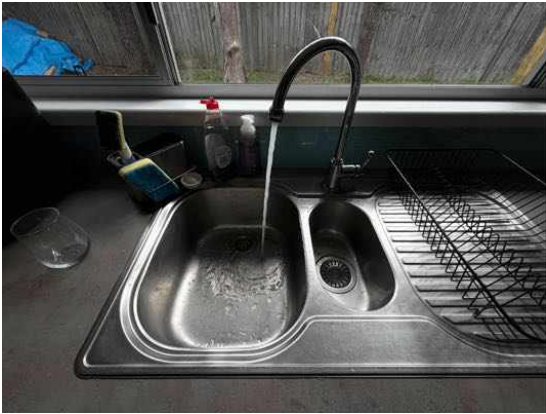
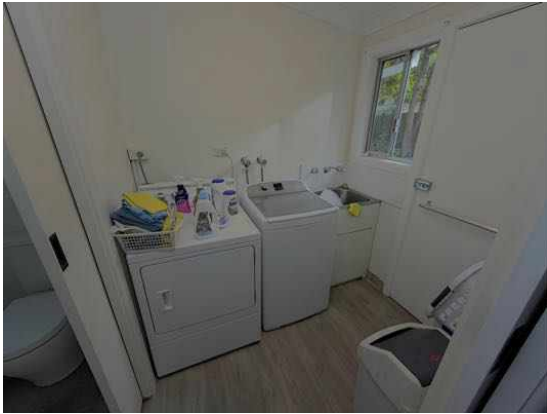
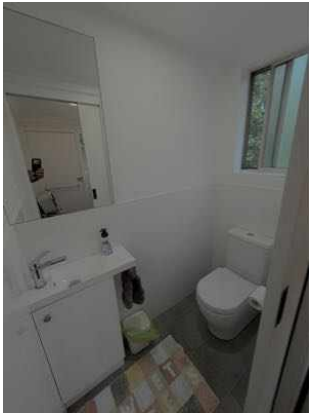
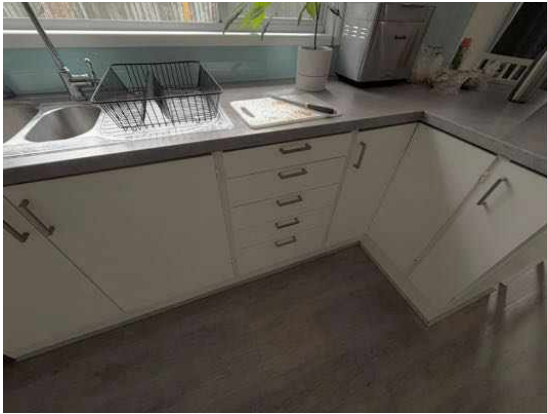
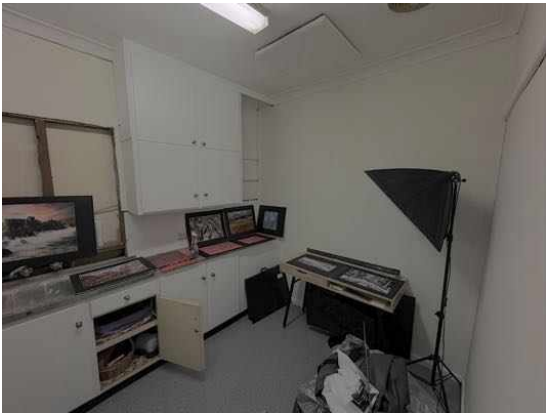
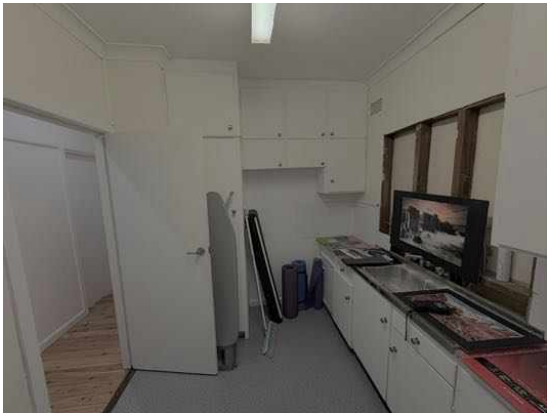
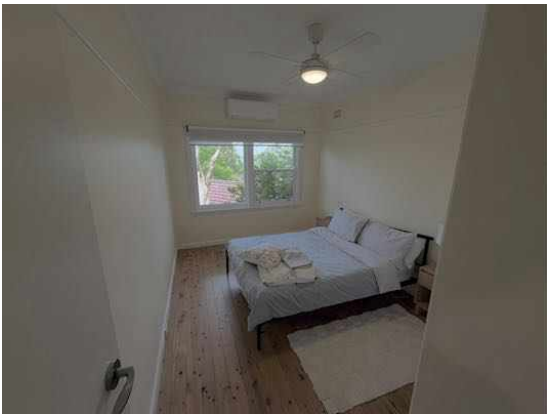
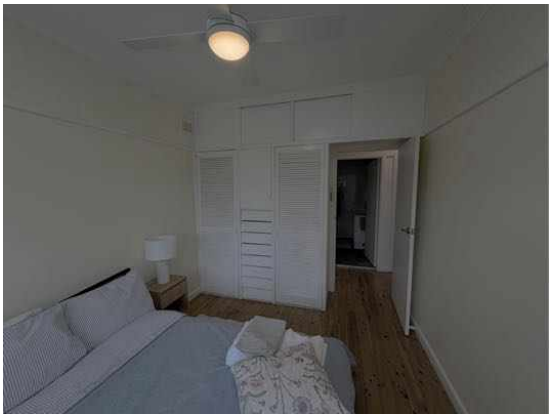
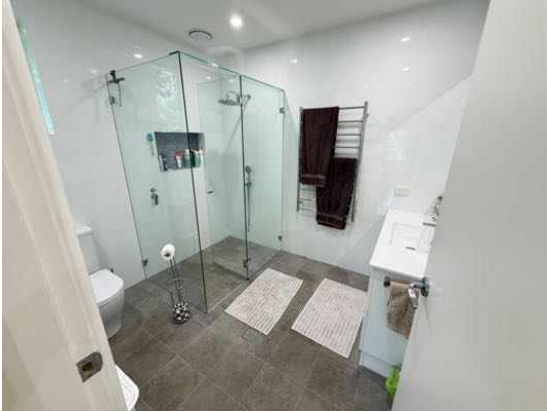
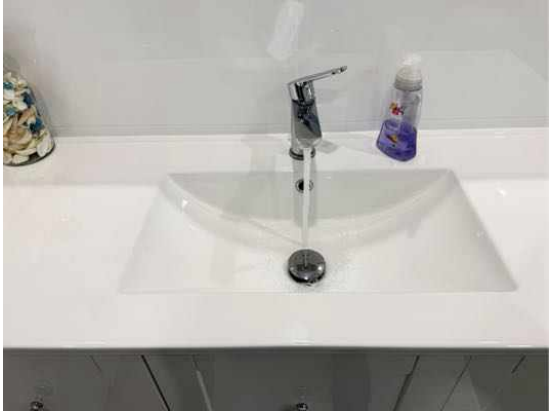
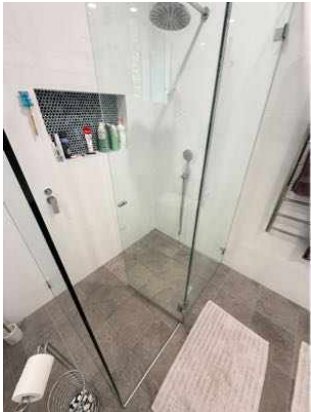
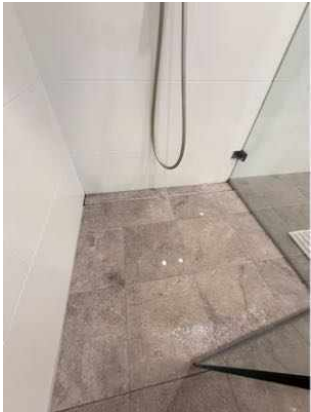
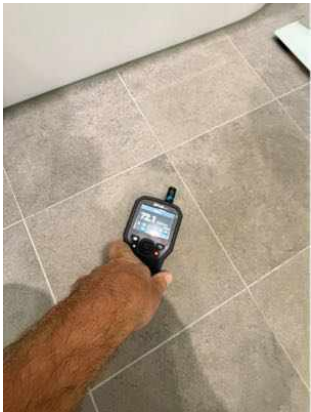
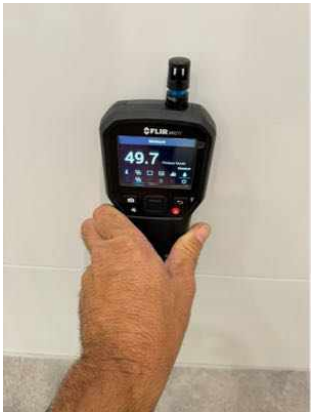
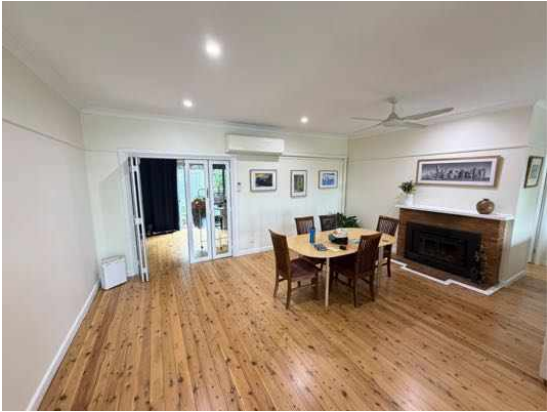
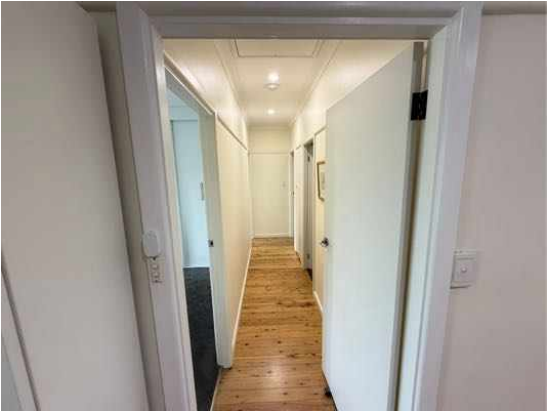
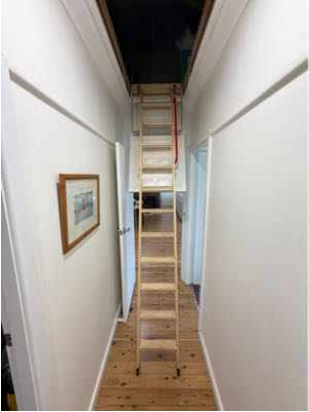
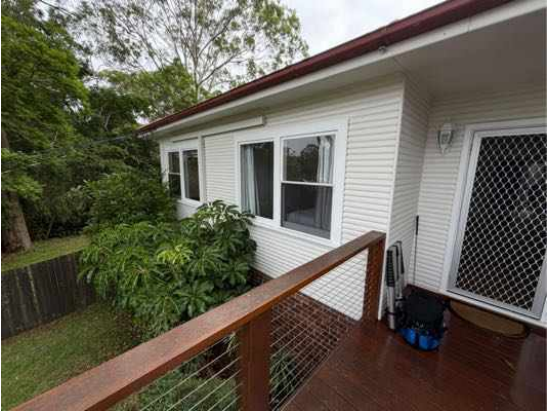
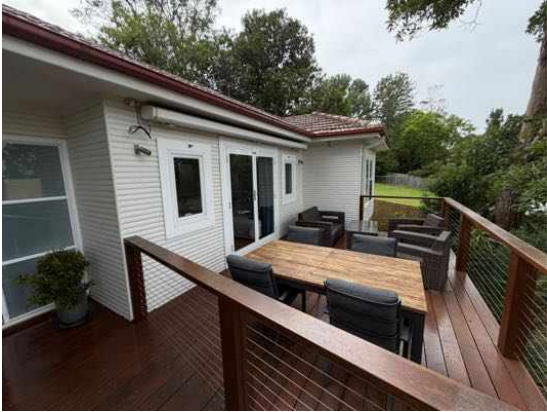
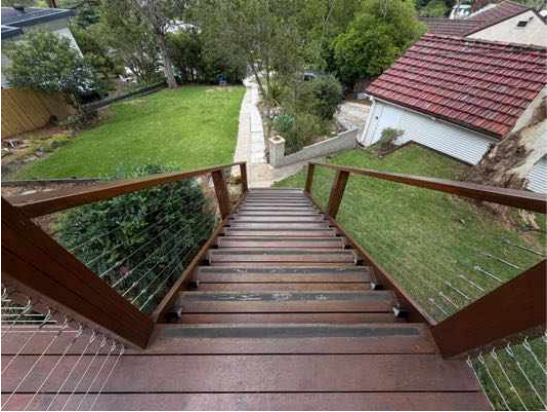
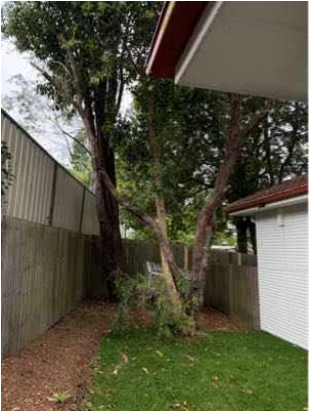
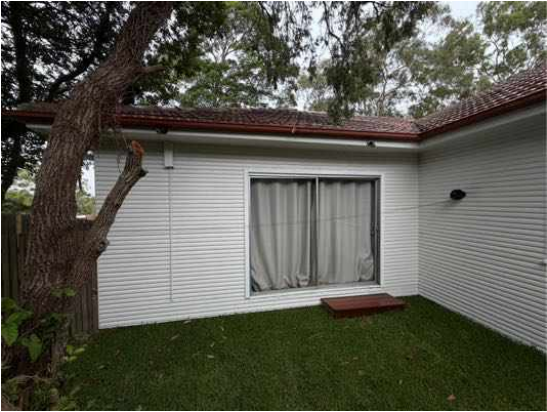
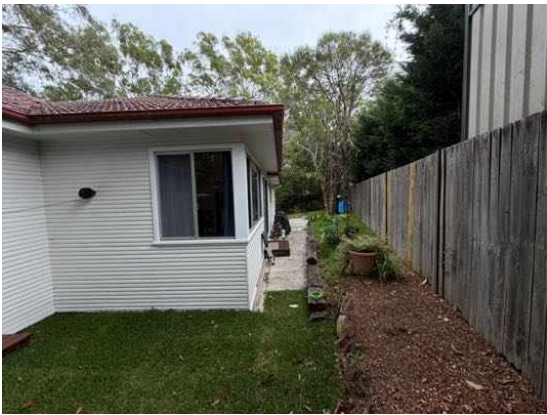
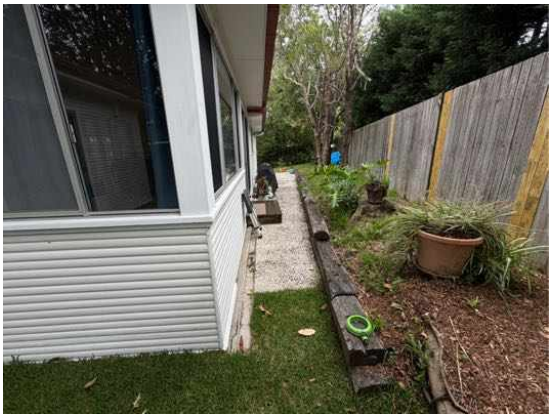
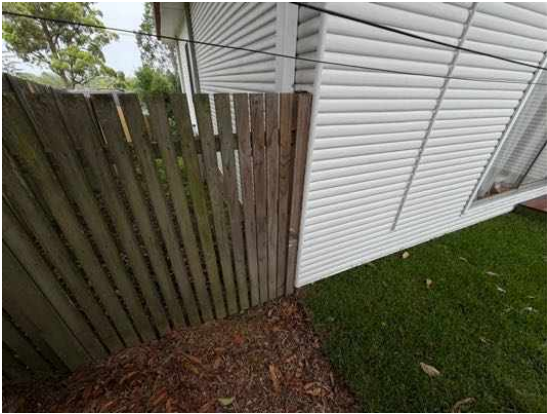
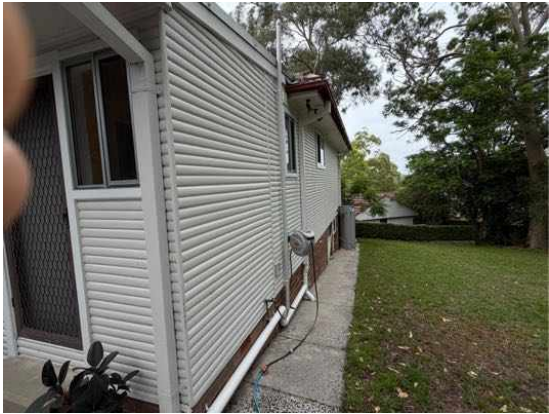
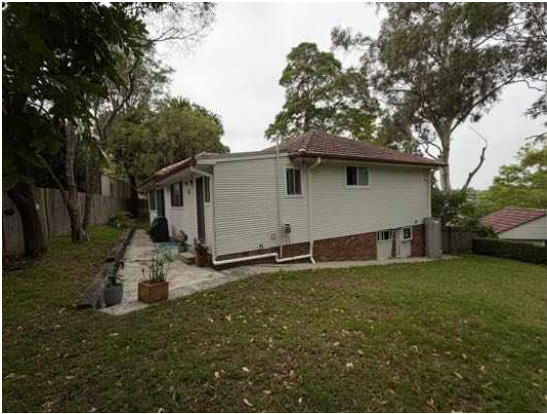
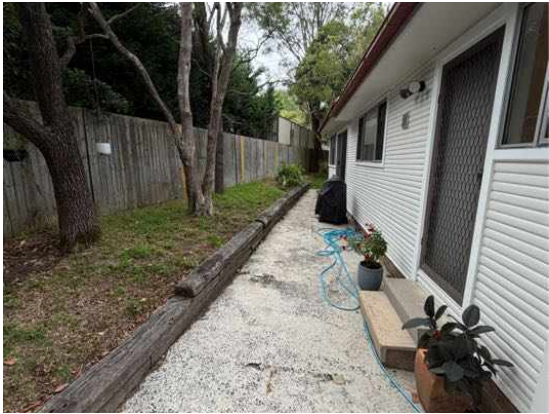
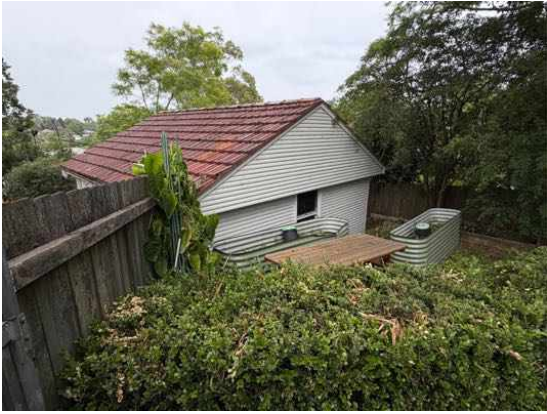
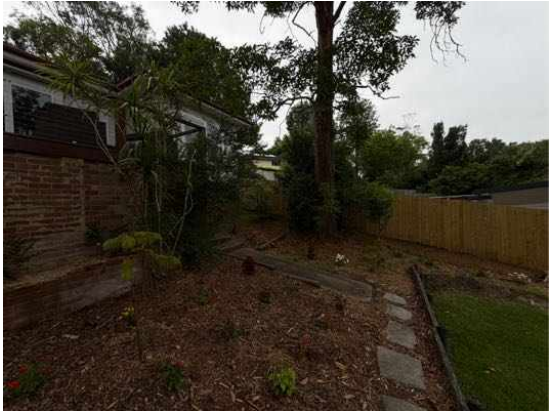
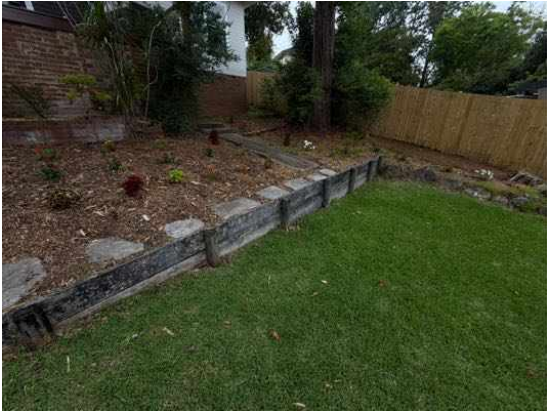
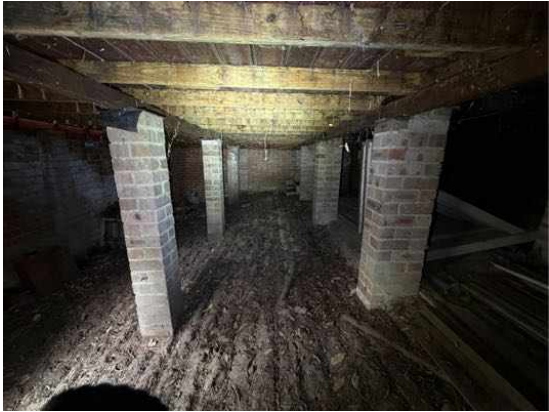
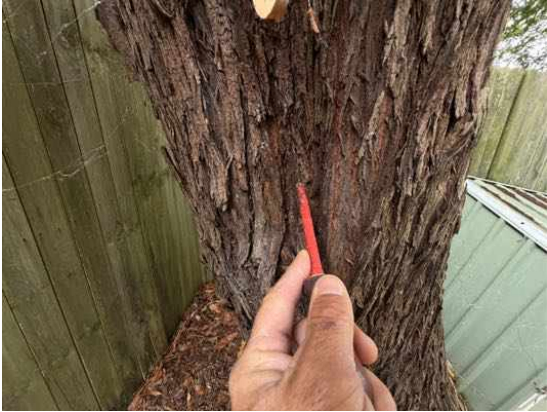
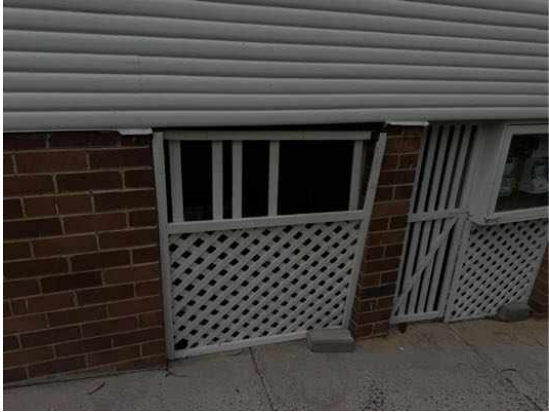
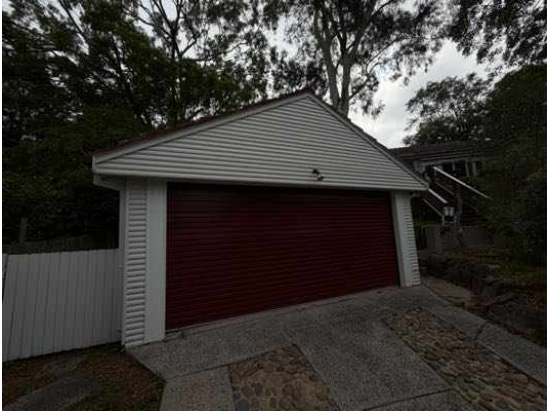
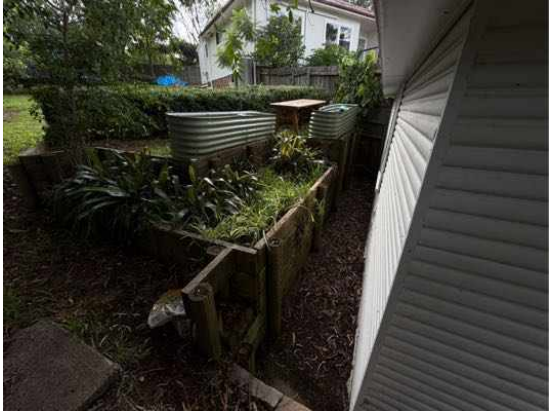
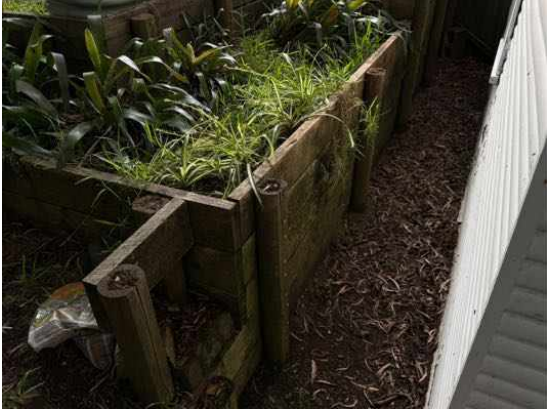
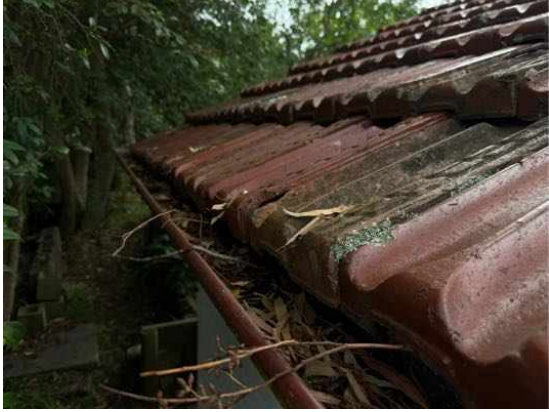
Building: Main Building
Location: All Areas
Finding: FYI-Additional Photos
Information: Additional photos are provided for your general reference and may include obstructions, testing of water and windows, moisture readings or minor maintenance items.
