Building and Timber Pest Inspection Report VR

Inspection Date: Thu, 12 Feb 2026

Property Address: 50 Ardoyne Rd, Corinda QLD 4075,
Australia

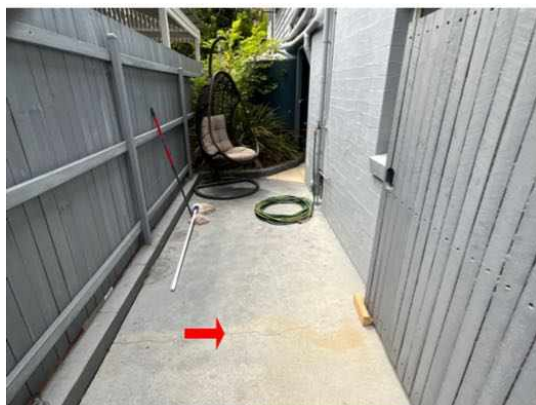
Building: Main Building
 Location: Exterior walls - left side
 Finding: Crack in concrete slab - Category 1
 Information: A crack coded as Category 1 was identified in the slab. A Category 1 crack is described as a fine but noticeable crack, with the slab at an otherwise reasonable level.

To be considered Category 1, the approximate width of the crack is less than 1.0mm, or a less than 10mm change in offset when a 3m straight edge is placed over the defect.

Category 1 cracks should be monitored for a period of 12 months. At the end of the monitoring period, identified cracks that are rated greater than Category 2 are considered defects, and require rectification.

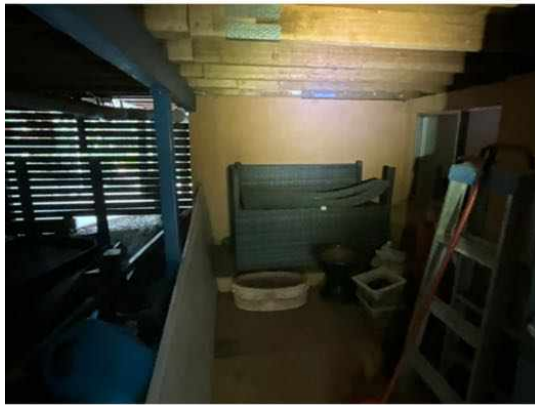
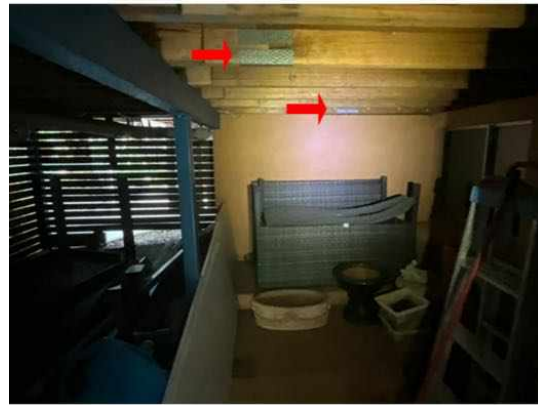
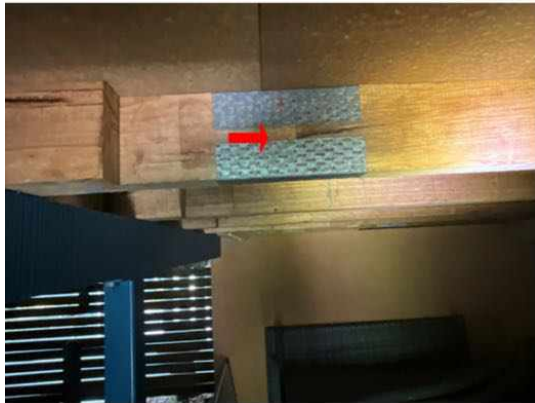
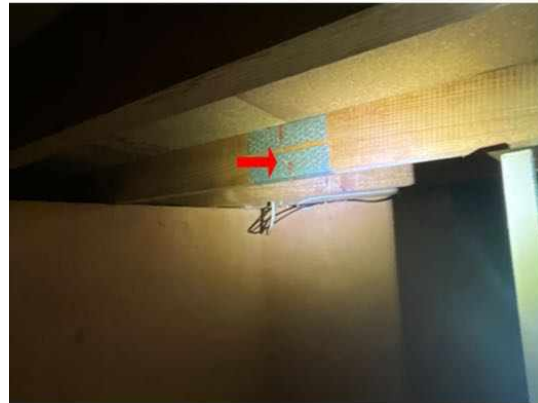
Finding 3.02

Building: Main Building
 Location: Subfloor
 Finding: Joined Floor Joists – Subfloor Area Beneath Living Areas

Mid-span joist joins can reduce structural performance and stiffness, potentially leading to floor deflection, movement, or long-term sagging. This type of repair or modification may not comply with standard framing practices and could indicate prior alteration or repair works. Ongoing movement may contribute to internal cracking, uneven floors, or reduced load capacity.

Assessment recommended within 30 days, with repairs carried out promptly following professional advice.

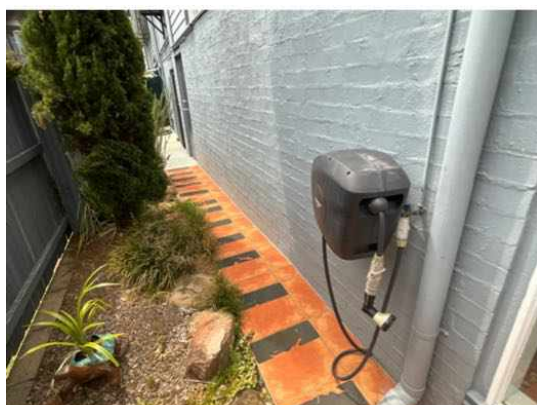
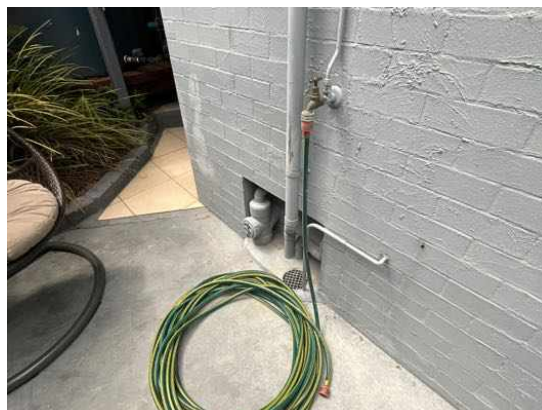
Building: Main Building
Location: All Areas
Finding: No Drain under tap.
Information: There is no drain installed under the tap, leading to water accumulation and creating conducive conditions for timber pests.

This defect needs immediate attention to prevent potential damage and pest infestation.

1. Water Accumulation: Without proper drainage, water can accumulate around the base of the tap, leading to persistent dampness in the surrounding area.
2. Timber Pest Infestation: The damp environment created by standing water is highly conducive to timber pests, such as termites and wood borers, which thrive in moist conditions and can cause significant damage to wooden structures.
3. Structural Damage: Prolonged exposure to moisture can lead to wood rot and deterioration of structural timber, compromising the integrity of the building.
4. Health Hazards: Persistent dampness can also promote mold and mildew growth, posing health risks to occupants.
5. Aesthetic Damage: Water stains and damage to finishes and materials around the tap area can detract from the appearance of the building and lead to costly repairs.

A licensed plumber or a qualified building contractor can address this defect by:

1. Assessment: Evaluating the area to determine the best approach for installing a proper drainage system under the tap.
2. Installation: Installing a drain that effectively channels water away from the base of the tap, preventing water accumulation and dampness.
3. Repair and Prevention: Inspecting and repairing any existing water damage and implementing measures to prevent future water accumulation and pest infestations.

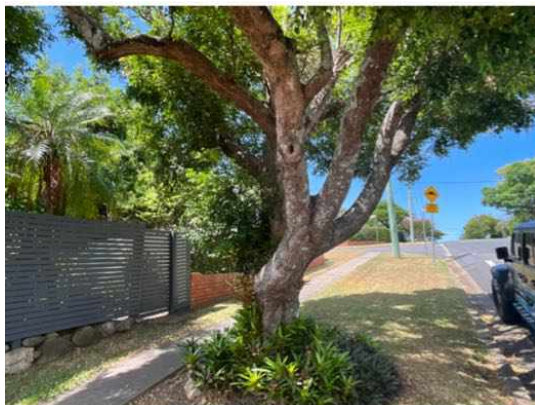
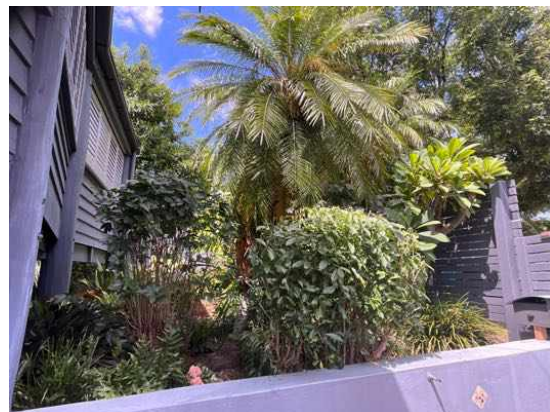
Finding 6.02

Building: Main Building

To address this, consider maintaining a clear space between the vegetation and your home.

If you suspect a termite issue, it's advisable to consult with a licensed pest control professional for inspection and treatment.

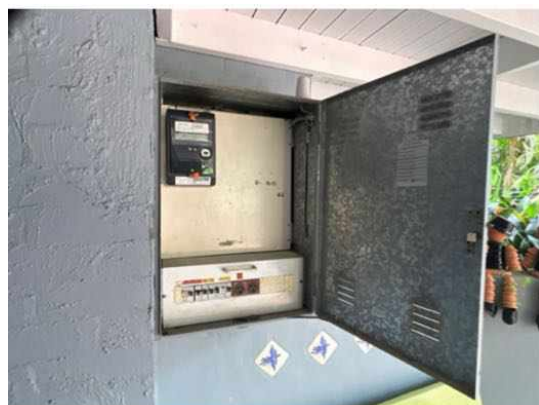
A durable notice should be placed in the switchboard unit to indicate current termite barriers. At the time of inspection, it appeared as though no termite management system has been installed, with no evidence to suggest preventative works taking place.

The client may consider gaining further advice from a pest controller as to the costs and procedures involved with this application. It is recommended that obtaining such advice be a short-term priority.

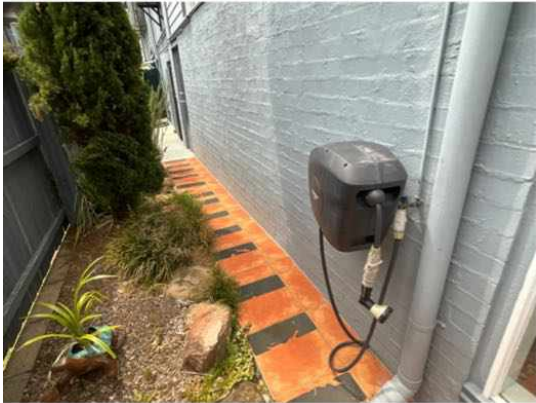
Building: Main Building
 Location: All Areas
 Finding: Slab Edge - Exposure
 Information: An inspection zone of at least 75mm in relation to the exposed slab edge, between the bottom brick and the perimeter pavement, is required. This inspection zone should be maintained in order to force termites into the open where they can be detected more readily during regular inspections. The slab edge should not be concealed by anything that may prevent inspection of the area, including render,

If the slab edge is not properly exposed there is a high risk of termite attack. Sometimes, in order to determine the type of slab, a suitably qualified person such as an architect or builder may be required to consult the construction plans.

Where the slab edge cannot be properly inspected, it is highly recommended that termite or timber pest inspections be carried out every 6-12 months to aid protection of the property against infestation.

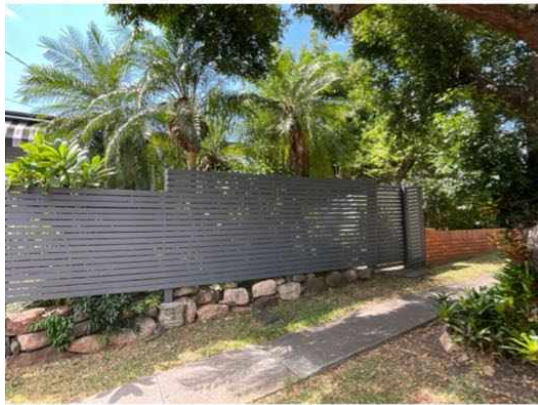
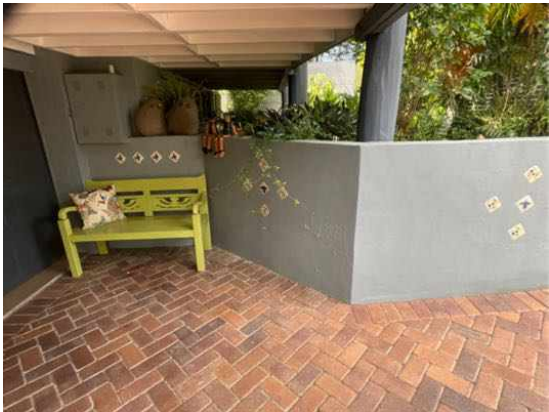
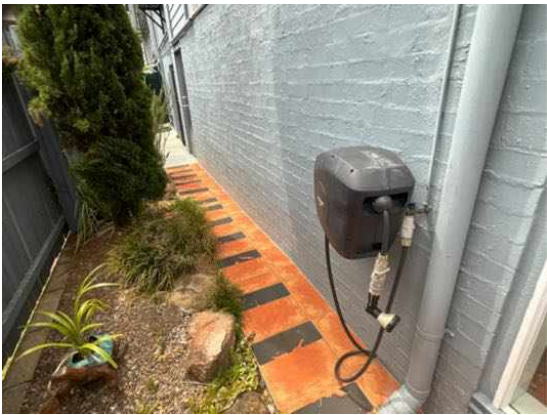
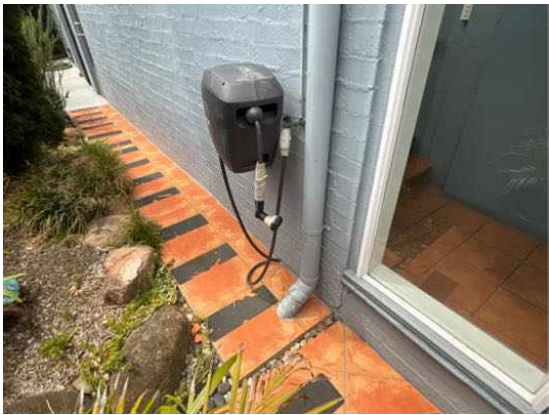
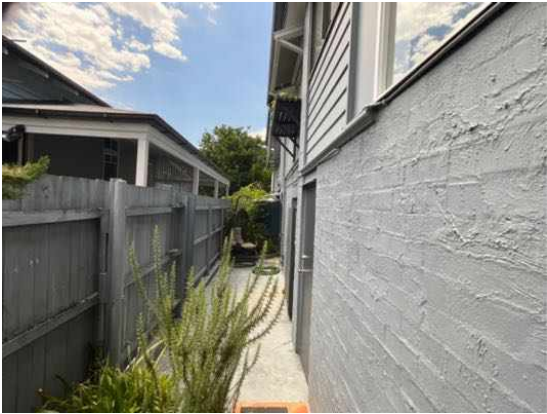
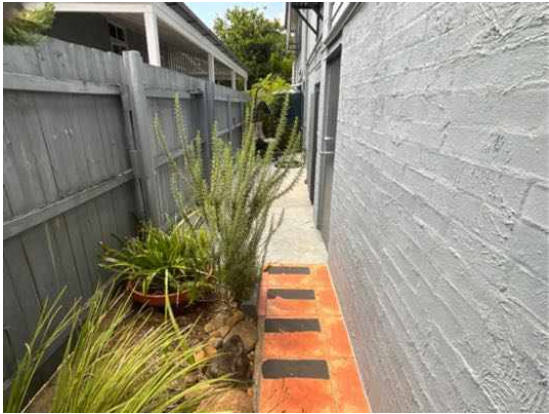
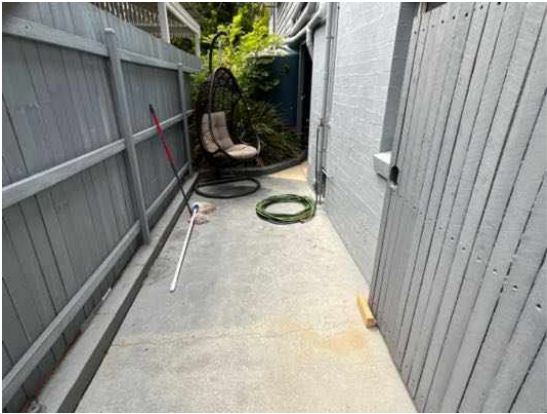
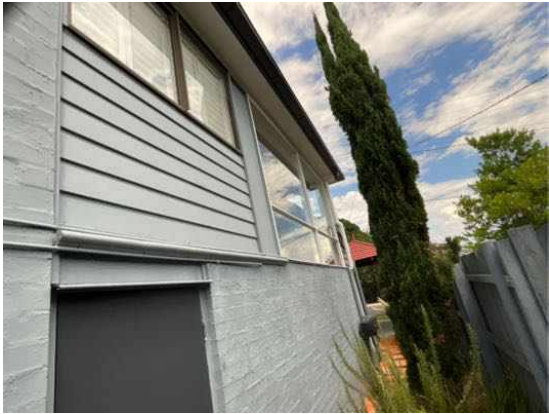
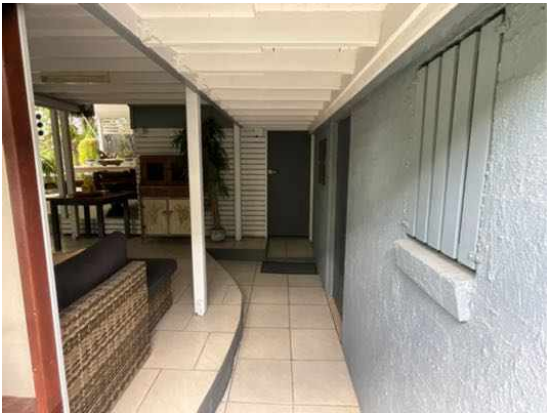
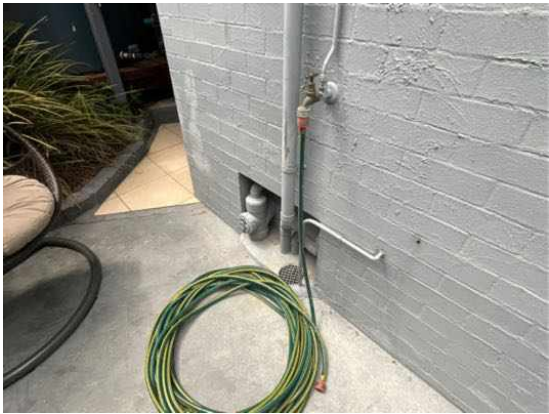
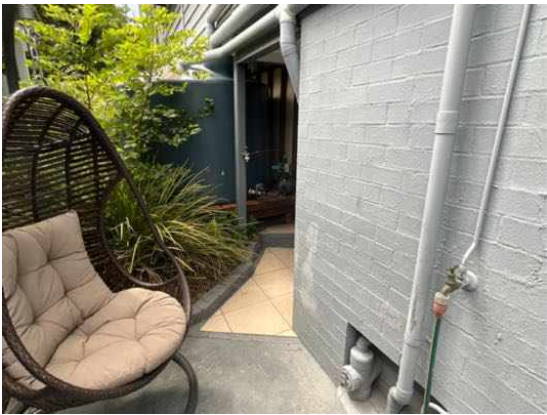
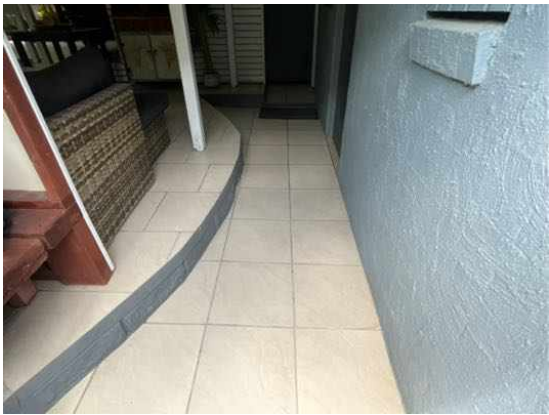
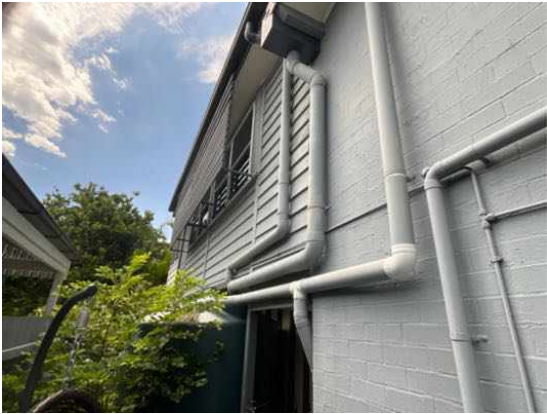
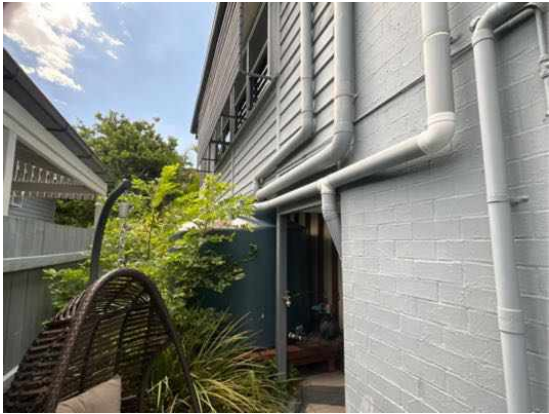
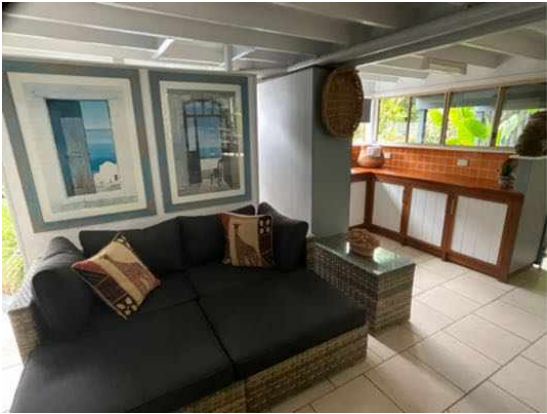
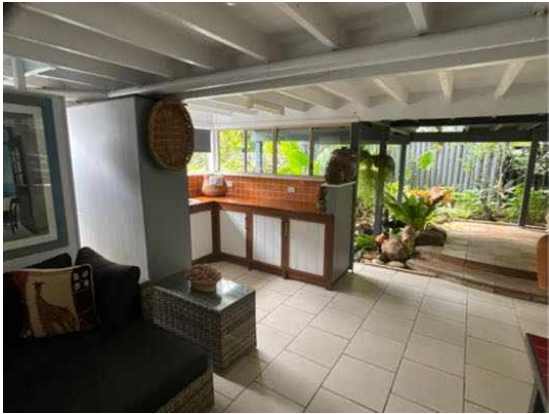
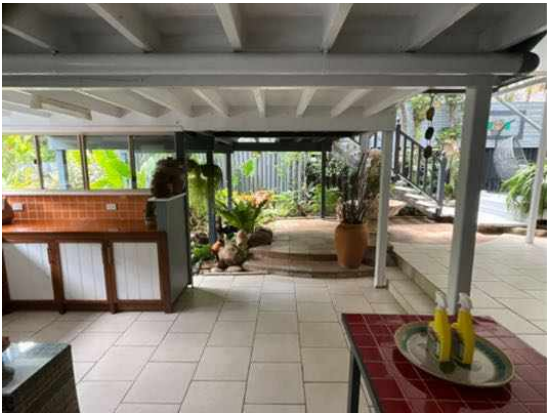
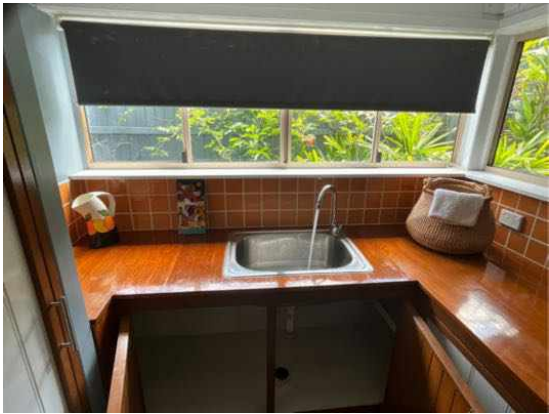
Building: Main Building
 Location: All Areas
 Finding: Additional Photos - Obstructions and Limitations
 Information: These photographs are an indication of the obstructions and limitations which impeded full inspection of the property at the time of inspection. These obstructions can hide an array of defects and should be removed to allow full inspection to be carried out. A re-inspection is recommended once the areas are made accessible.

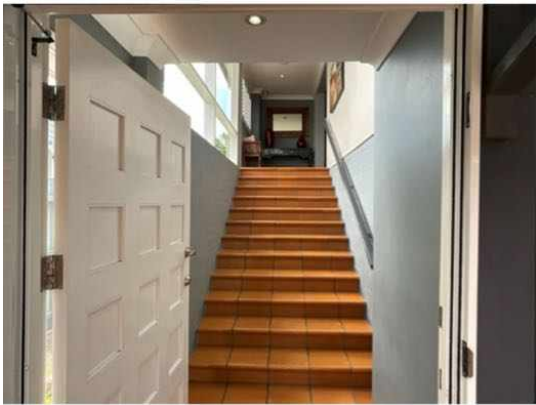
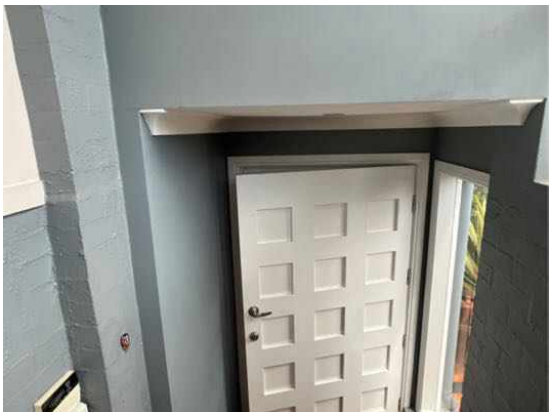
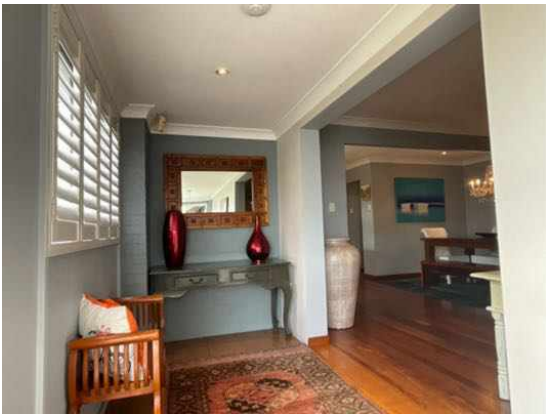
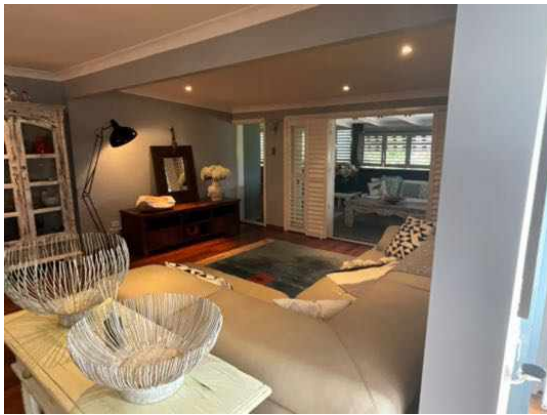
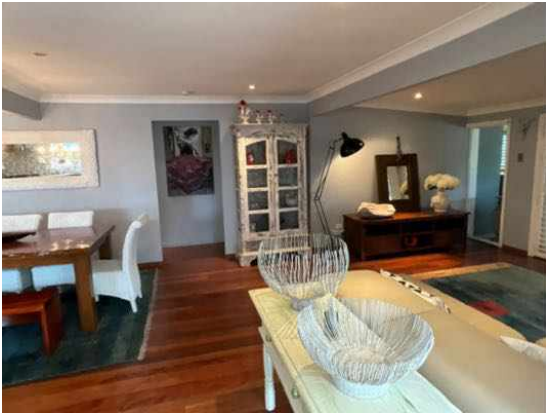
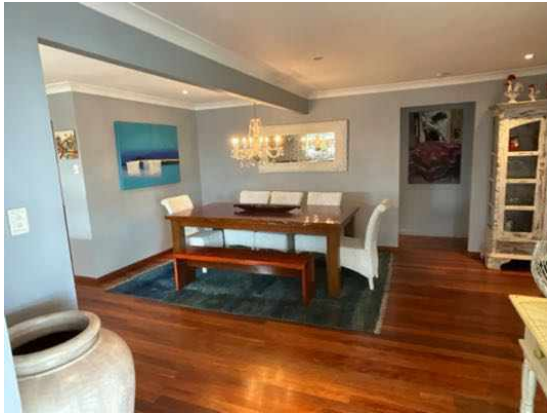
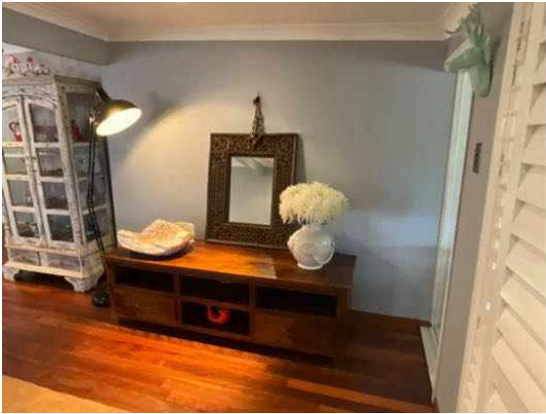
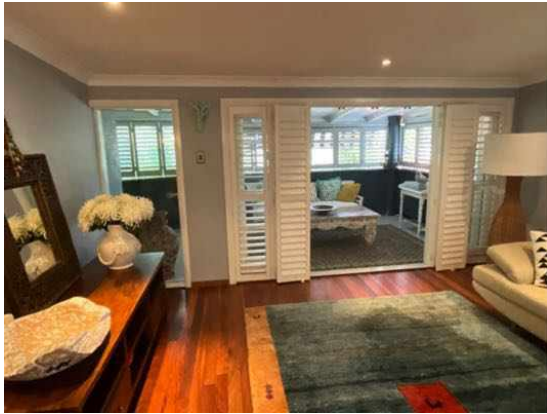
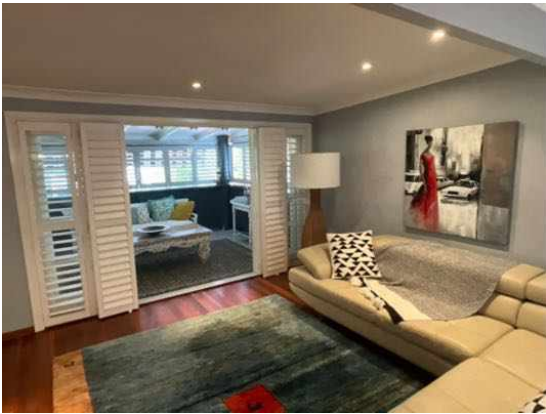
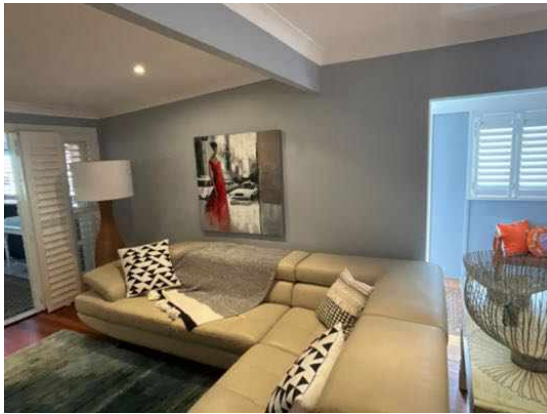
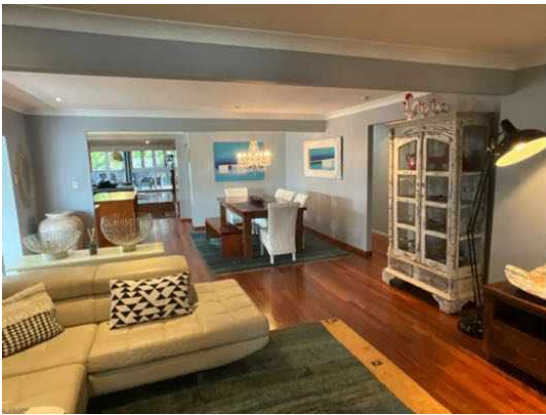
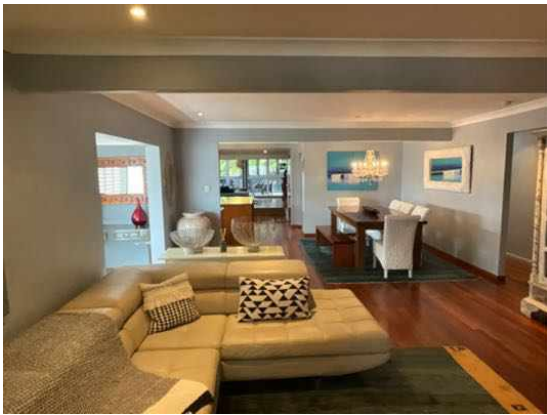
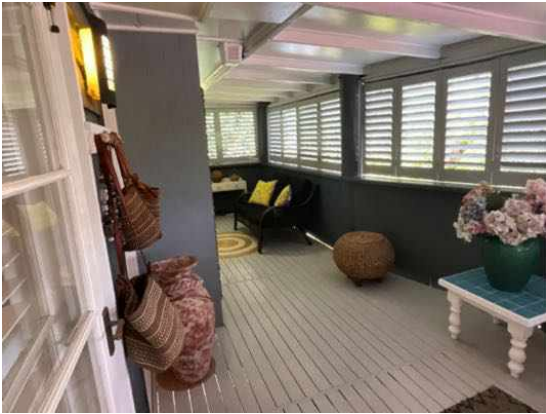
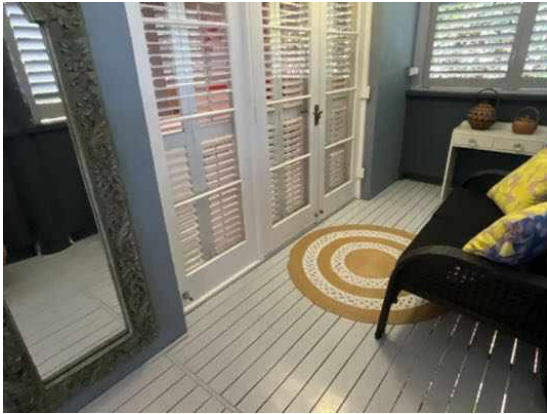
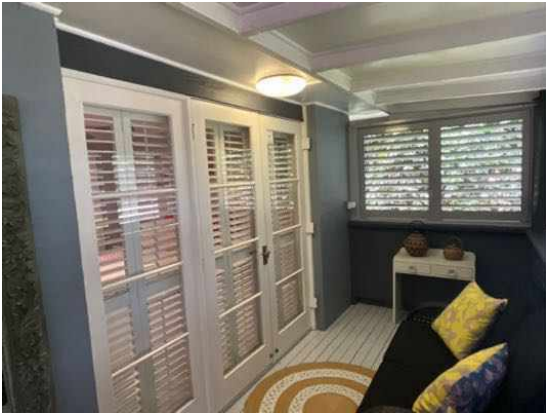
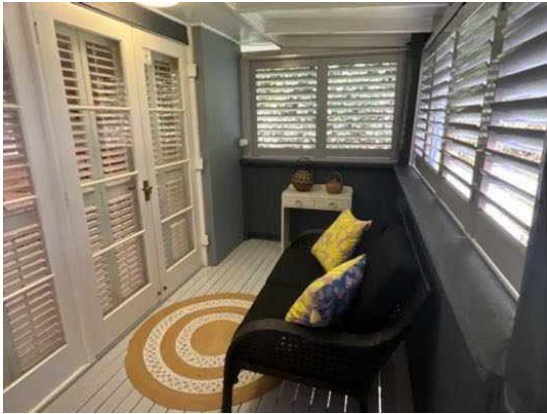
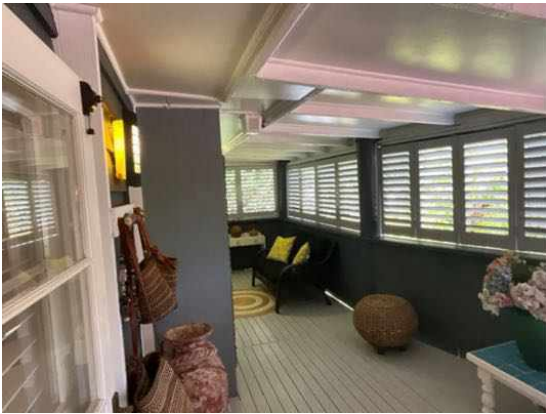
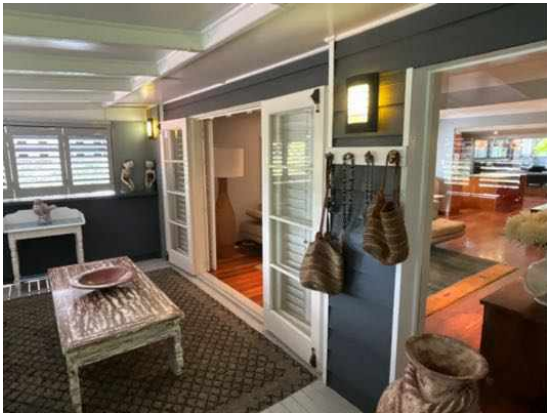
Building:	Main Building
Location:	All Areas
Finding:	Additional Photos - Obstructions and Limitations
Information:	These photographs are an indication of the obstructions and limitations which impeded full inspection of the property at the time of inspection. These obstructions can hide an array of defects and should be removed to allow full inspection to be carried out. A re-inspection is recommended once the areas are made accessible.
