Building and Timber Pest Inspection Report

Inspection Date: Wed, 4 Mar 2026

Property Address: 20 Ravenswood Rise, Bella Vista NSW 2153, Australia

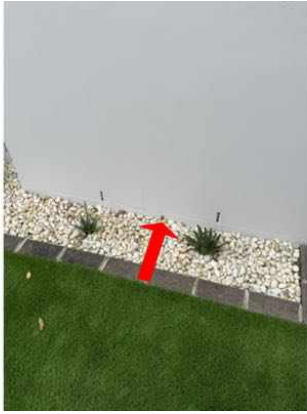
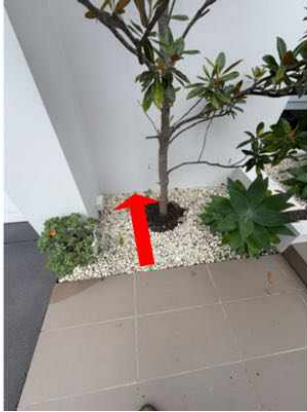
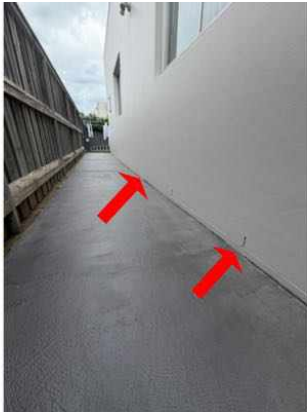
If the slab edge is not properly exposed there is a high risk of termite attack. Sometimes, in order to determine the type of slab, a suitably qualified person such as an architect or builder may be required to consult the construction plans.

Where the slab edge cannot be properly inspected, it is highly recommended that termite or timber pest inspections be carried out every 6-12 months to aid protection of the property against infestation.

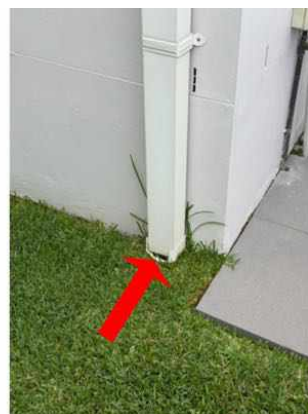
Finding 6.02

Building:	Main Building
Location:	Downpipes
Finding:	Downpipe(s)-not connected
Information:	The roof plumbing is not adequately connected to stormwater drainage on the site. This disconnection negatively impacts the functional capacity of the roof plumbing.

Where roof plumbing doesn't drain adequately, the area at the base perimeter can become excessively damp, potentially creating an environment that is susceptible to rust and corrosion of surrounding building elements, as well as attracting termites and other pests.

It is highly recommended that a plumber be appointed to further inspect the area and to connect all downpipes adequately as soon as possible.

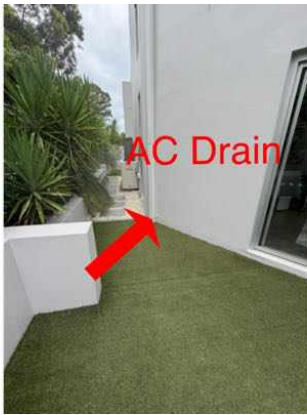
Finding 6.03

Building:	Main Building
Location:	Hot Water/AC units
Finding:	Overflows not plumbed to drainage
Information:	The overflow is not plumbed or connected to suitable drainage, which has resulted in the surrounding area becoming excessively damp.

These damp conditions can lead to secondary defects such as rot, rust or corrosion of associated building elements, the formation of fungal decay, or even the creation of potential slip hazards. When coupled with poor site drainage, pooling of water may also attract termite activity to this area.

It is highly recommended that a qualified plumber be appointed to install adequate drainage to the overflow. These works will ensure that the area remains dry and free of any secondary defects.

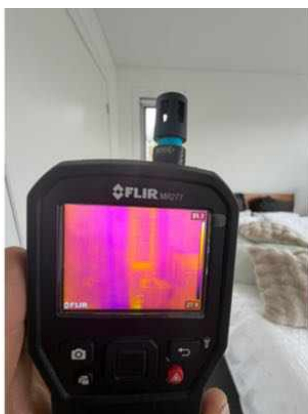
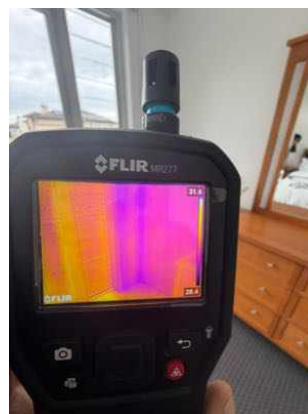
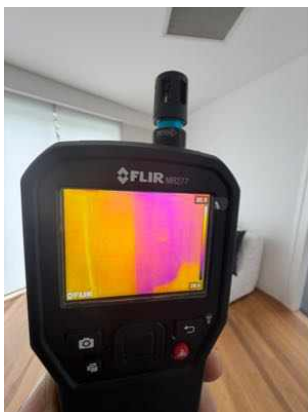
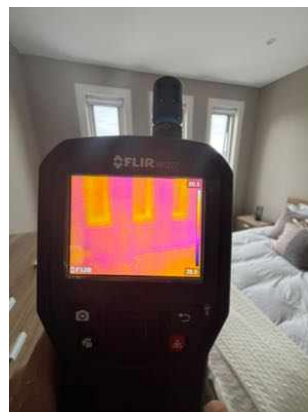
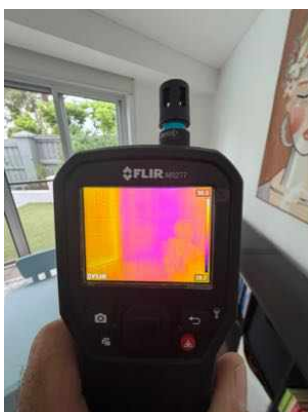
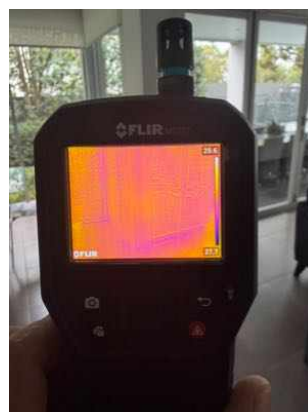
Building: Main Building
 Location: All Internal Areas
 Finding: For your information-Thermal camera
 Information: AS 3660.2:2017 is the recommendation for the carrying out of 'Additional Tests' using specialist non-destructive tools:

A thermal imaging inspection was carried out throughout the interior of the house using a Flir MR277 thermal camera. No thermal anomalies were noted that would be consistent with any current termite activity, however various factors must be taken into effect which may hamper or impede the reading obtainable by the imager. These factors include obstructions, ambient temperature, wall material and thickness etc. If any surface is restricted visually or otherwise, a proper thermal reading is not possible and is not within the scope of this inspection. Any findings or otherwise is reported on at the time of the inspection only.

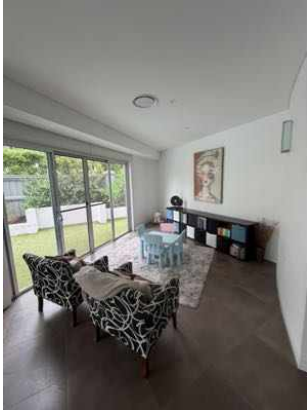
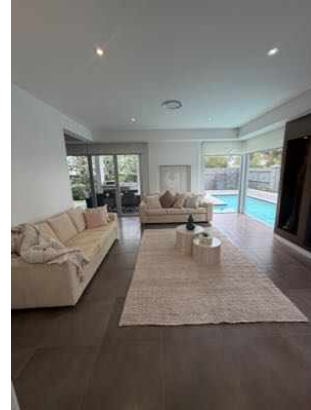
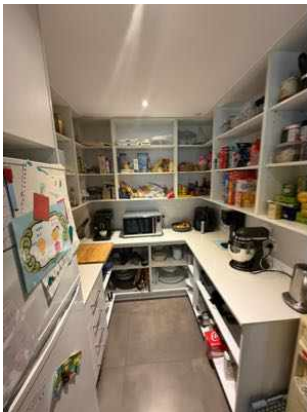
Building:	Main Building
Location:	Internal Areas
Finding:	Obstructions and Limitations-Internal areas
Information:	These photographs are an indication of the obstructions and limitations which impeded full inspection of the internal areas at the time of inspection. These obstructions can hide an array of defects and should be removed to allow a full inspection to be carried out. A re-inspection is recommended once the areas are made accessible.

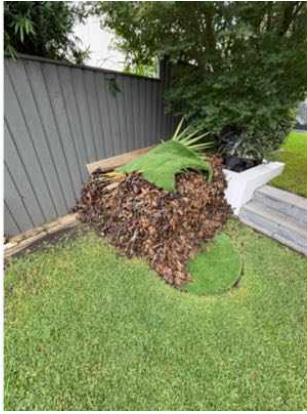
Building:	Main Building
Location:	External Areas/Sub-Floor
Finding:	Obstructions and Limitations-External Areas/Sub-Floor
Information:	These photographs are an indication of the obstructions and limitations which impeded full inspection of the external areas/subfloor at the time of inspection. These obstructions can hide an array of defects and should be removed to allow full inspection to be carried out. A re-inspection is recommended once the areas are made accessible.

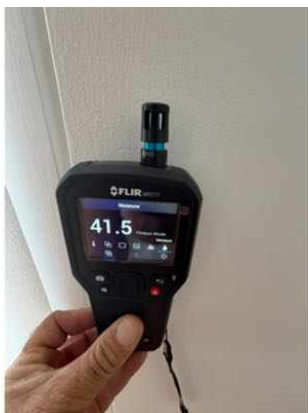
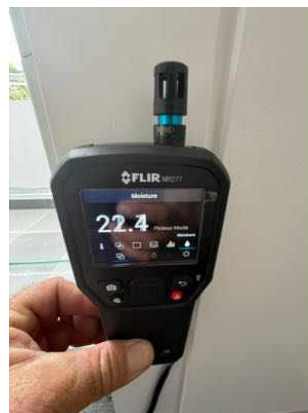
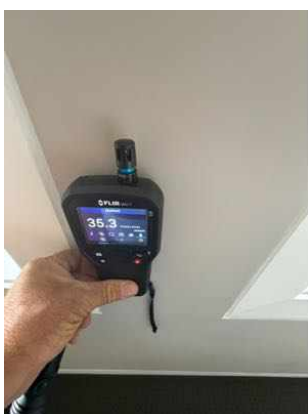
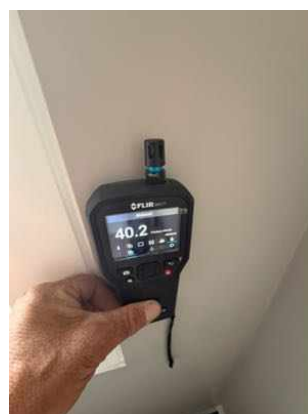
Building:	Main Building
Location:	All Areas
Finding:	FYI-Moisture Readings
Information:	Moisture readings taken during the inspection were recorded using a FLIR MR277 moisture meter, which provides numerical values rather than direct percentage readings. These values are not expressed as a percentage of moisture content but rather as relative indicators of moisture presence within building materials. Each material-such as plasterboard, timber, tile or concrete wall surfaces -has its own baseline range of ambient moisture, and the meter's readings reflect deviations from that baseline.

The FLIR MR277 uses both pin and pinless sensors, along with thermal imaging, to detect hidden moisture anomalies. Its readings are designed to highlight relative changes rather than provide absolute moisture percentages. This approach is particularly effective in building diagnostics, as it allows for non-invasive detection of moisture trends across different substrates.

In short, while percentages are familiar, the meters numeric scale offers a more nuanced and material - sensitive method of identifying moisture issues. Elevated readings – especially those exceeding baseline values by around 20 points or more – are flagged for further investigation, even if no visible damage is present.

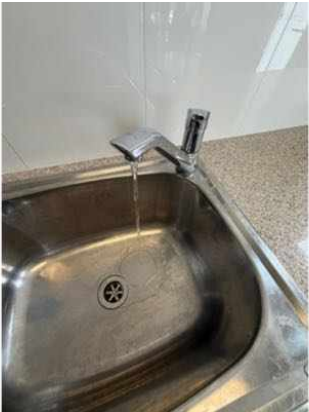
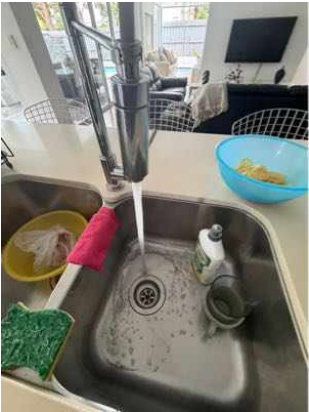
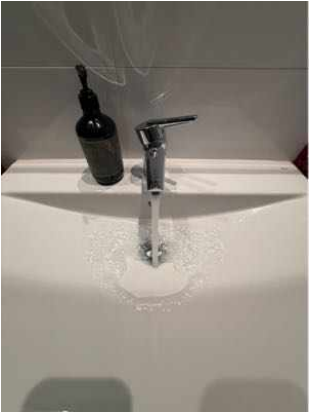
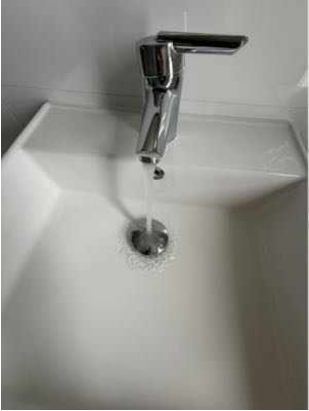
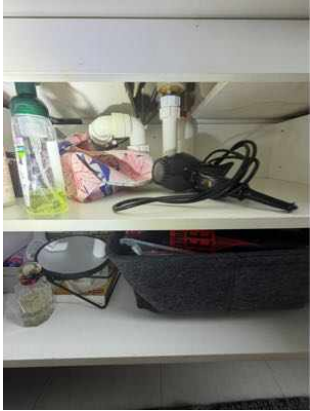
Building: Main Building
 Location: Cabinetry Plumbing
 Finding: FYI-Cabinetry Plumbing
 Information: All cupboards where sinks and basins with drainage plumbing were inspected no evidence of leaks were present at the time of inspection.

For your information only no remedial works are required at the time of inspection.

NOTE: Please be aware that although cupboards have had a thorough inspection, obstructions in cupboards may conceal potential water damage, prevent a full inspection and conditions can change after the initial inspection was carried out, therefore damage may be found after obstructions are removed.

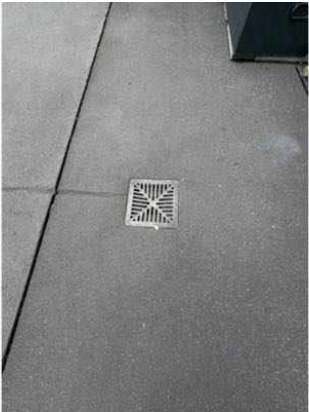
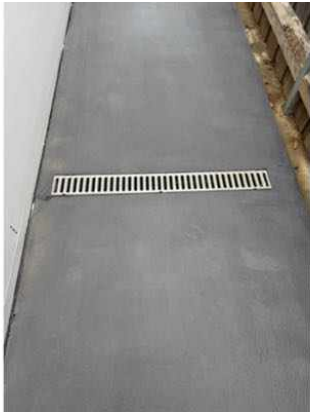
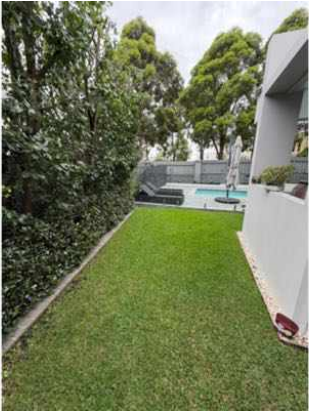
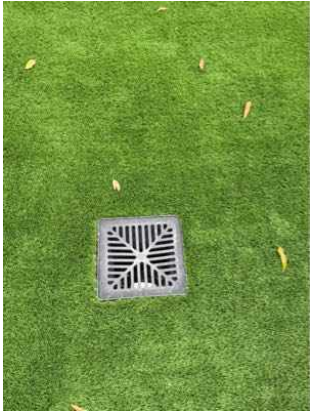
Building: Main Building
Location: Site Drainage
Finding: FYI-Site Drainage
Information: Site drainage appears to be acceptable at the time of inspection, however the site/yard should be monitored during heavy rain to determine whether the existing drains can cope. If it appears that they cannot cope, then additional drains may be required.

Any comments made in this section are relevant only in light of the conditions present at the time of inspection. It is recommended that a smoke test be obtained to determine any illegal connections, blocked or broken drains.

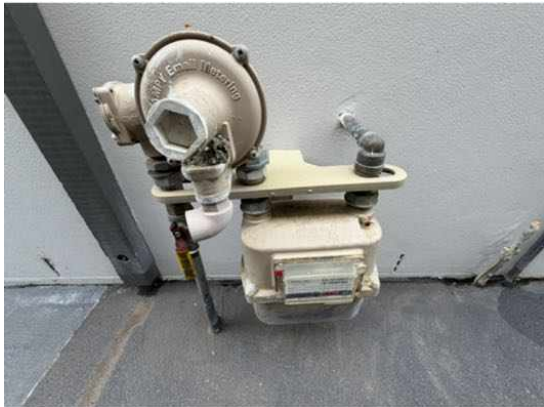
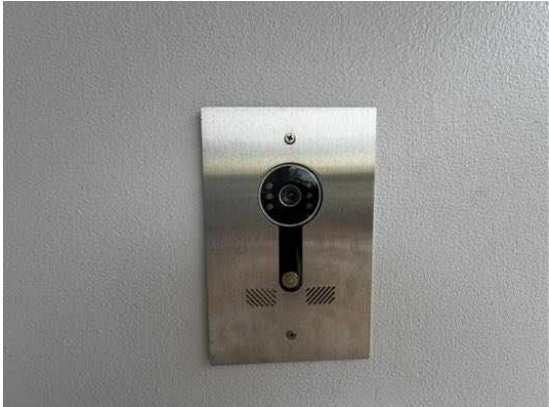
Building: Main Building
 Location: Plumbing/electrical/gas/aircon/pool equipment etc
 Finding: FYI-Plumbing and Electrical
 Information: Plumbing and Electrical inspections are outside the scope of the building inspection and must be conducted by a licensed and registered trades person.

It is highly recommended that the client makes immediate arrangements to have the gas appliances checked by a licensed gas plumber to ensure that the appliances are working safely and efficiently.

We recommend all other installations be checked also.

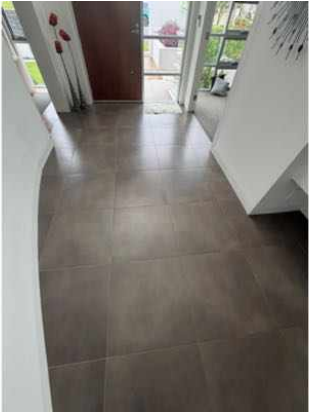
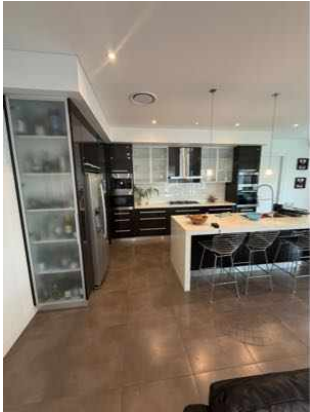
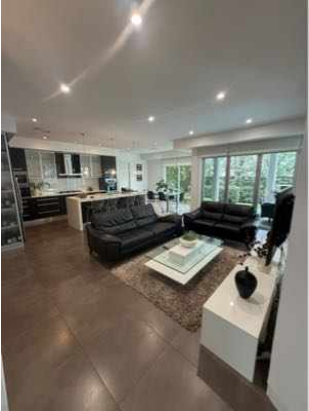
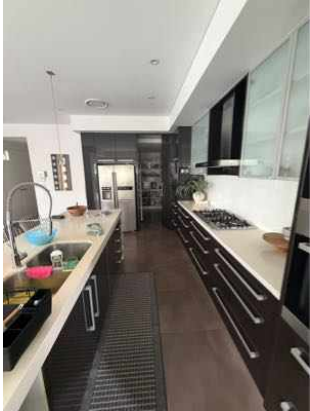
Building: Main Building
 Location: All Internal tiling
 Finding: FYI-Internal Tiling
 Information: All internal floor tiling was in good condition with no obvious cracking or drummy tiling identified.

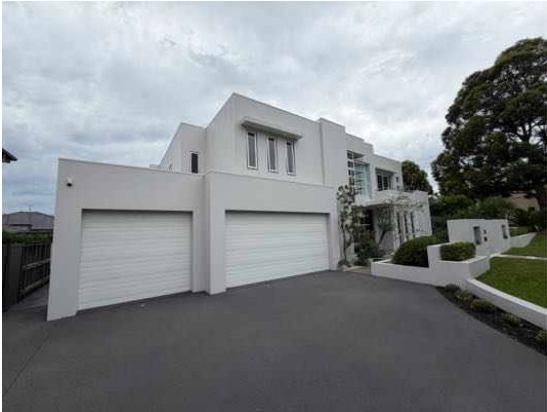
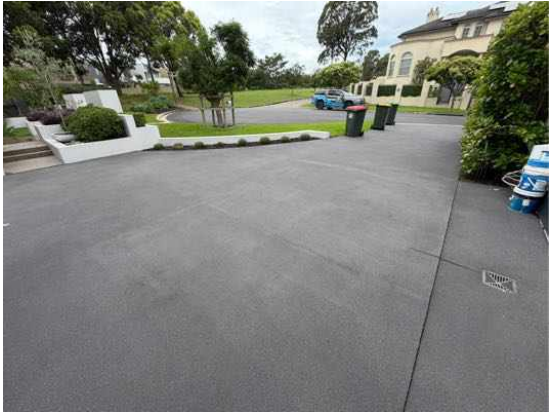
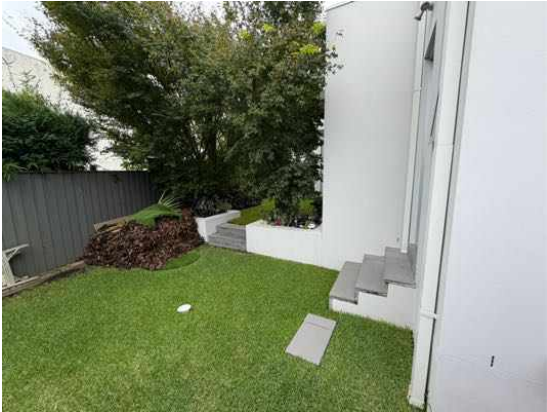
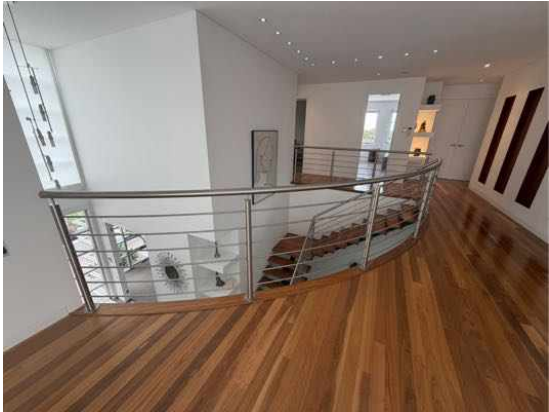
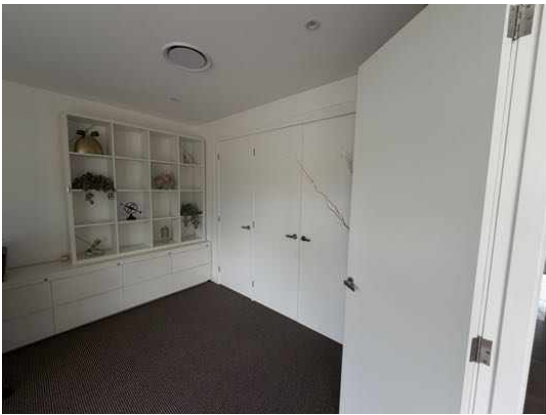
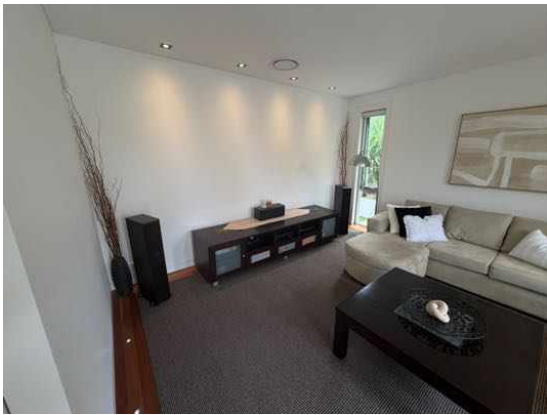
Building: Main Building
Location: All Areas
Finding: FYI-Additional Photos
Information: Additional photos are provided for your general reference and may include obstructions, testing of water and windows, moisture readings or minor maintenance items.
