Building and Timber Pest Inspection Report VR

Inspection Date: Mon, 16 Feb 2026

Property Address: 90/316 Long St E, Graceville QLD 4075, Australia

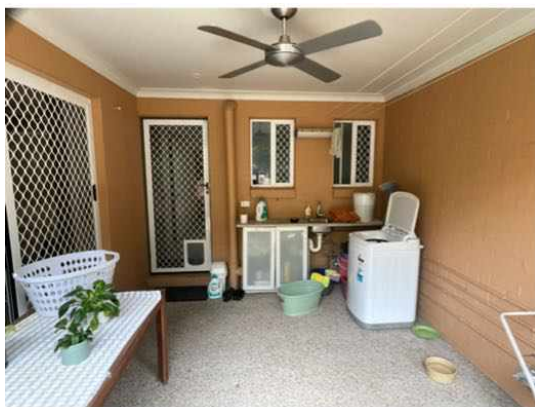
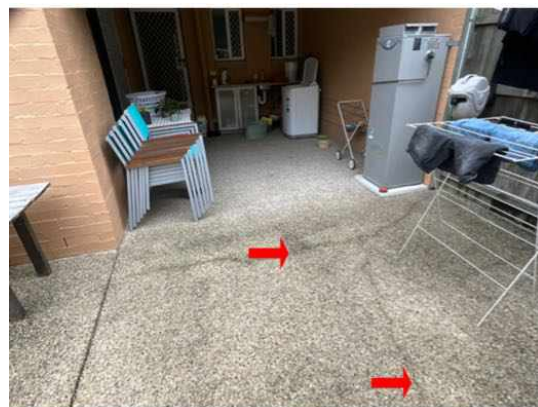
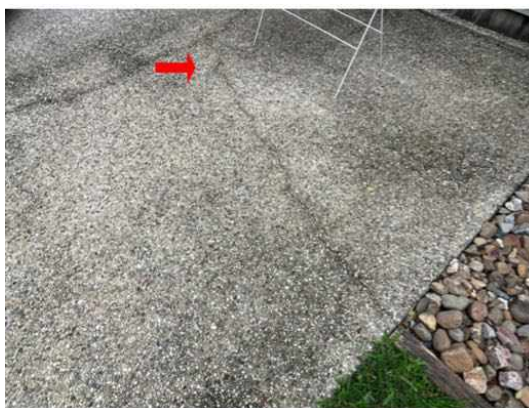
Building: Main Building
Location: Yard - Back
Finding: Crack in concrete slab - Category 1
Information: A crack coded as Category 1 was identified in the slab. A Category 1 crack is described as a fine but noticeable crack, with the slab at an otherwise reasonable level.

To be considered Category 1, the approximate width of the crack is less than 1.0mm, or a less than 10mm change in offset when a 3m straight edge is placed over the defect.

Category 1 cracks should be monitored for a period of 12 months. At the end of the monitoring period, identified cracks that are rated greater than Category 2 are considered defects, and require rectification.

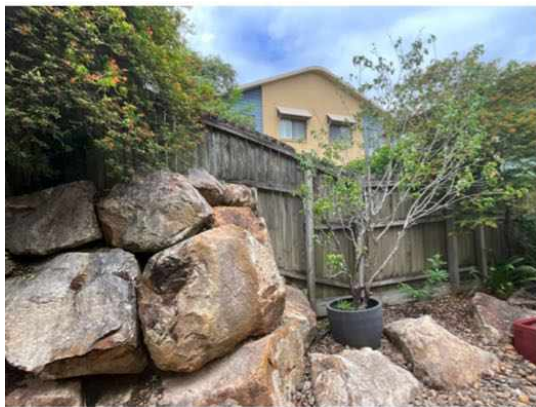
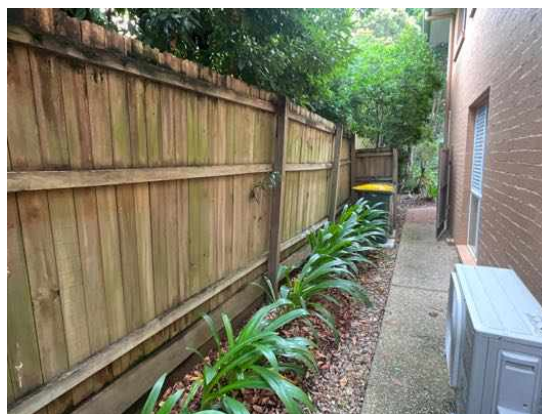
Finding 3.02

Building:	Main Building
Location:	Yard - Back & Side
Finding:	Timber Boundary Fence – General Deterioration and Weathering (Rear and Side Boundaries)
Information:	Timber Boundary Fence – General Deterioration and Weathering (Rear and Side Boundaries)

The timber boundary fence exhibits advanced weathering and deterioration, including aged and discoloured palings, surface decay, biological growth (algae/mould staining), uneven alignment, and localized timber degradation to rails and posts. Several palings appear warped or weakened, and overall structural condition is considered poor to fair. These conditions are consistent with prolonged exposure to moisture and lack of ongoing maintenance.

Continued deterioration may result in loss of structural integrity, reduced privacy and security, and potential fence failure during high winds. Degraded timber also increases

the likelihood of pest activity and further decay if left unaddressed.

Engage a licensed fencing contractor or qualified carpenter to assess the fence integrity. Repairs may include replacement of damaged palings, rails, and posts, or full fence replacement depending on extent of deterioration. Consider pressure cleaning and protective coating only if structural condition allows.

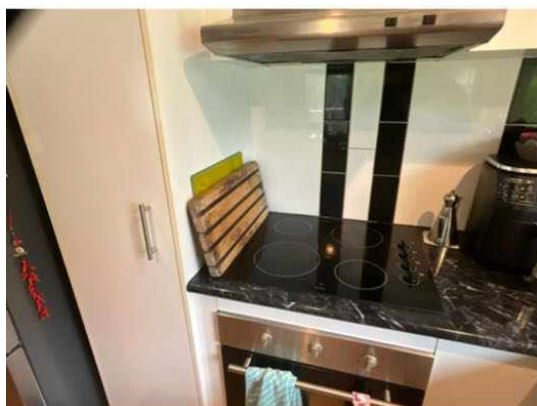
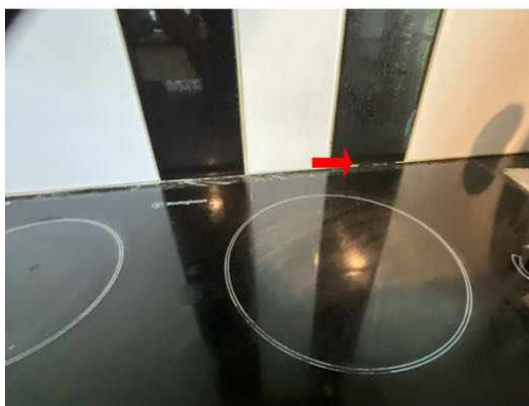
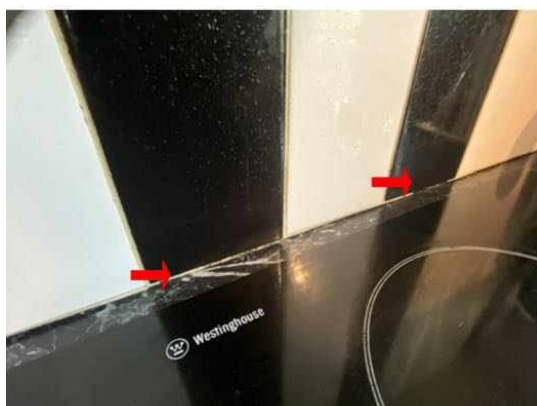
Finding 3.03

Building:	Main Building
Location:	Kitchen
Finding:	Sealant and grouting - Missing or damaged Kitchen bench
Information:	It was noted on inspection that sealant or grout is degraded to the tiled splash back in kitchen area.

Different materials and floor areas move at different rates, generally causing cracking to grout or sealant at this point. A flexible sealant is required to allow for expected expansion and contraction, while keeping the joint water tight and protective of all associated building materials.

Flexible and mould resistant materials should be applied to affected areas to prevent any subsequent water damage that is likely to occur. Regular maintenance and replacement of damage or missing or damaged sealant and grout is highly recommended to the wet areas, as this is a regular wear and tear defect.

Sealant and grouting in areas that come into regular contact with water should be maintained for the long term care of your property.

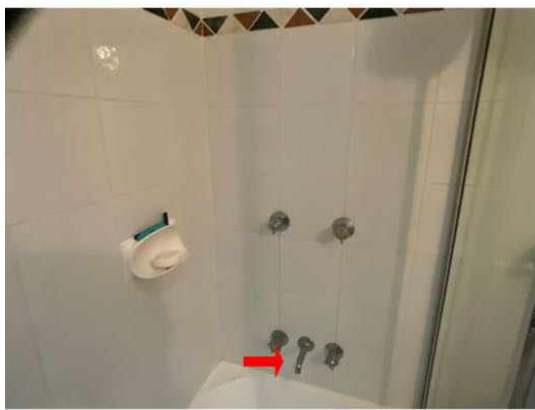
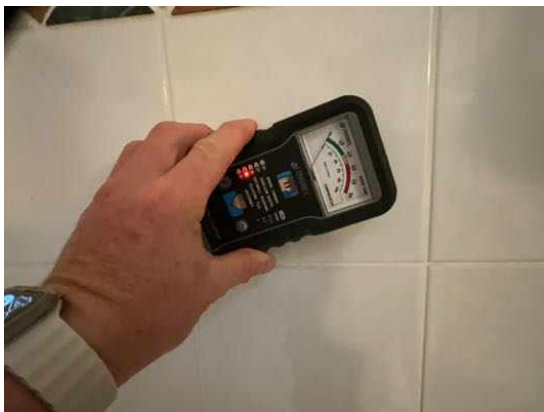
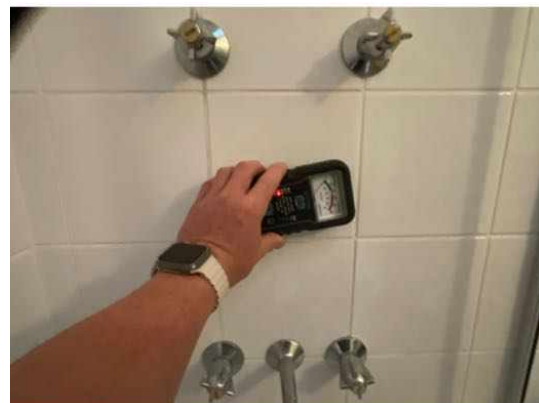
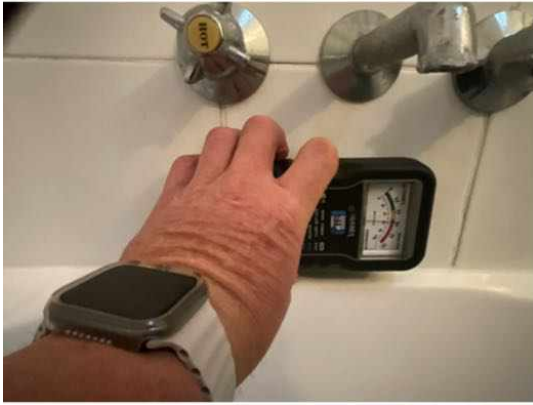
Finding 3.04

Building:	Main Building
Location:	Bathroom
Finding:	Shower damp - Monitor - high moisture readings
Information:	Damp is evident to the lower 400mm of wall to the shower alcove. There is high reading around the taps, but not high readings transferring to the other side of the wall.

This defect is quite common, and is suspected to have been caused by moisture permeating or leaching through the grouting and perhaps gaps in the sealant prior to repair.

Unmanaged damp in the shower recess is likely to facilitate the formation and development of mould and fungi growth, decaying associated building materials and compromising their structural integrity. It is important to address damp conditions, as the World Health Organisation notes that excess moisture leads - on almost all indoor materials - to growth of microbes such as moulds, fungi and bacteria, which subsequently emit spores and other matter into the indoor air. Exposure to these

Highly recommend a leak detection test is done on shower to determine if there is a tap or shower head leaking.

Monitoring the area is advised and if any visual signs of excessive moisture appear (peeling paint, mould) then consultation with a qualified plumber or bathroom specialist would be advised to identify the cause of damp and to perform remedial works as required.

Always ensure that sealant and grout is in good condition to prevent any moisture issues occurring in the future.

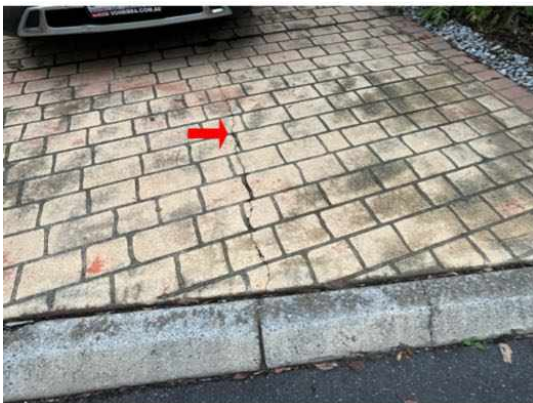
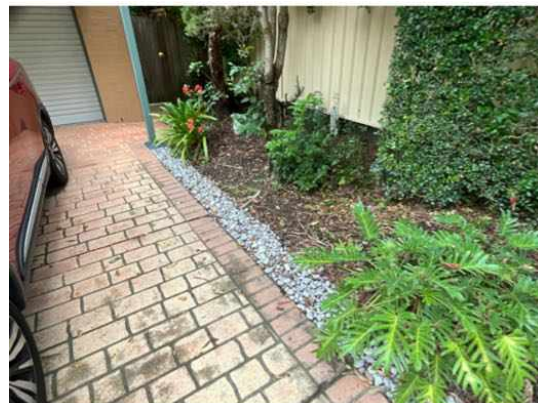
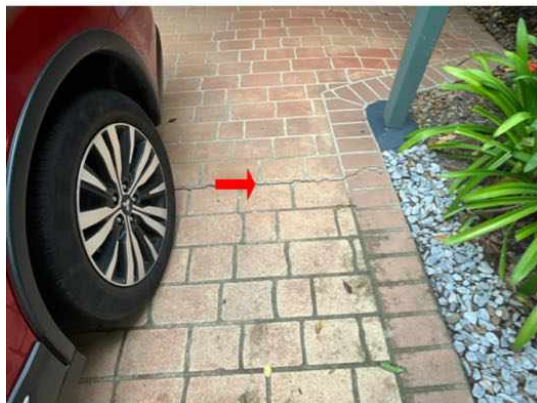
Finding 3.05

Building: Main Building
 Location: Driveway
 Finding: Crack in concrete slab - Category 1
 Information: A crack coded as Category 1 was identified in the slab. A Category 1 crack is described as a fine but noticeable crack, with the slab at an otherwise reasonable level.

To be considered Category 1, the approximate width of the crack is less than 1.0mm, or a less than 10mm change in offset when a 3m straight edge is placed over the defect.

Category 1 cracks should be monitored for a period of 12 months. At the end of the monitoring period, identified cracks that are rated greater than Category 2 are considered defects, and require rectification.

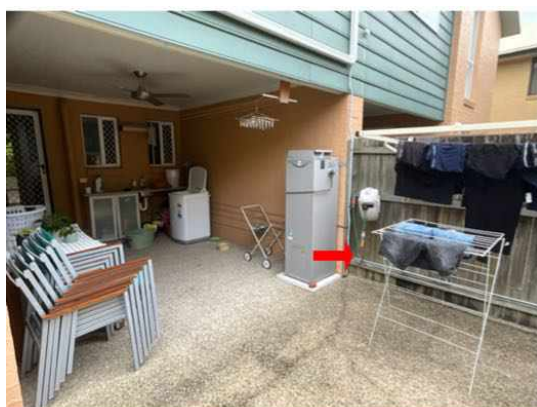
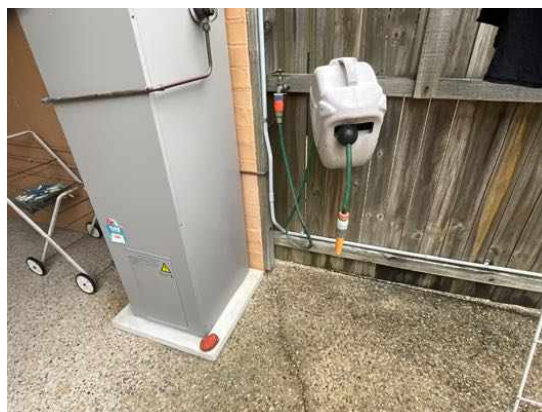
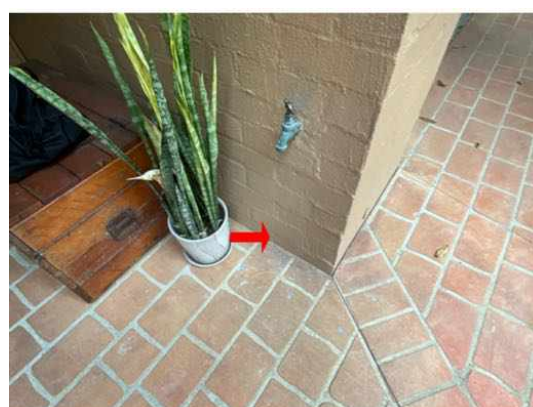
Building:	Main Building
Location:	All Areas
Finding:	No Drain under tap.
Information:	There is no drain installed under the tap, leading to water accumulation and creating conducive conditions for timber pests.

This defect needs immediate attention to prevent potential damage and pest infestation.

1. Water Accumulation: Without proper drainage, water can accumulate around the base of the tap, leading to persistent dampness in the surrounding area.
2. Timber Pest Infestation: The damp environment created by standing water is highly conducive to timber pests, such as termites and wood borers, which thrive in moist conditions and can cause significant damage to wooden structures.
3. Structural Damage: Prolonged exposure to moisture can lead to wood rot and deterioration of structural timber, compromising the integrity of the building.
4. Health Hazards: Persistent dampness can also promote mold and mildew growth,

5. Aesthetic Damage: Water stains and damage to finishes and materials around the tap area can detract from the appearance of the building and lead to costly repairs.

A licensed plumber or a qualified building contractor can address this defect by:

1. Assessment: Evaluating the area to determine the best approach for installing a proper drainage system under the tap.
2. Installation: Installing a drain that effectively channels water away from the base of the tap, preventing water accumulation and dampness.
3. Repair and Prevention: Inspecting and repairing any existing water damage and implementing measures to prevent future water accumulation and pest infestations.

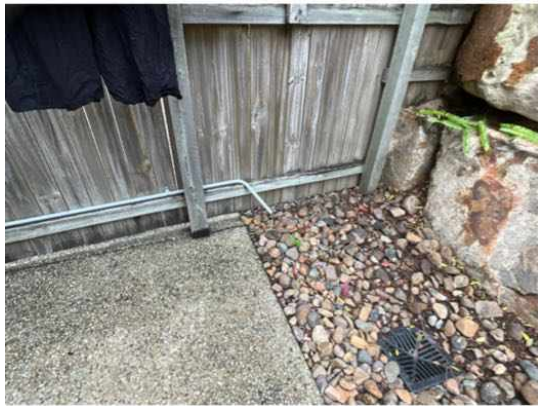
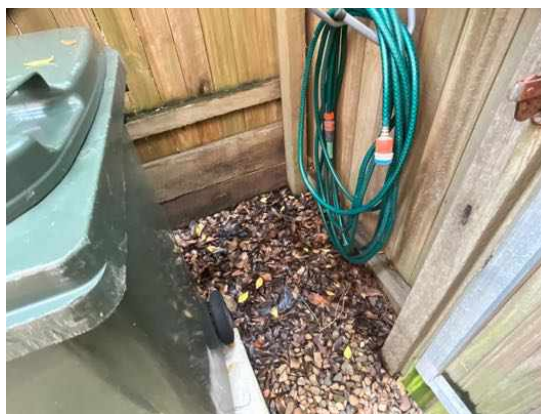
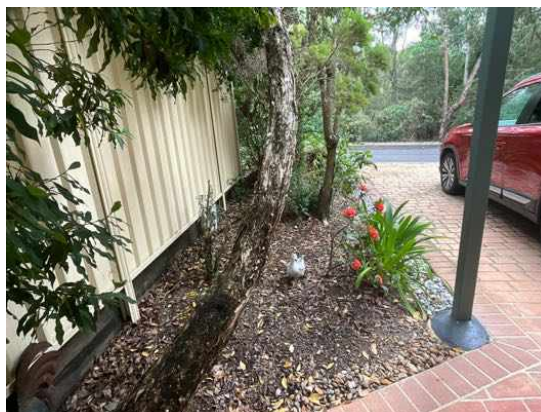
Finding 6.03

Building: Main Building
Location: All Areas
Finding: Timber on ground / conducive conditions to termite damage.
Information: Timber on the ground is indeed conducive to termite damage.

Termites are known to thrive in moist environments, and wood in contact with soil or moisture is more susceptible to infestation.

To prevent this, it's important to keep timber elevated and away from direct ground contact.

Regular inspections and proper termite control measures are also essential to protect your wooden structures from termite damage.

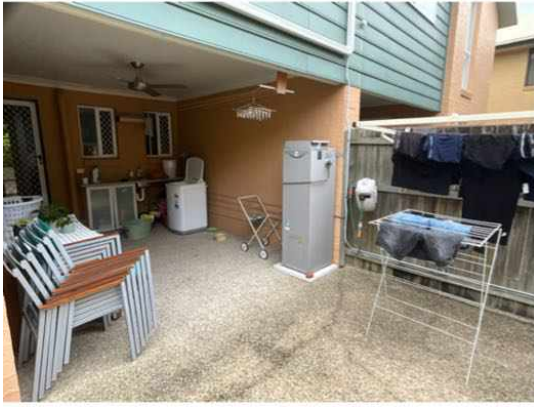
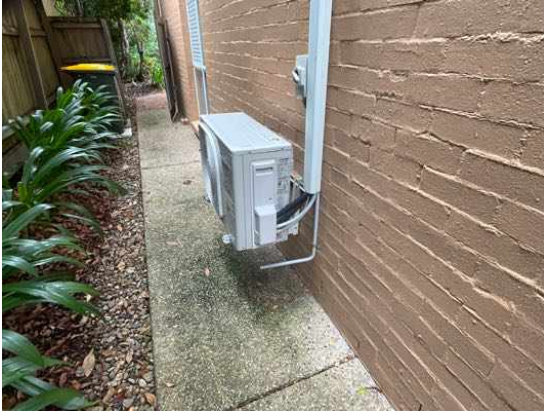
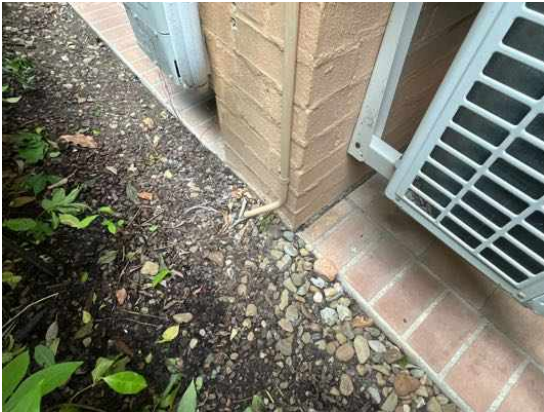
Finding 6.04

Building:	Main Building
Location:	All Areas
Finding:	Air conditioner - Disconnected overflow
Information:	The Air Conditioner (A/C) overflow was found to be disconnected from storm water drainage and is creating excessive moisture in the surrounding area.

Such leaking creates an environment which is conducive to an array of defects, including water damage to associated building elements and the attraction of termite or timber pest infestation.

It is highly recommended that a licensed plumber be appointed to connect the A/C overflow in order to prevent such an environment from being created. These minor works should be carried out as soon as possible.

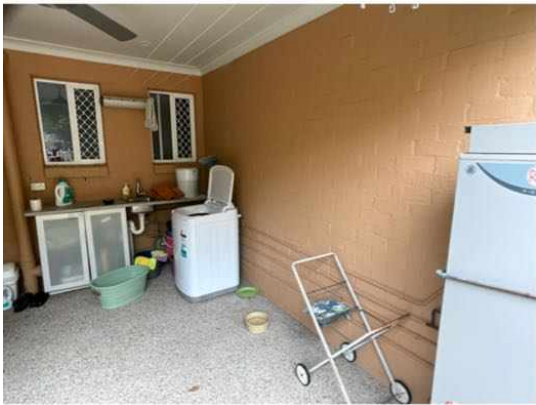
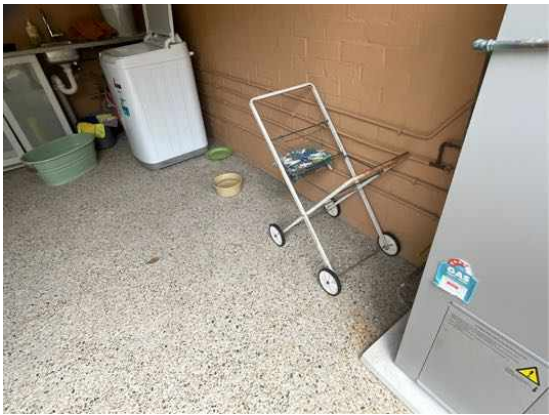
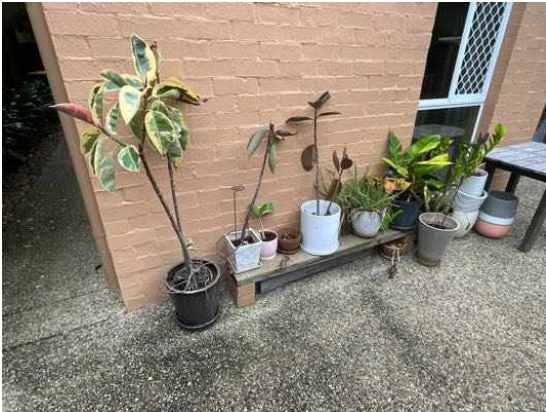
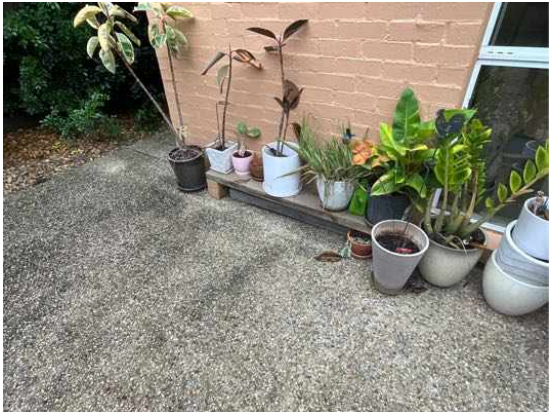
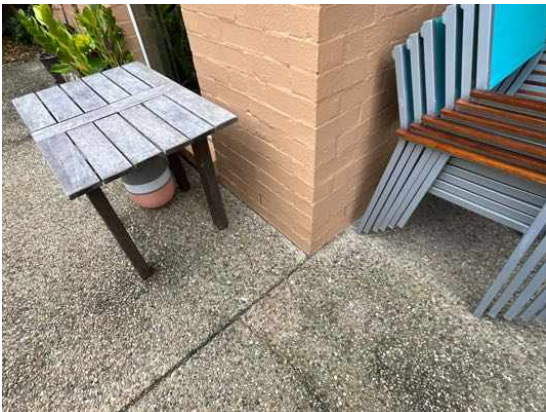
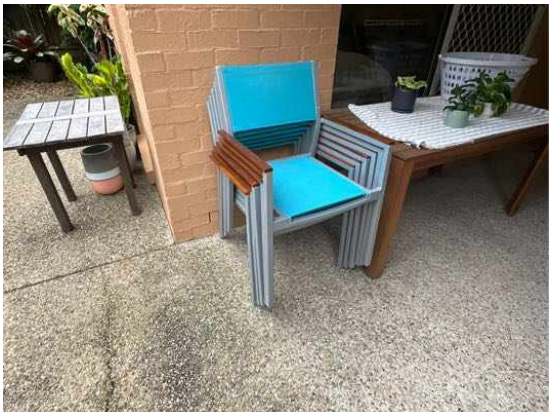
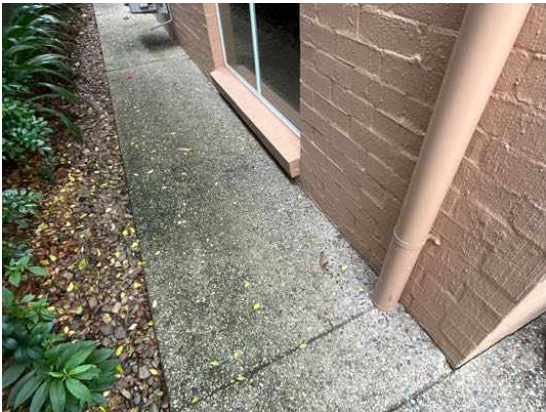
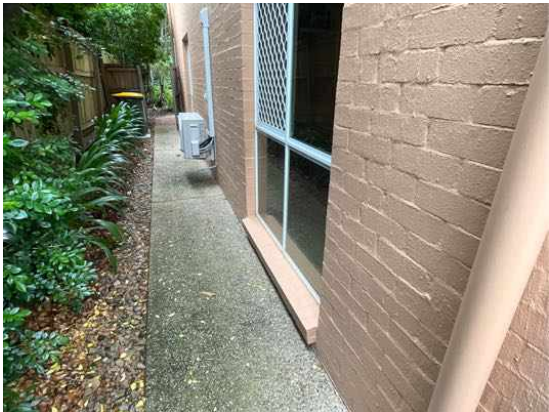
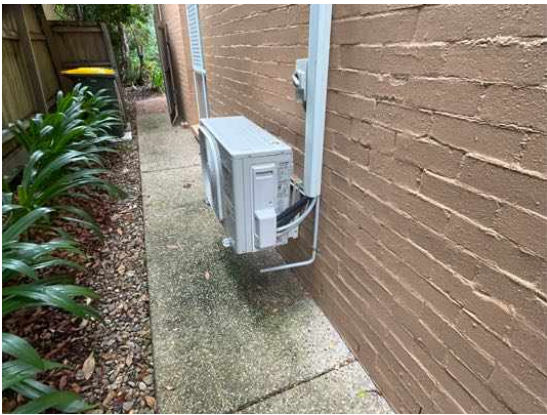
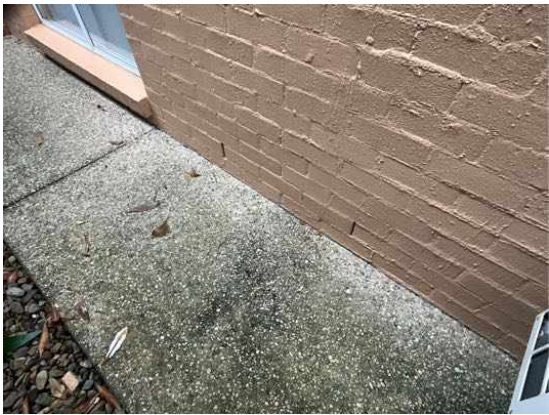
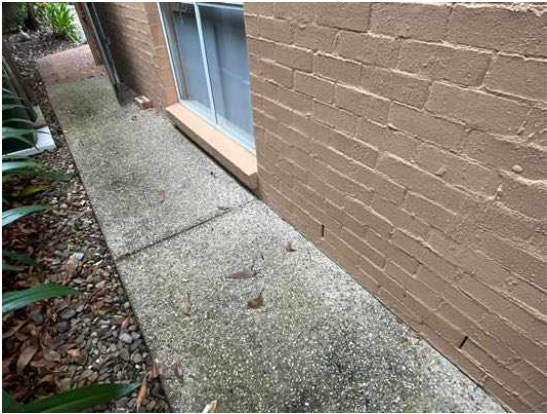
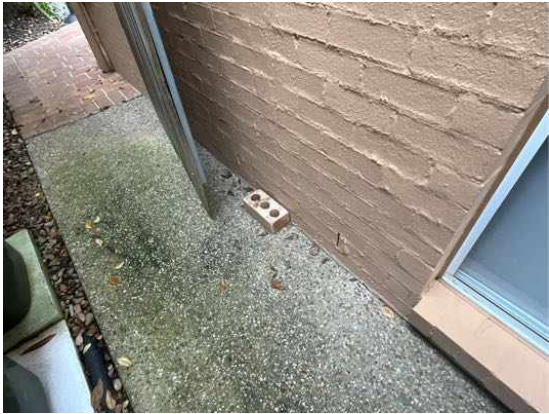
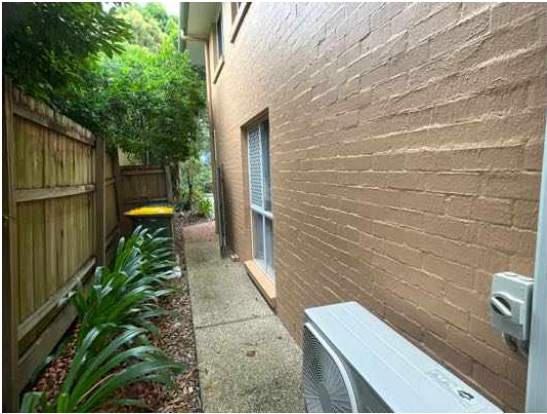
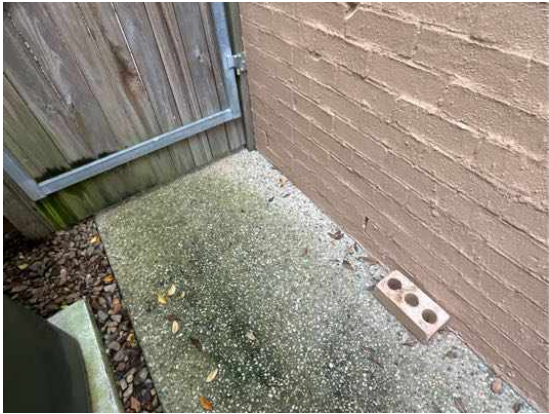
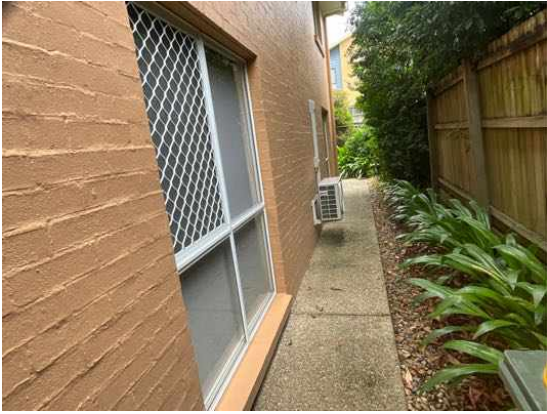
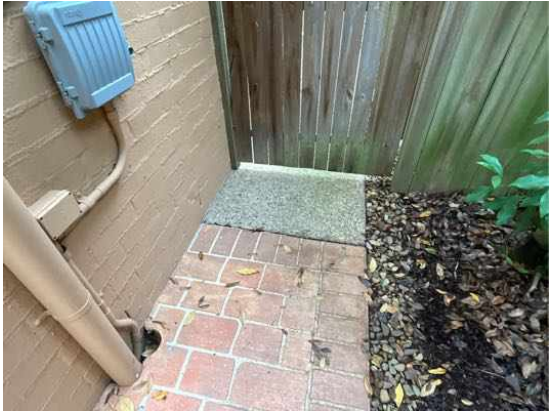
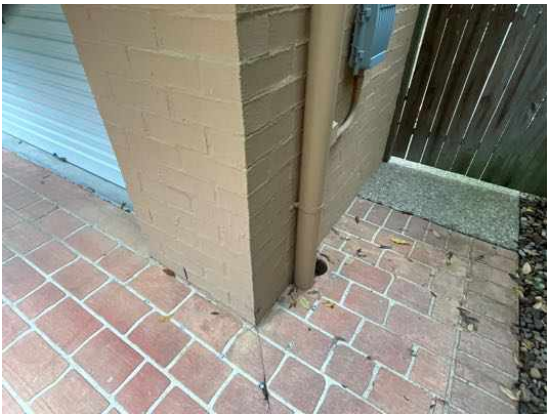
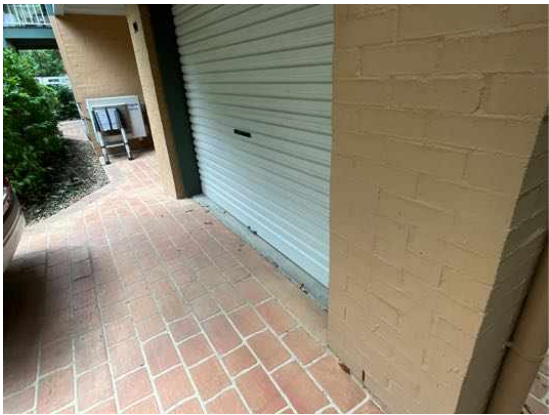
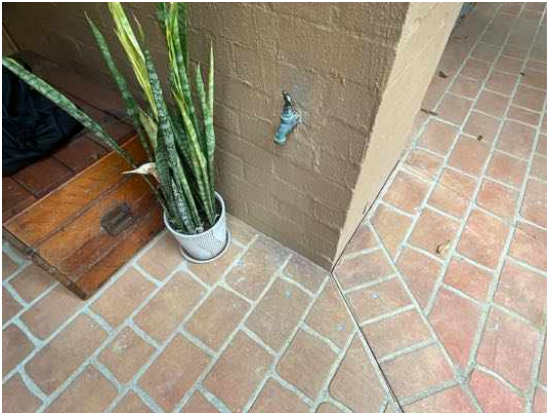
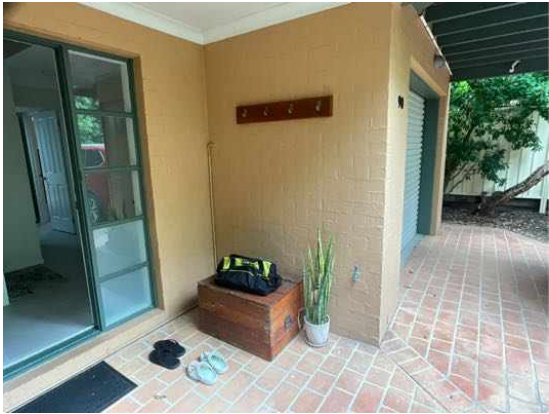
If the slab edge is not properly exposed there is a high risk of termite attack. Sometimes, in order to determine the type of slab, a suitably qualified person such as an architect or builder may be required to consult the construction plans.

Where the slab edge cannot be properly inspected, it is highly recommended that termite or timber pest inspections be carried out every 6-12 months to aid protection of the property against infestation.

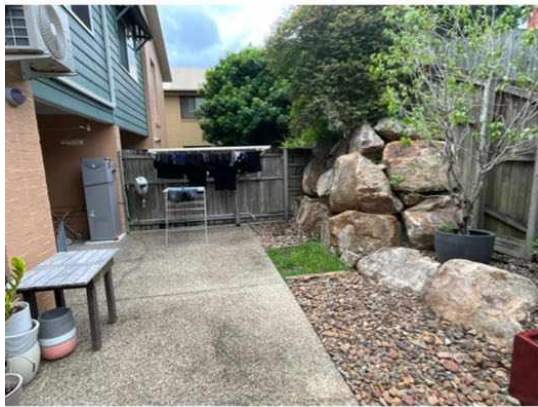
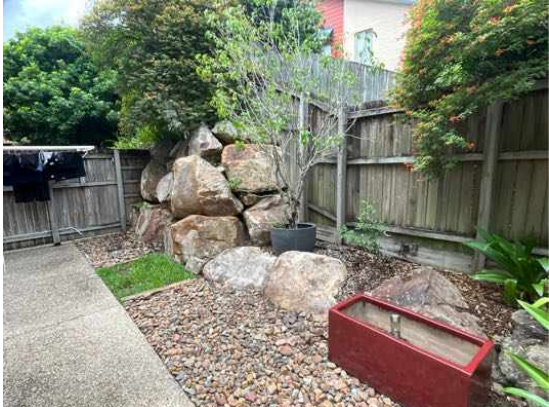
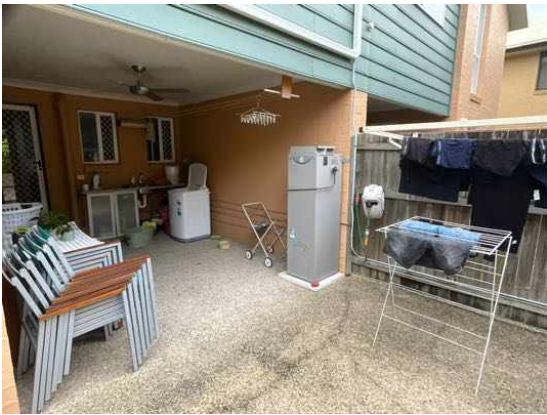
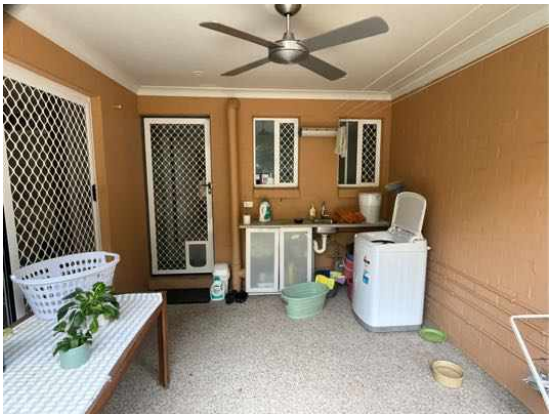
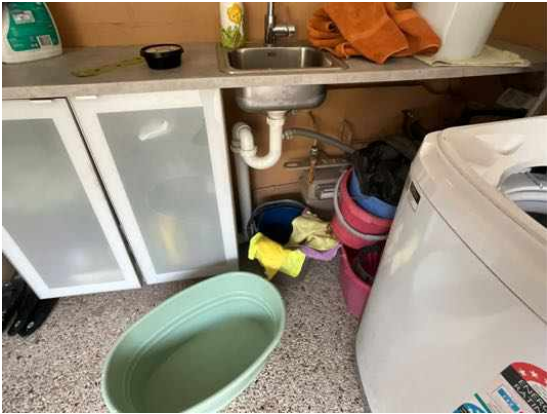
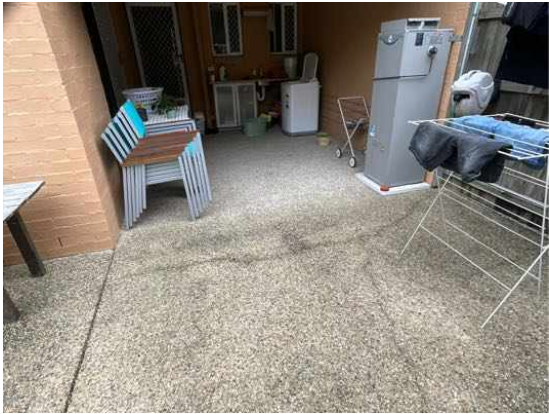
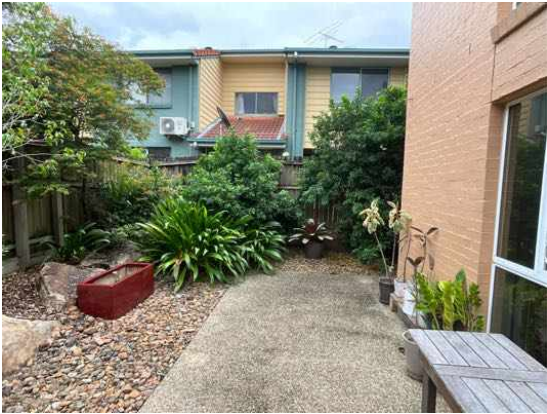
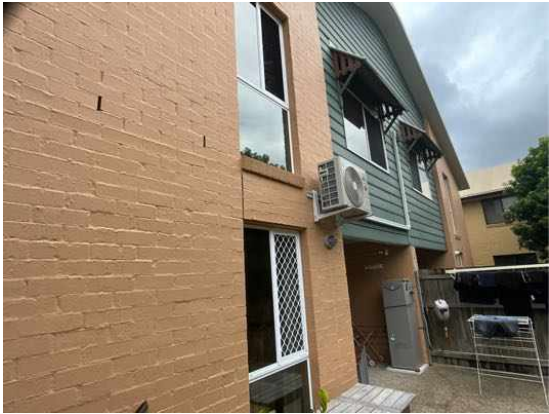
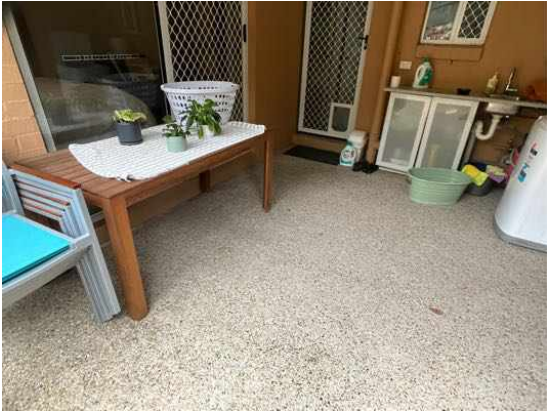
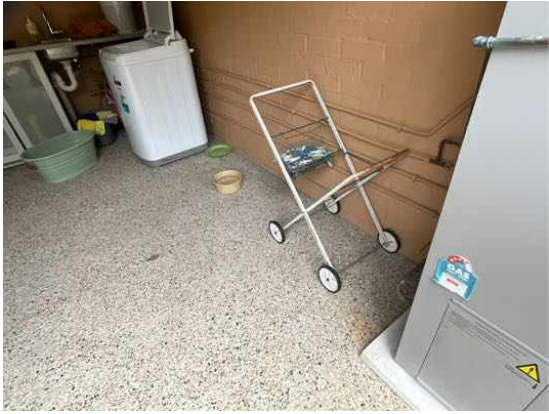
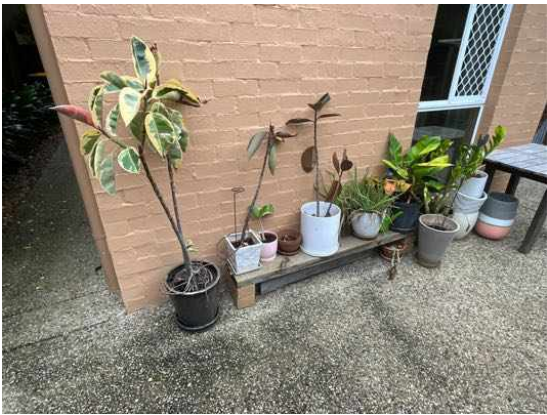
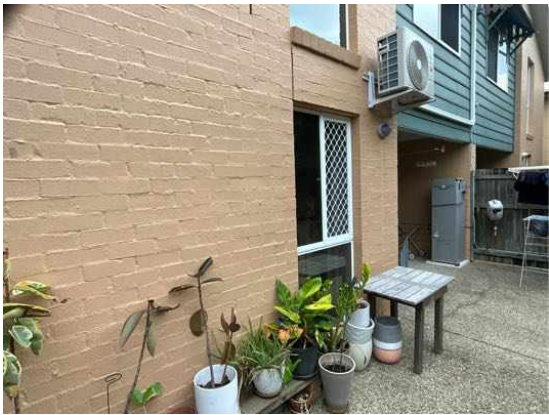
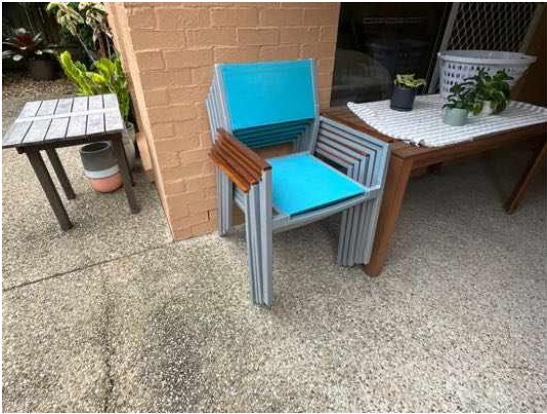
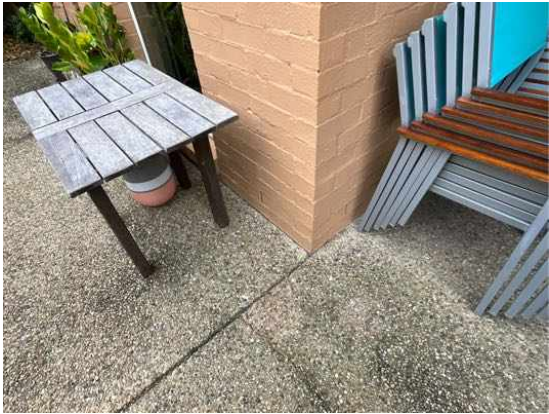
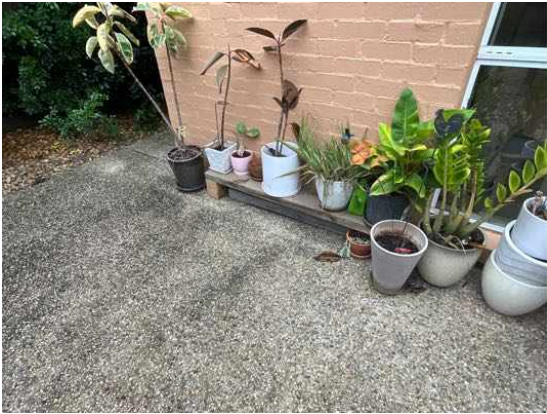
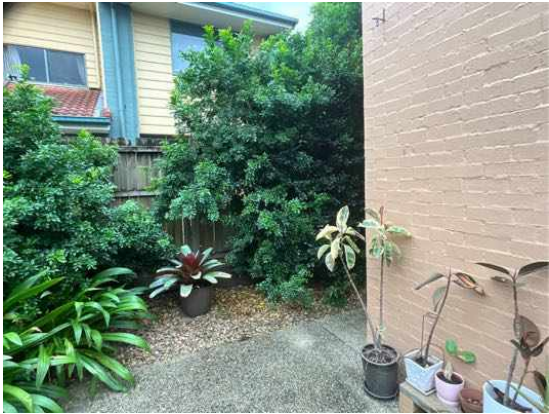
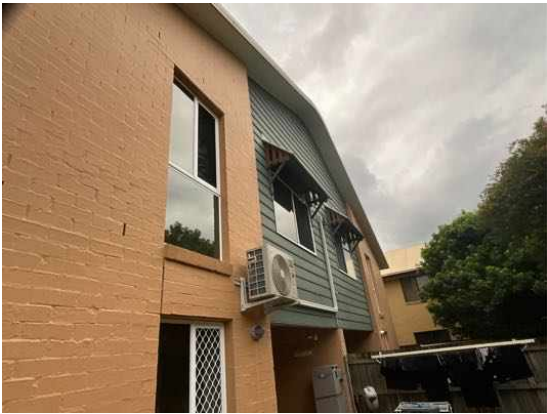
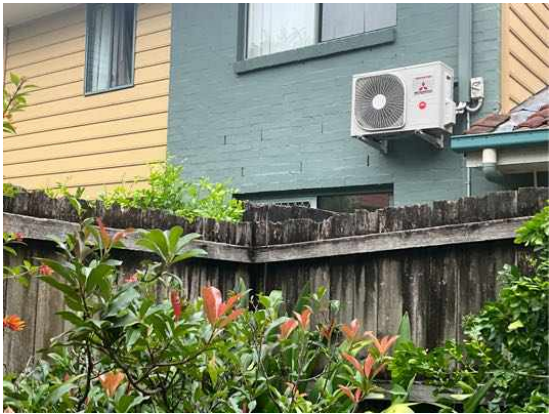
Building: Main Building
 Location: All Areas
 Finding: Additional Photos - Obstructions and Limitations
 Information: These photographs are an indication of the obstructions and limitations which impeded full inspection of the property at the time of inspection. These obstructions can hide an array of defects and should be removed to allow full inspection to be carried out. A re-inspection is recommended once the areas are made accessible.
