Building and Timber Pest Inspection Report VR

Inspection Date: Mon, 16 Feb 2026

Property Address: 90/316 Long St E, Graceville QLD 4075, Australia

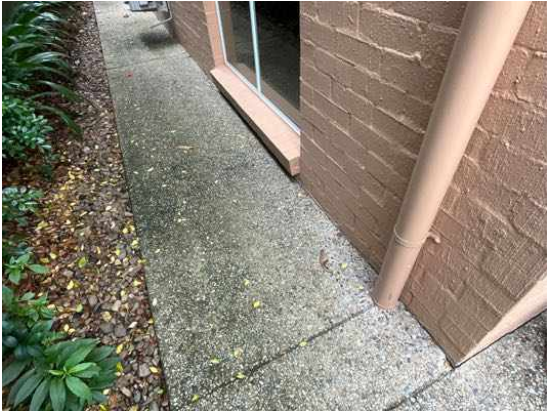
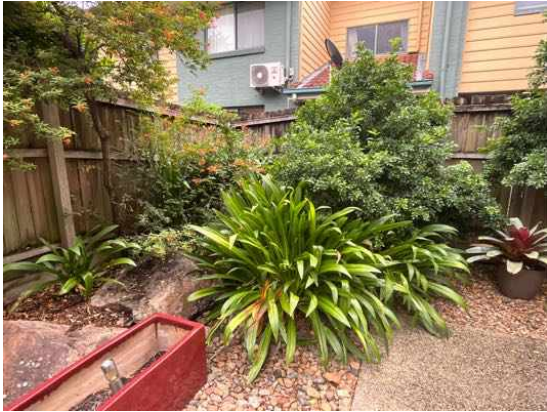
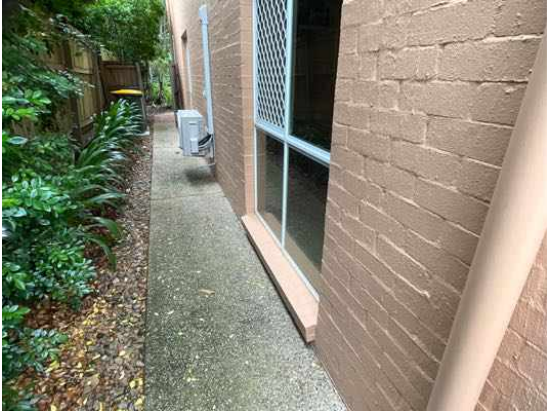
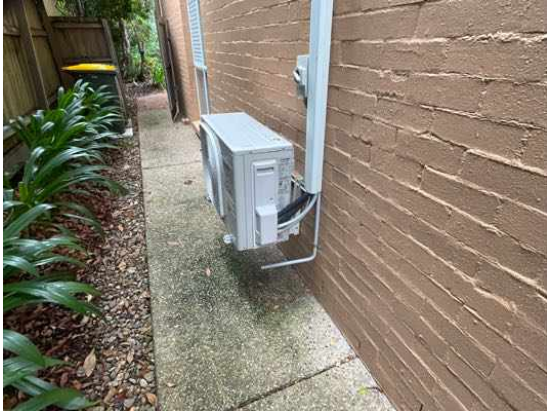
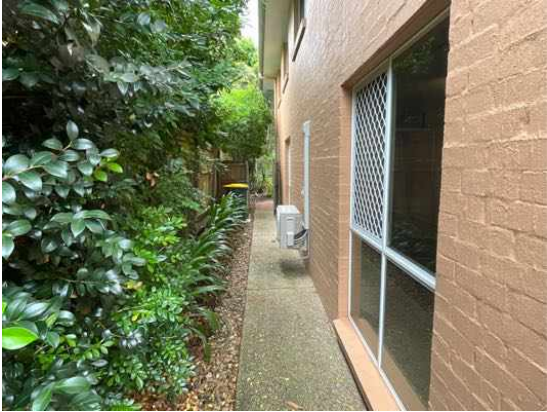
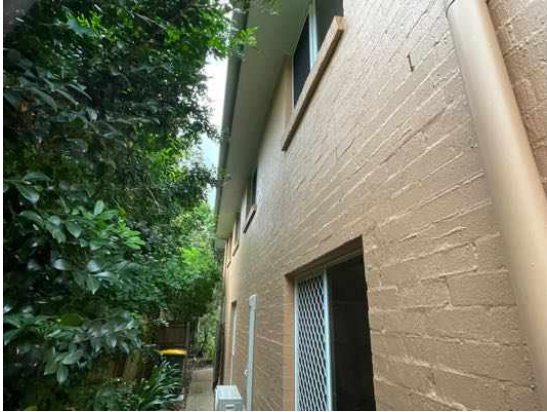
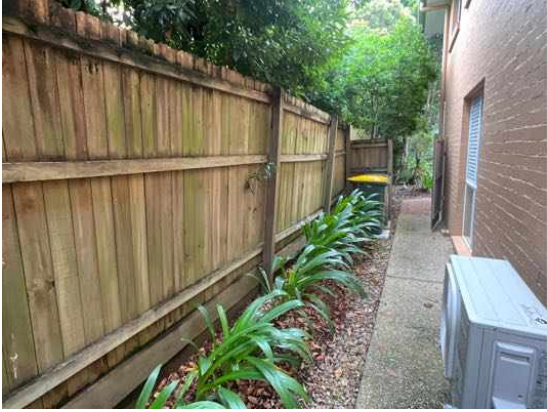
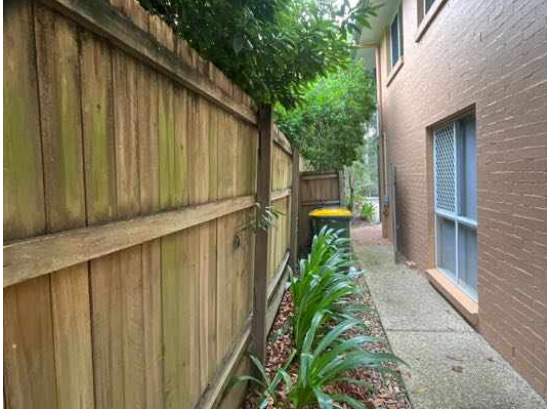
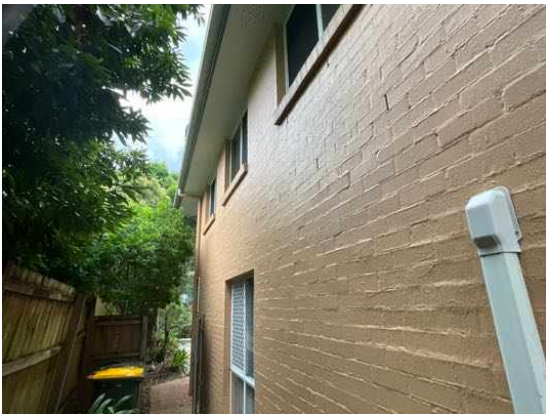
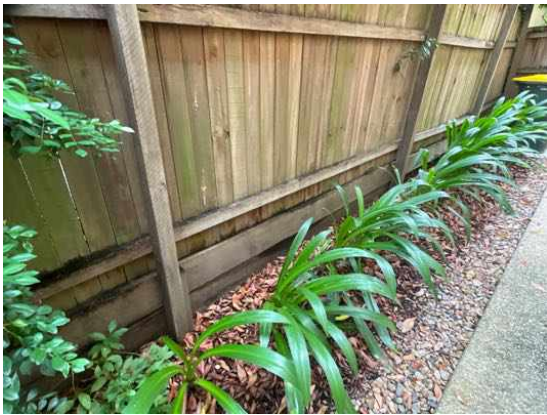
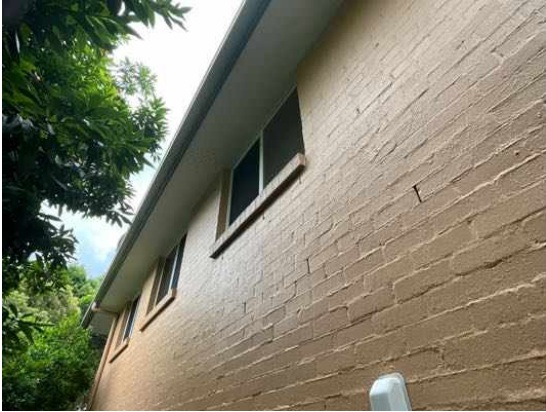
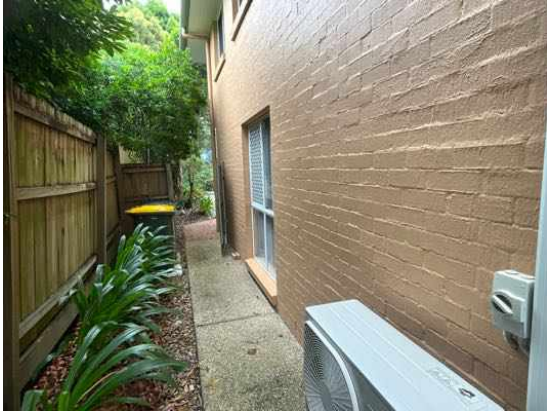
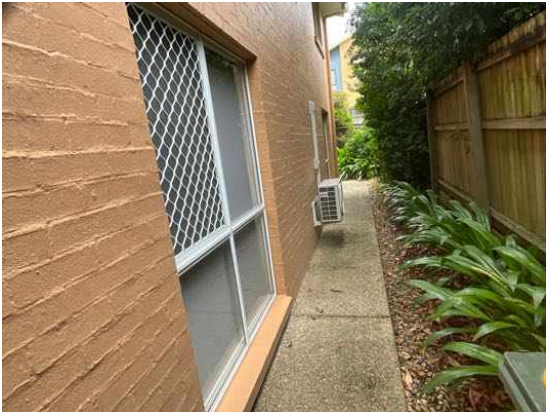
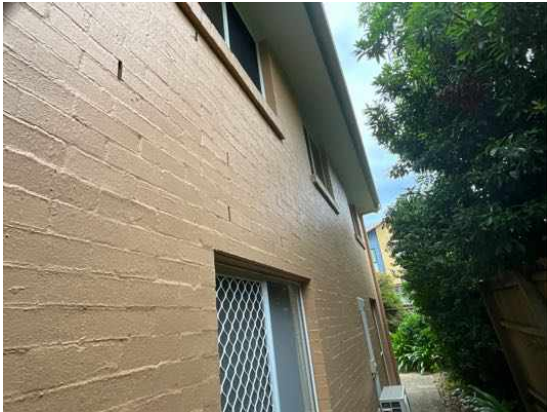
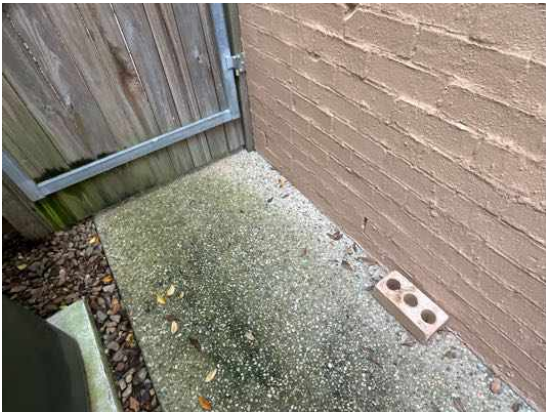
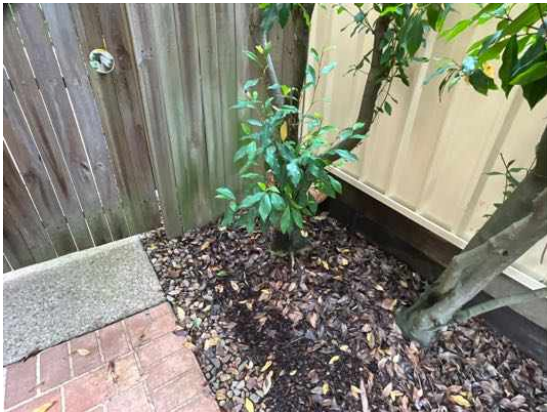
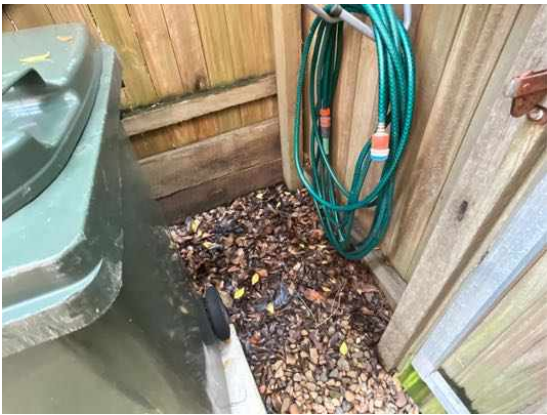
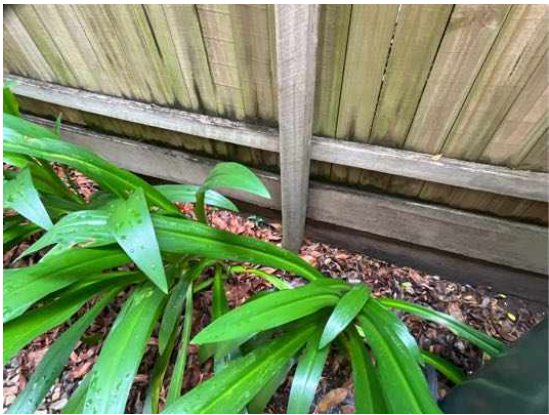
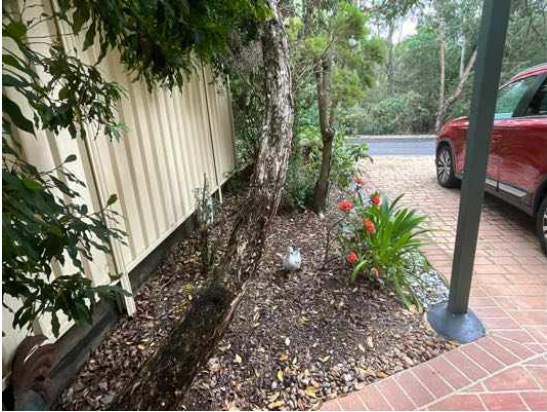
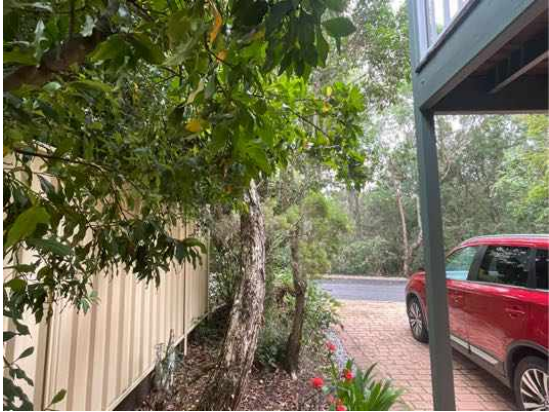
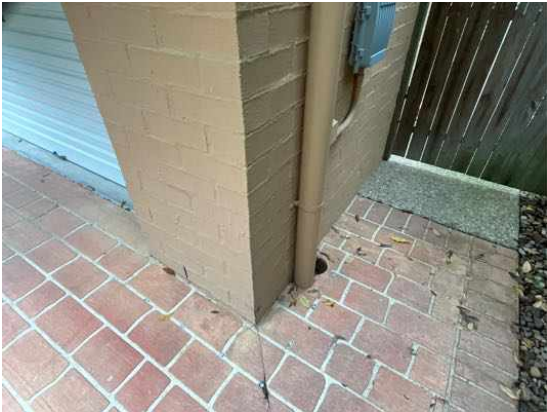
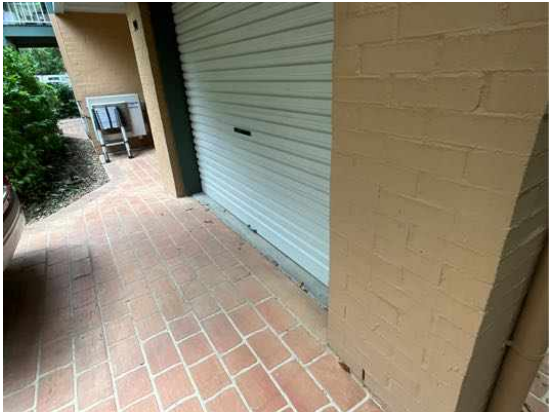
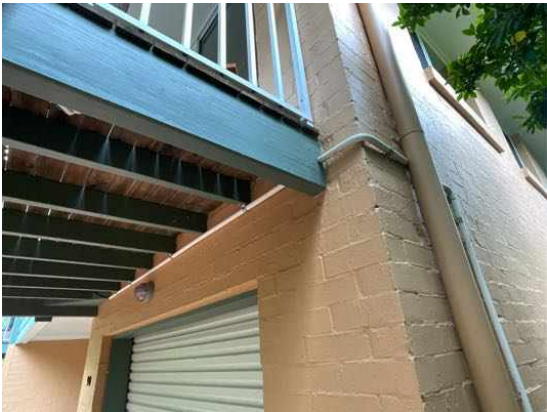
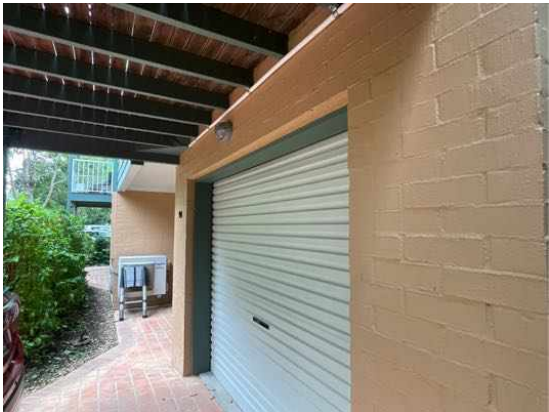
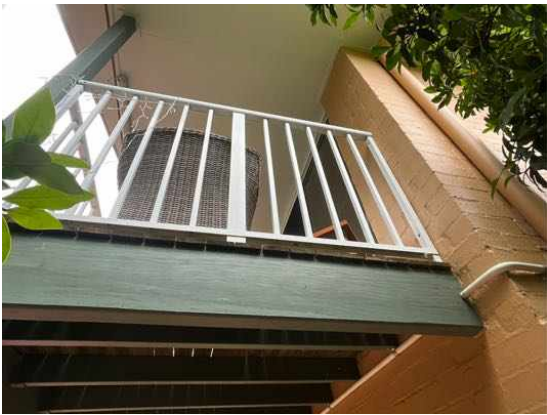
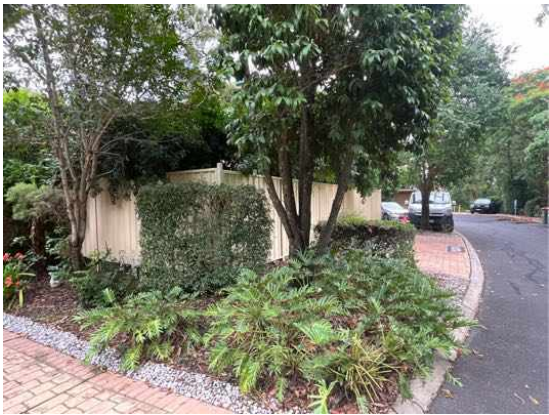
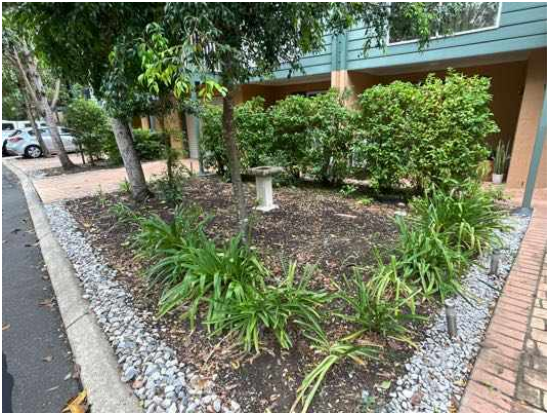
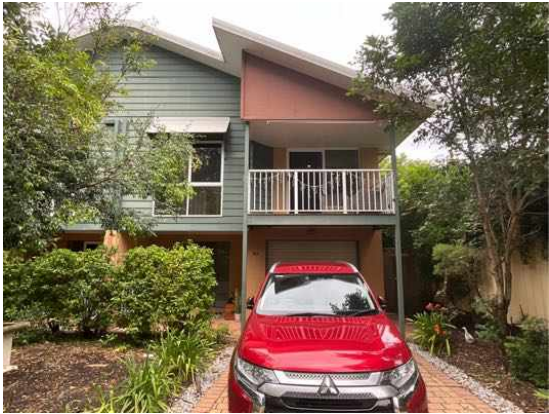
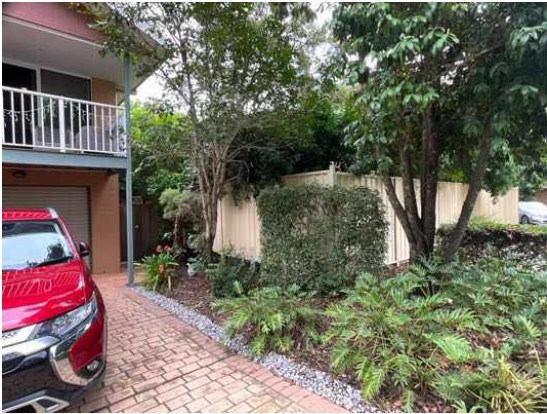
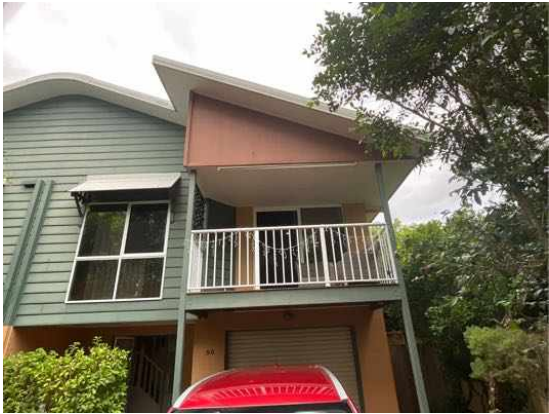
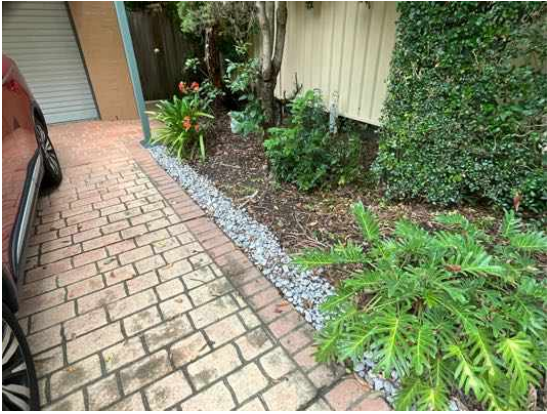
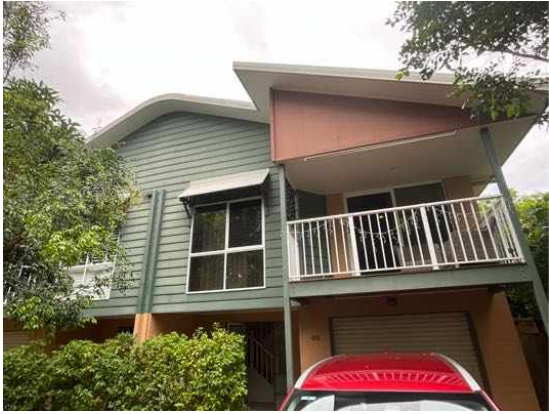
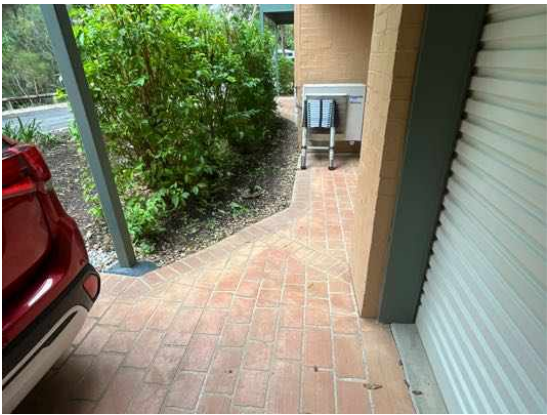
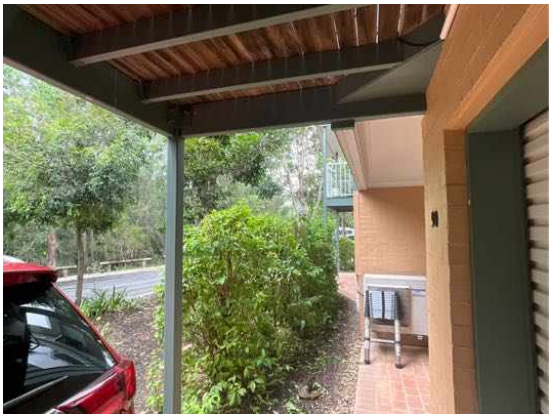
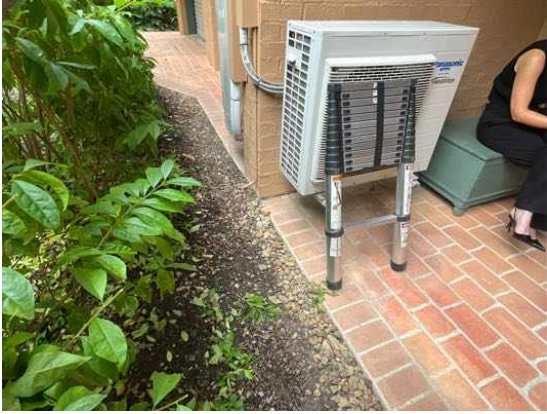
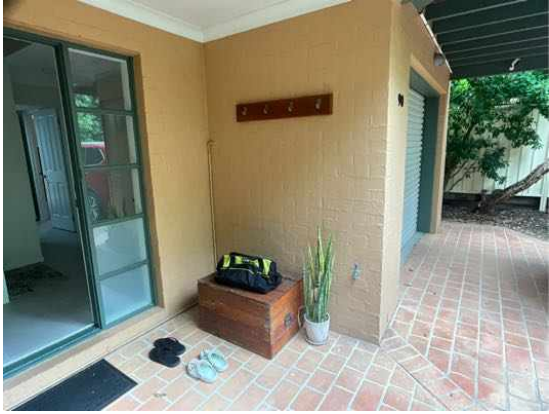
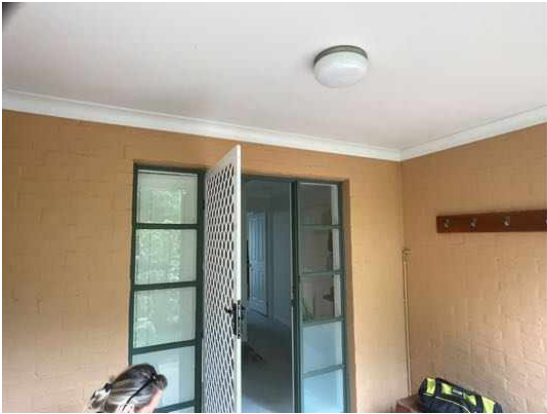
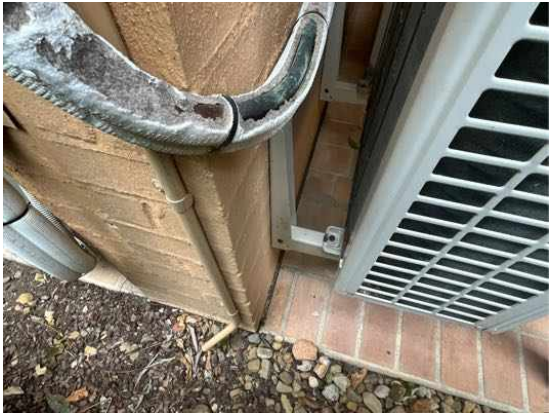
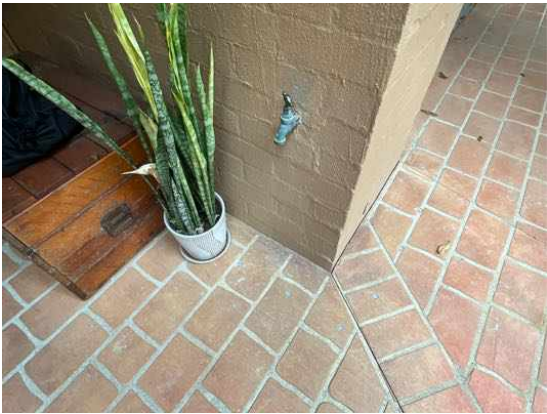
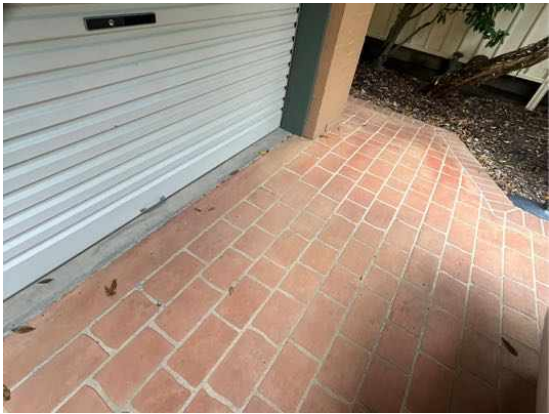
Building: Main Building
 Location: All Areas
 Finding: Additional Photos - Obstructions and Limitations
 Information: These photographs are an indication of the obstructions and limitations which impeded full inspection of the property at the time of inspection. These obstructions can hide an array of defects and should be removed to allow full inspection to be carried out. A re-inspection is recommended once the areas are made accessible.

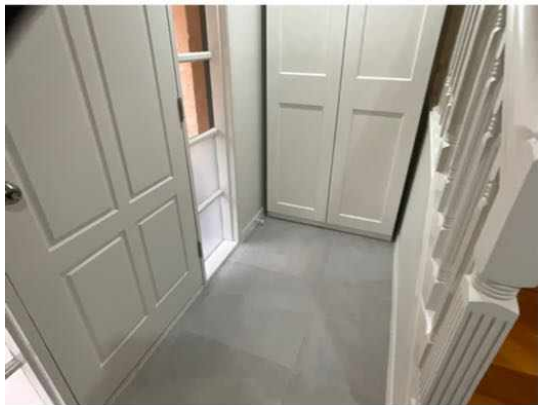
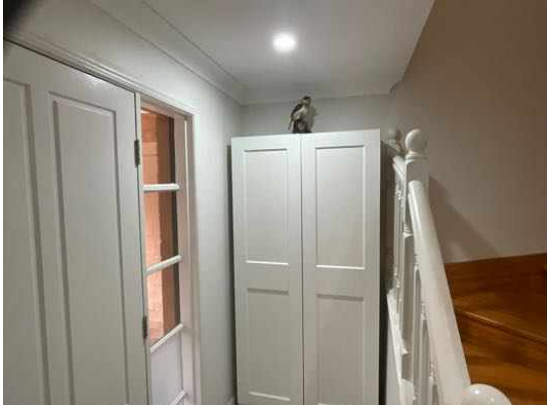
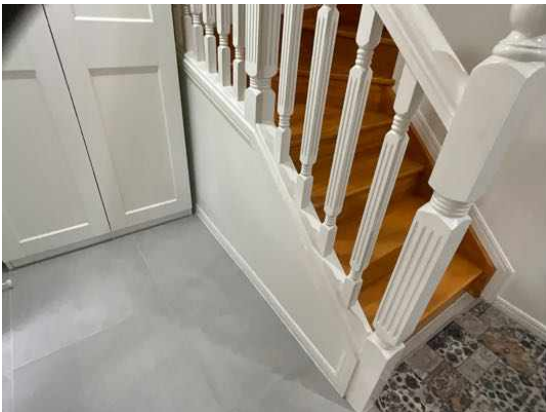
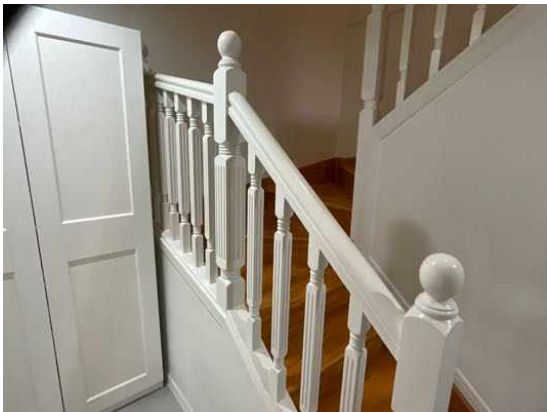
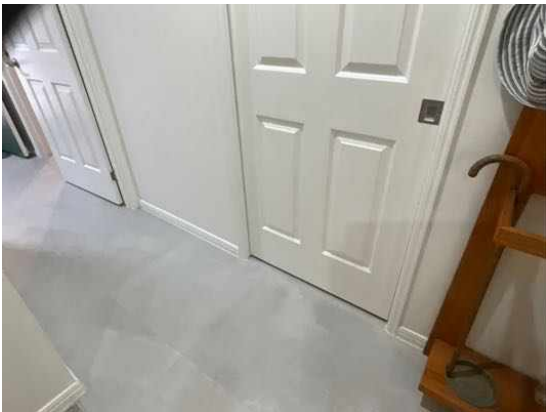
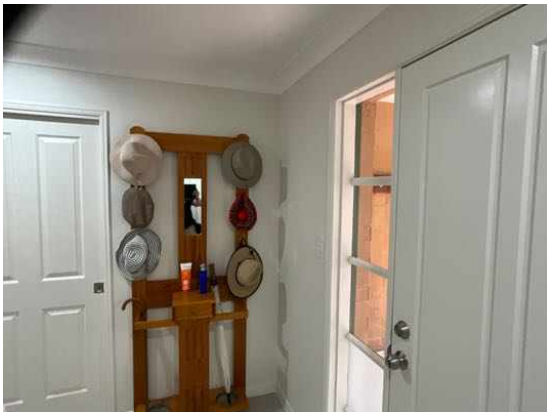
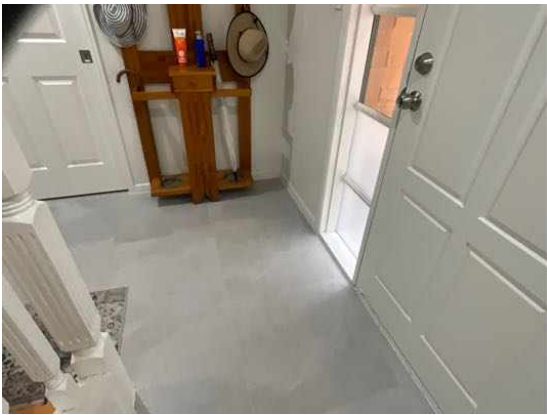
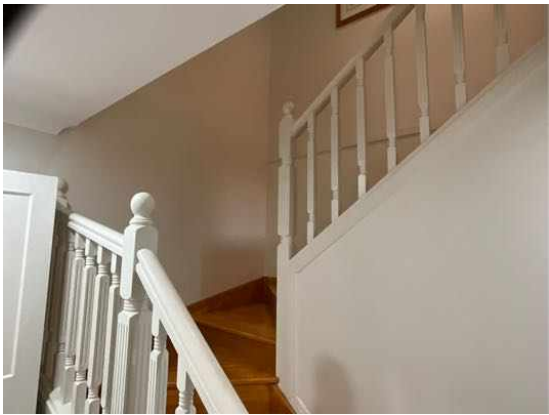
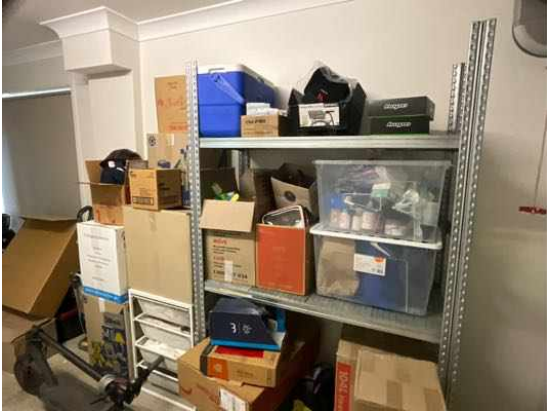
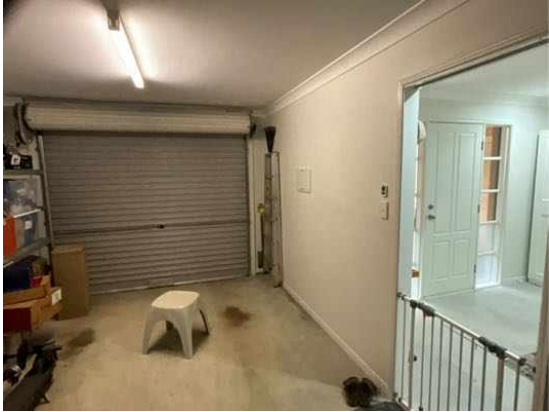
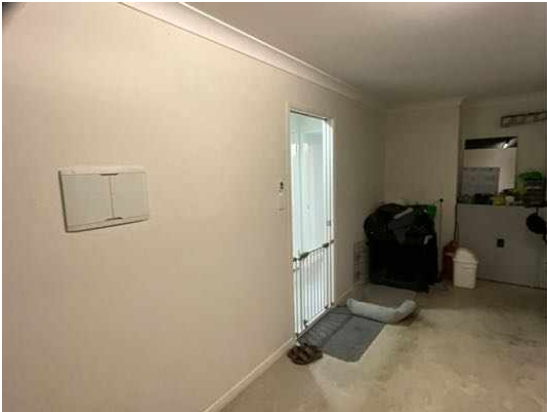
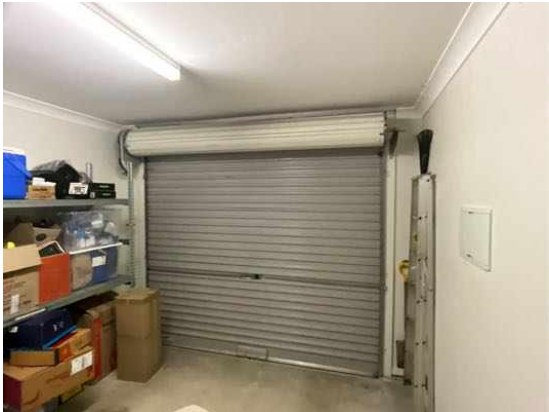
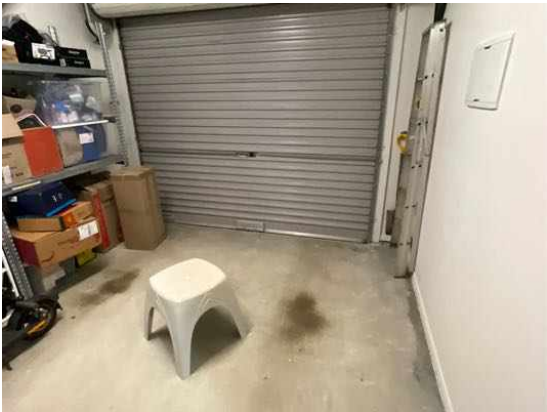
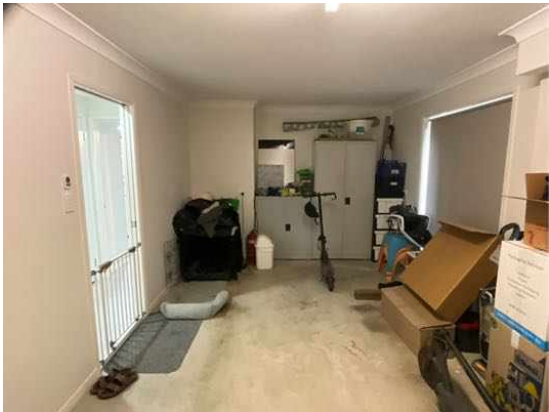
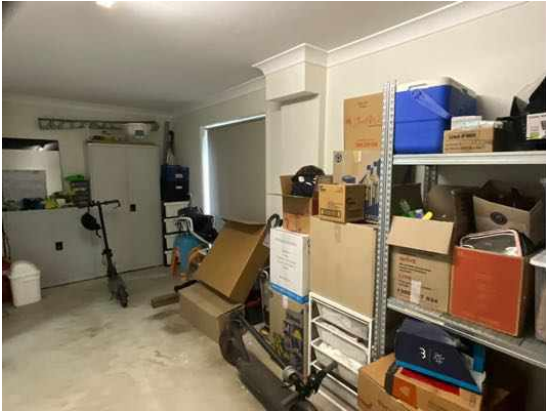
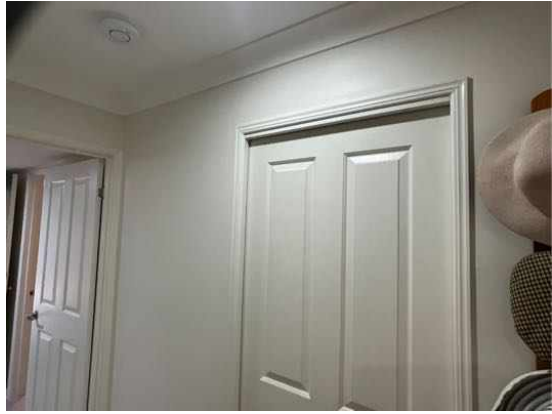
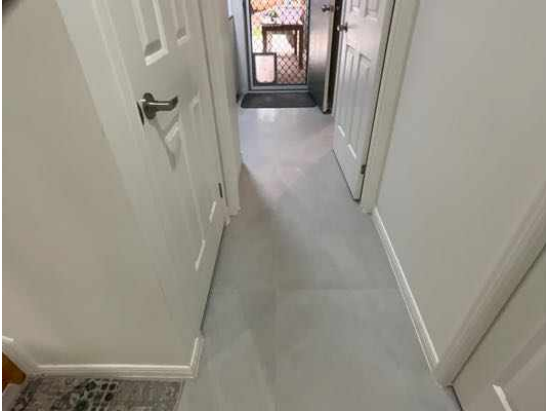
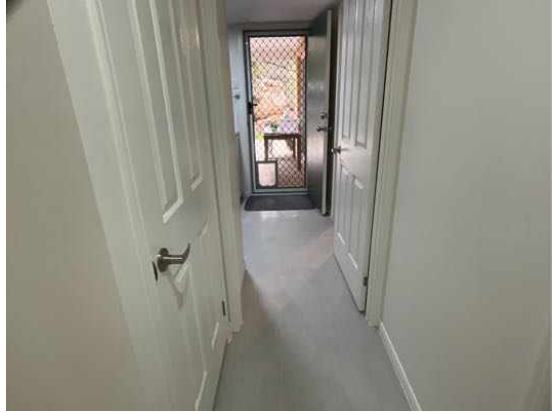
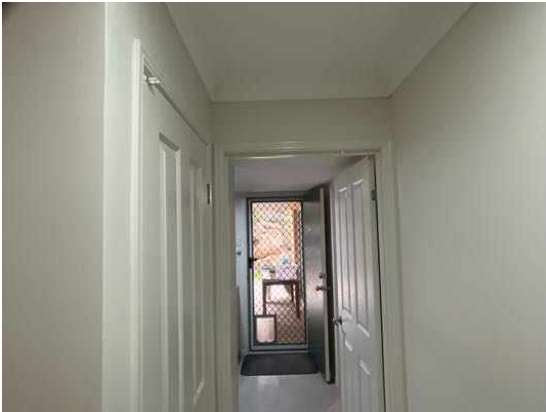
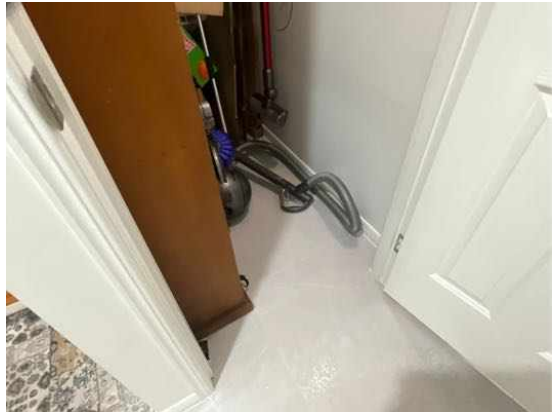
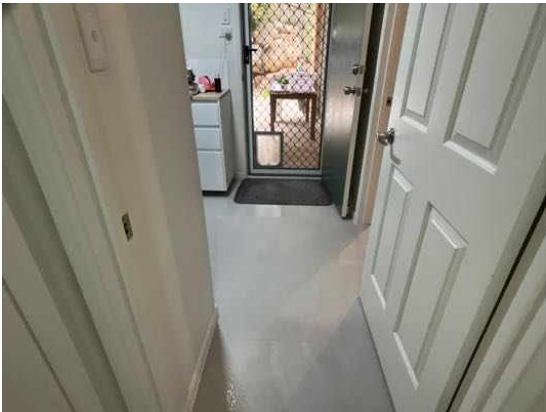
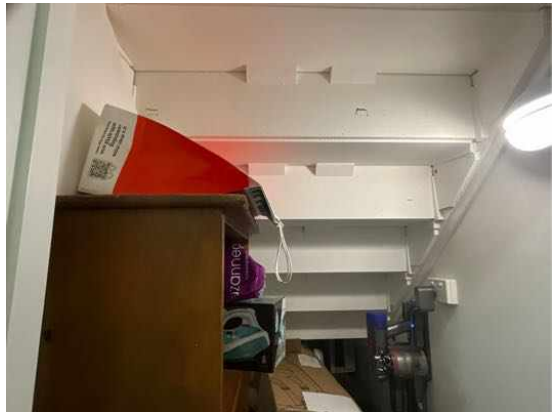
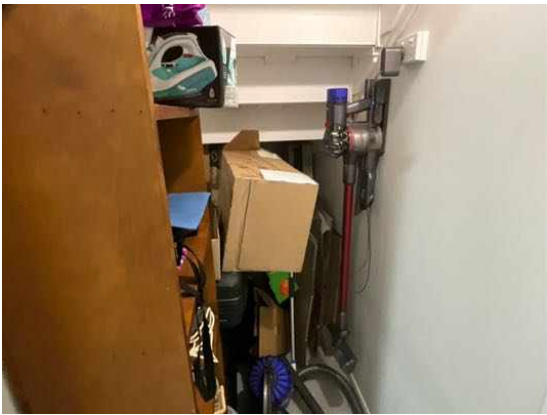
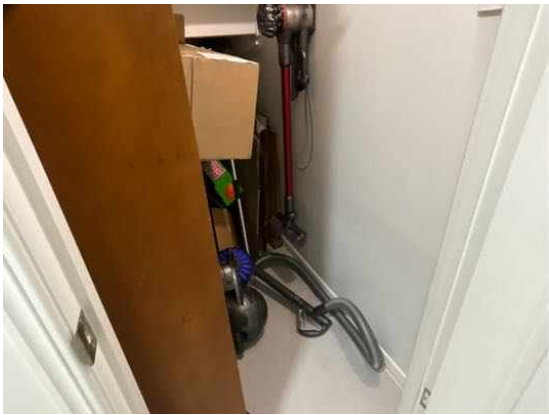
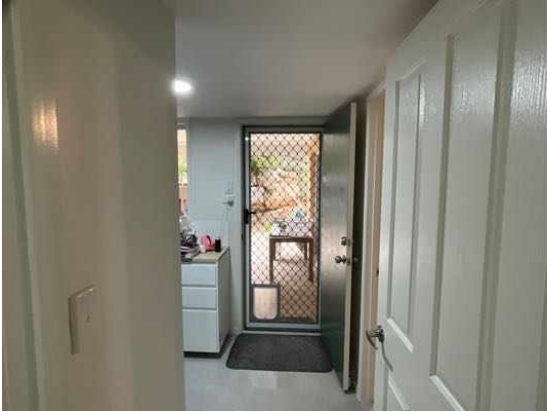
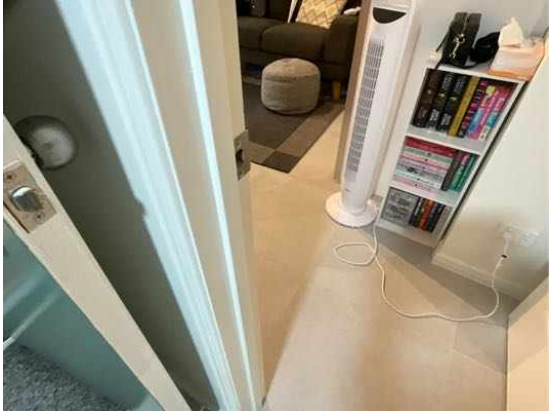
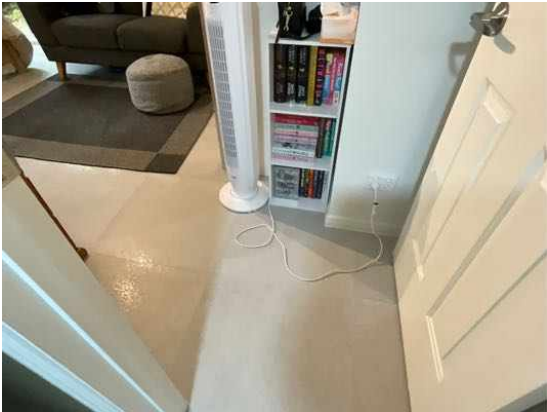
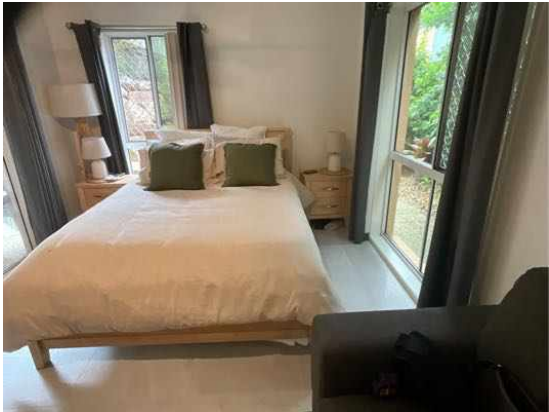
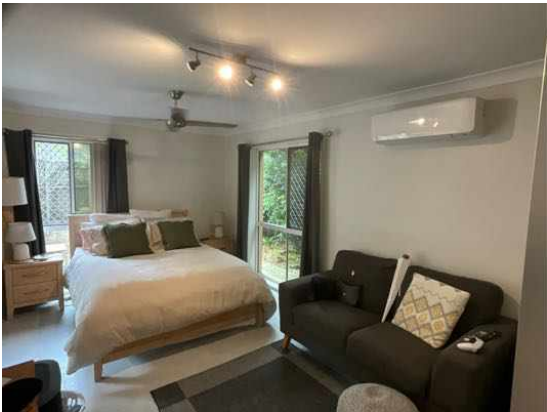
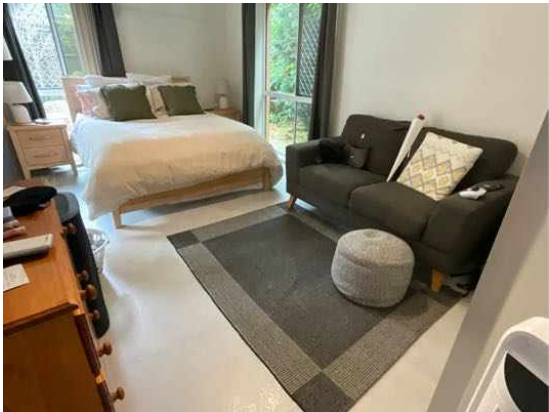
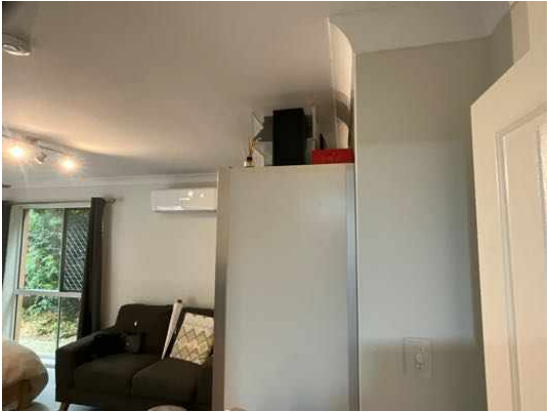
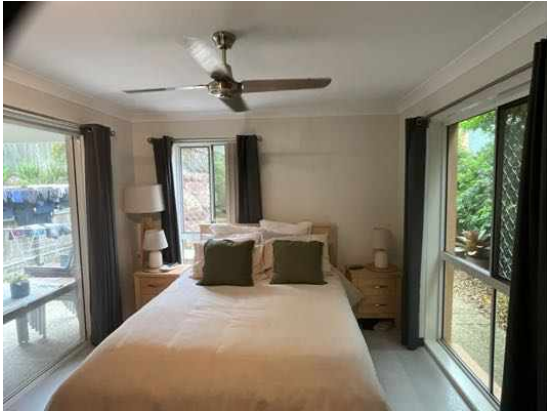
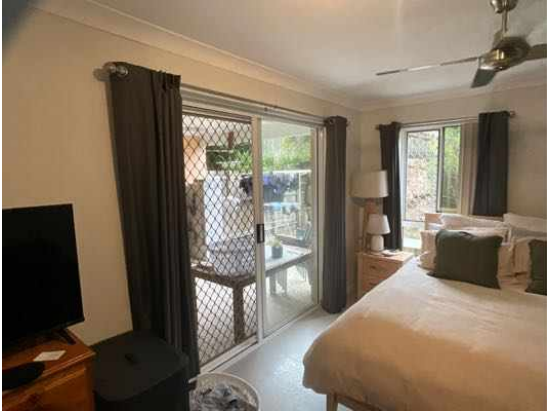
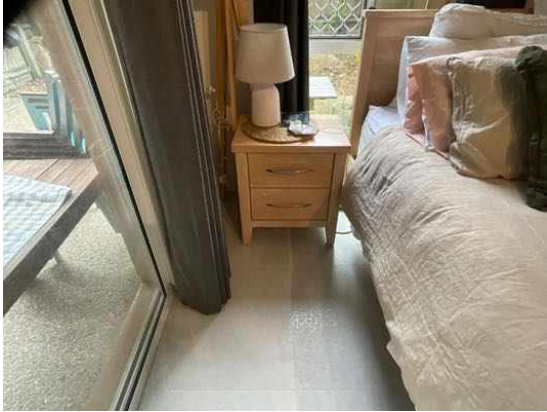
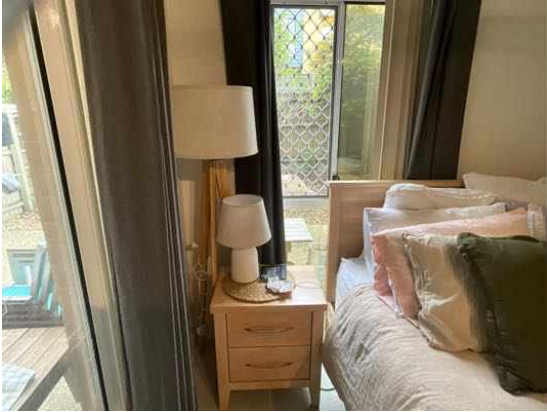
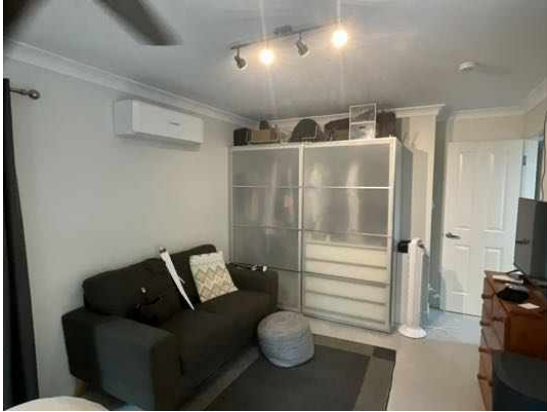
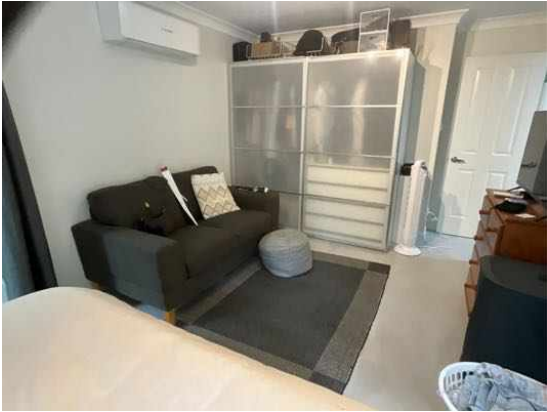
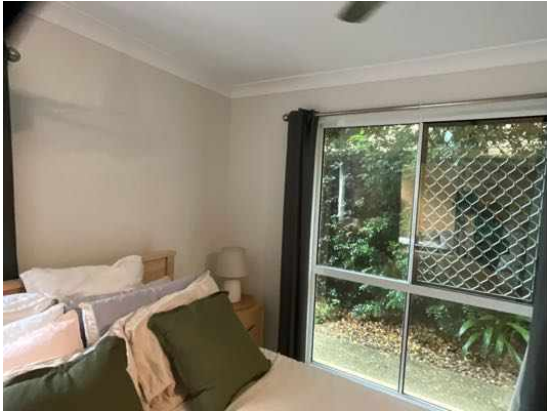
Building: Main Building
Location: All Areas
Finding: Additional Photos - Obstructions and Limitations
Information: These photographs are an indication of the obstructions and limitations which impeded full inspection of the property at the time of inspection. These obstructions can hide an array of defects and should be removed to allow full inspection to be carried out. A re-inspection is recommended once the areas are made accessible.
