Building and Timber Pest Inspection Report VR

Inspection Date: Mon, 16 Feb 2026

Property Address: 90/316 Long St E, Graceville QLD 4075, Australia

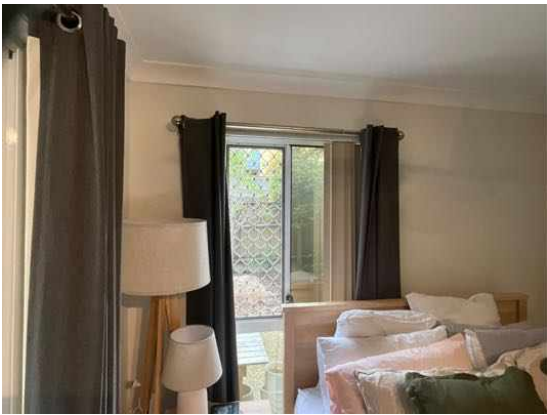
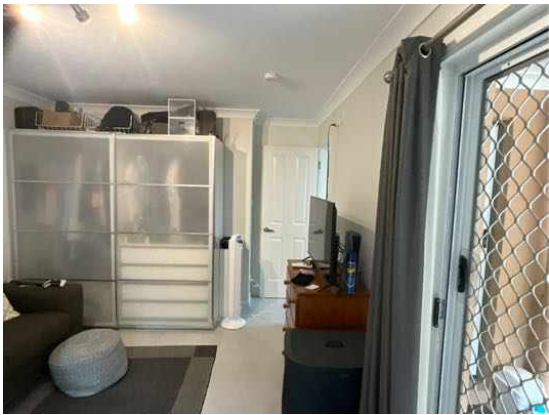
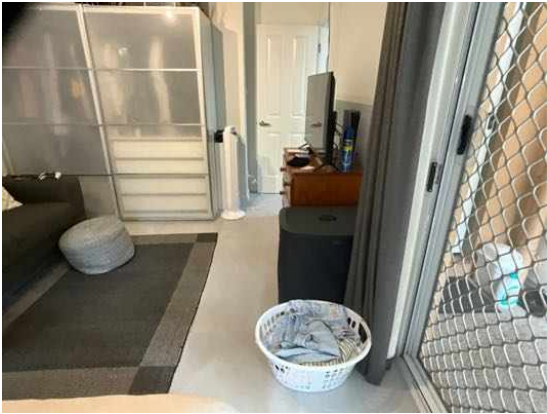
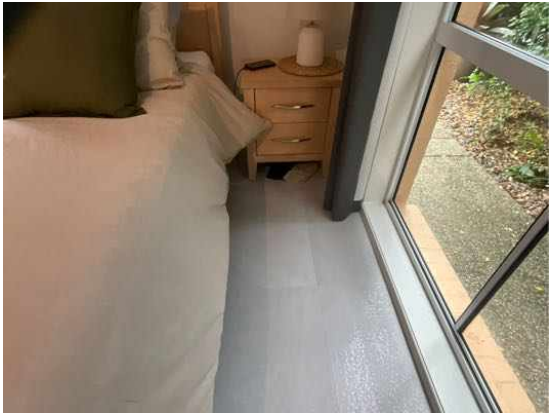
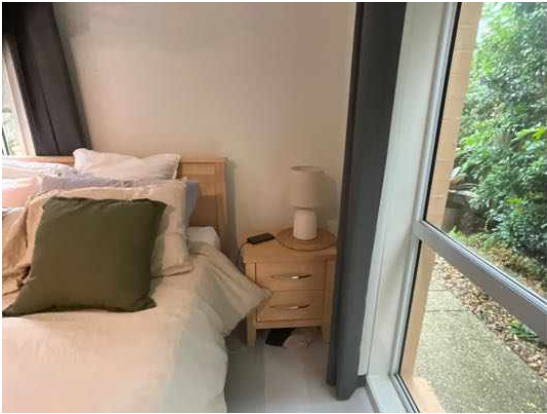
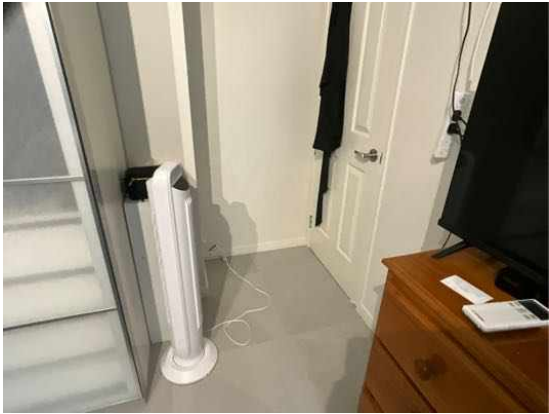
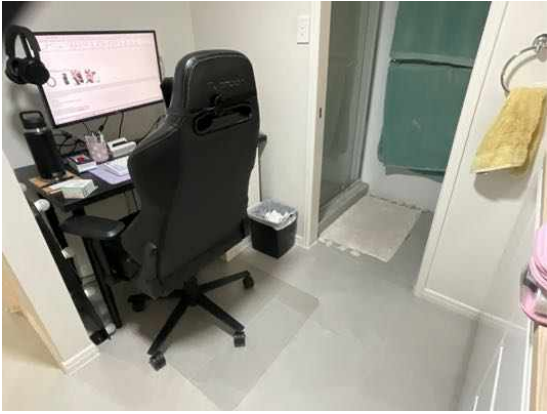
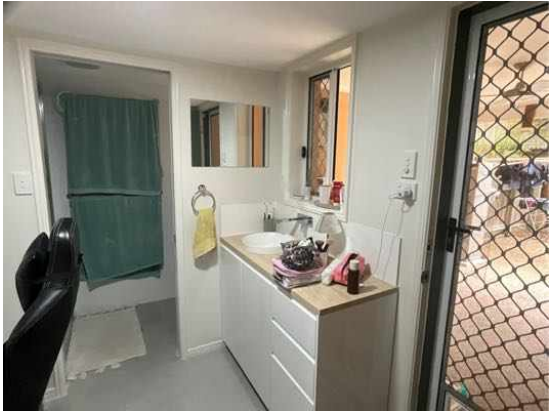
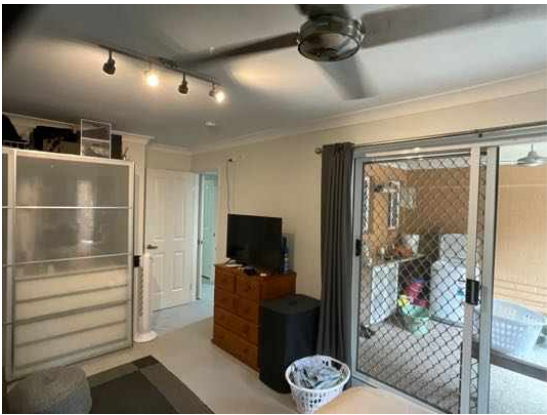
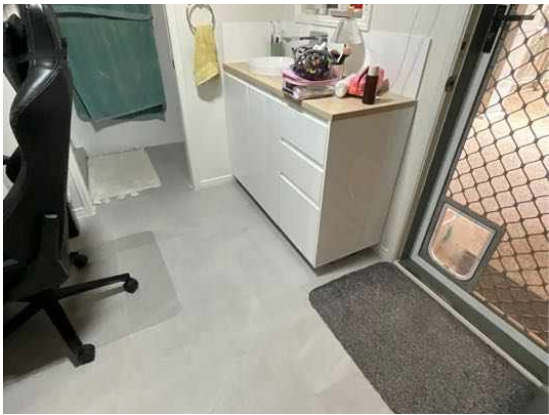
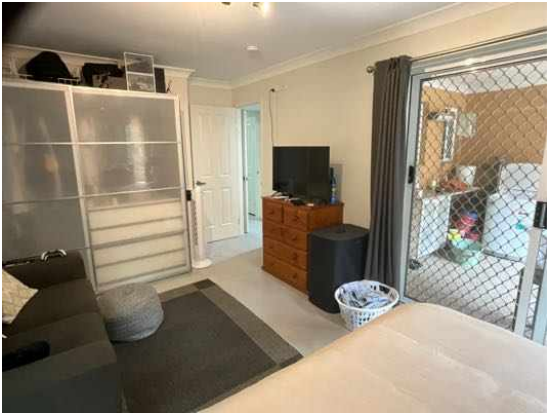
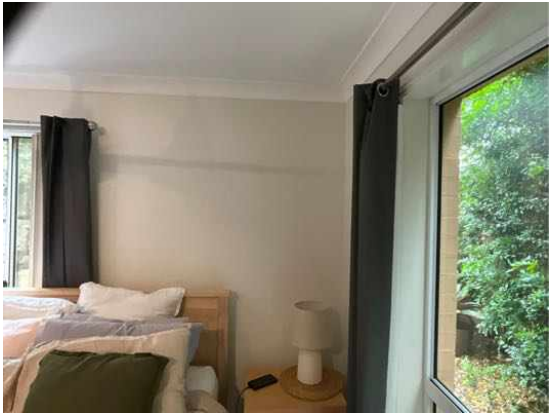
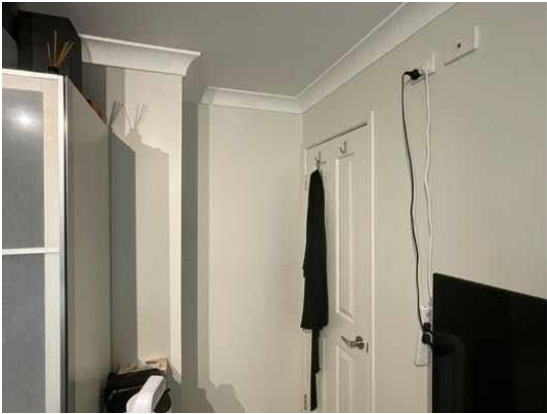
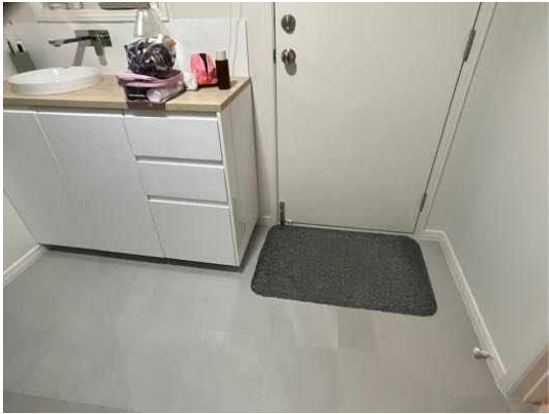
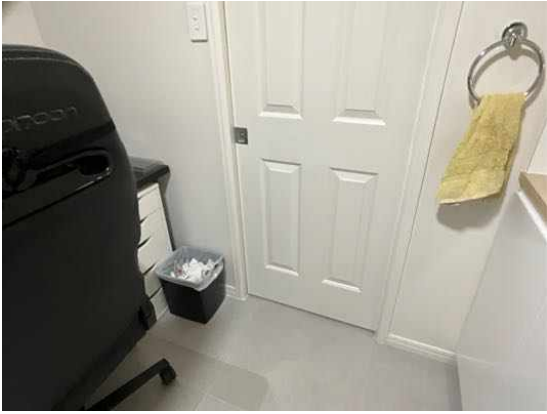
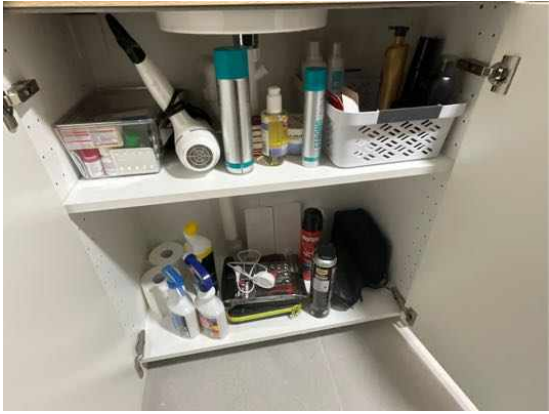
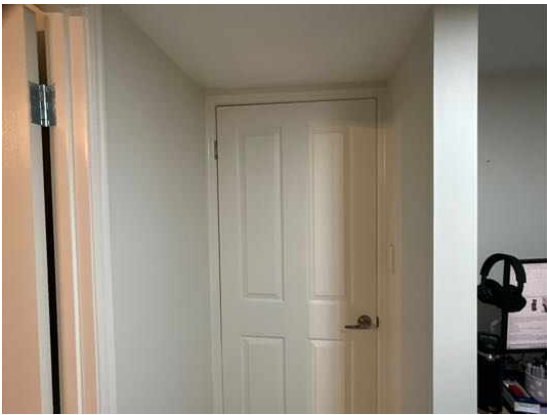
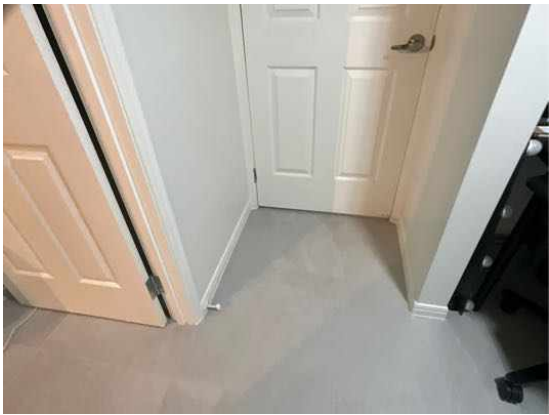
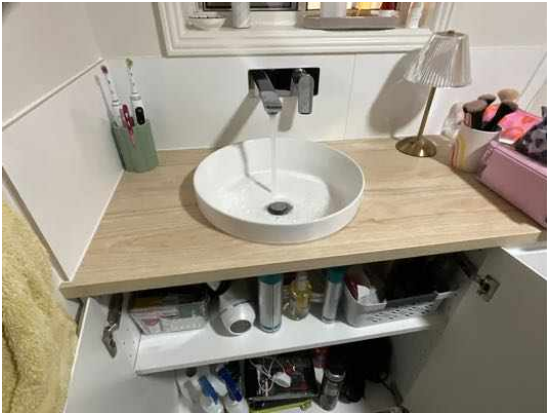
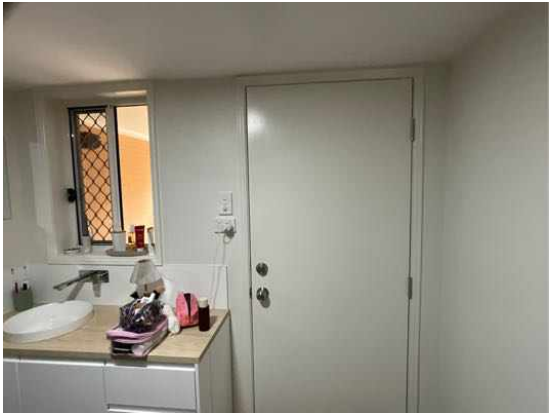
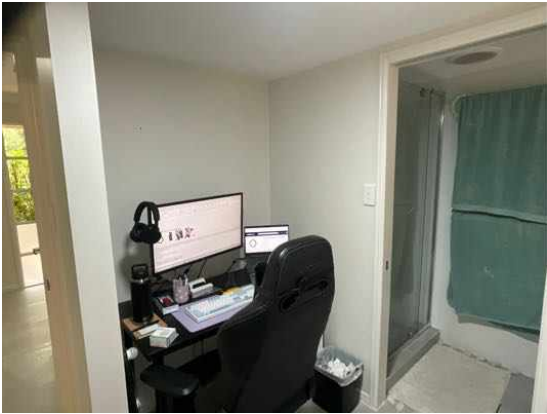
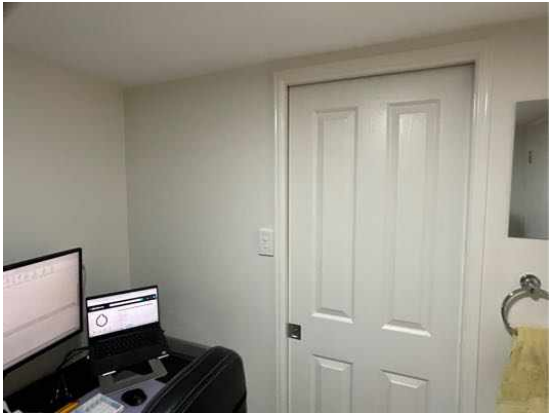
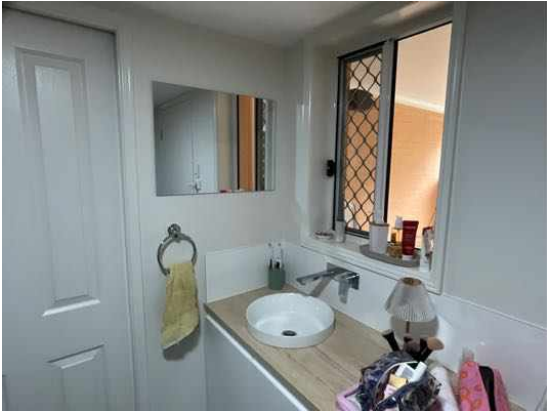
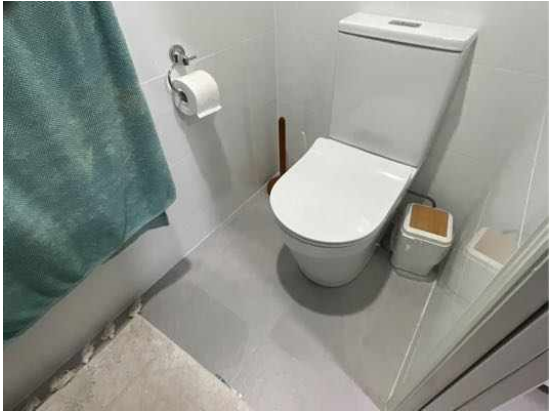
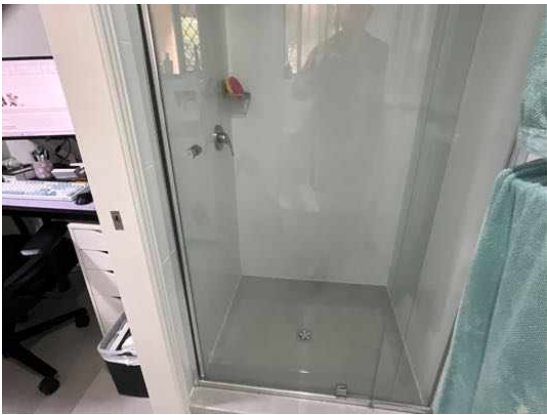
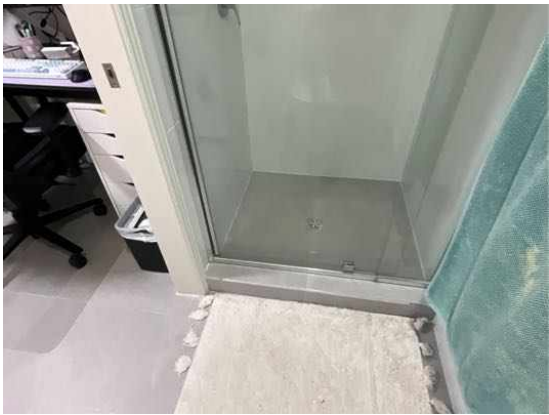
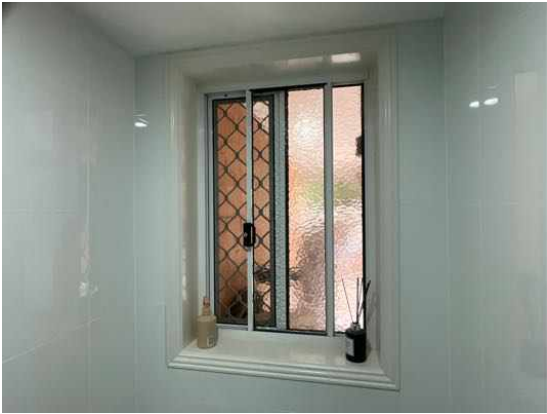
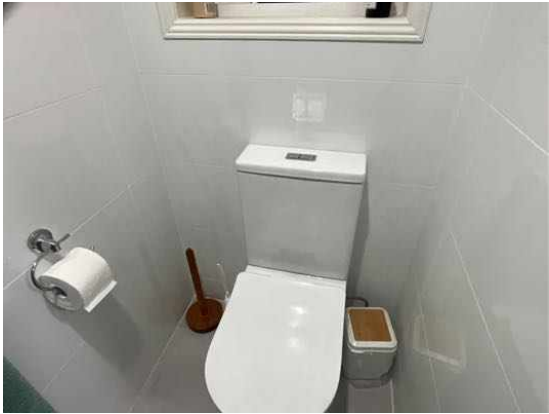
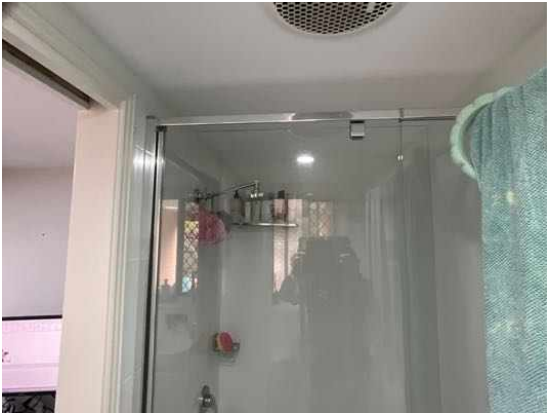
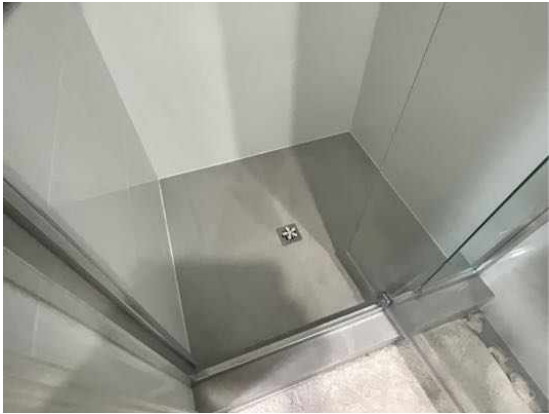
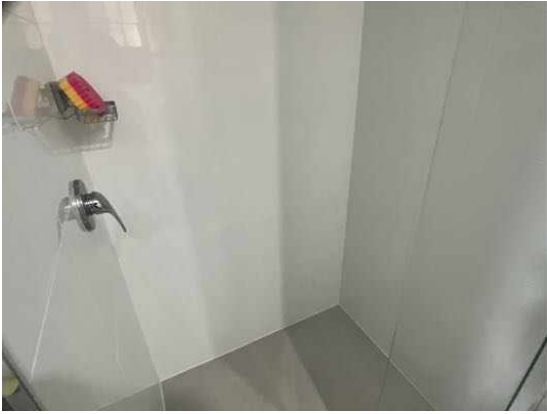
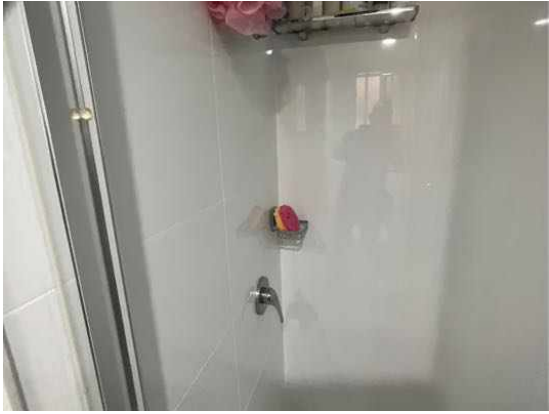
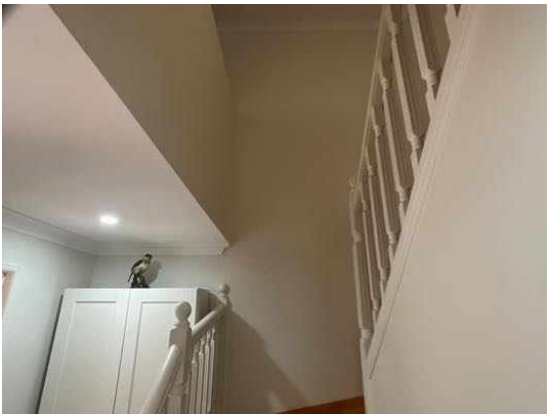
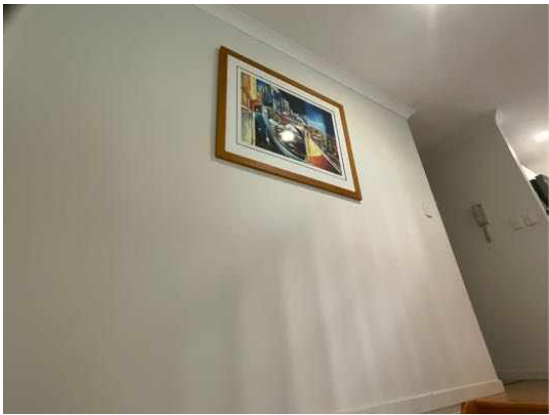
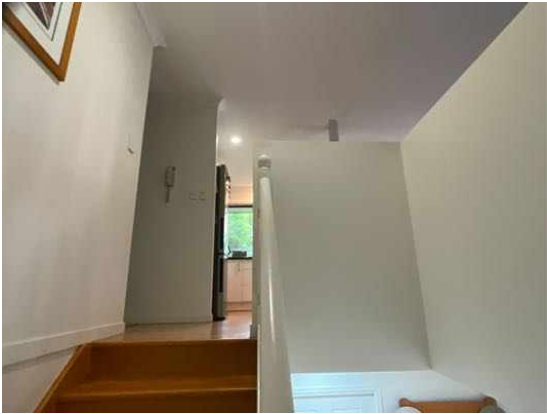
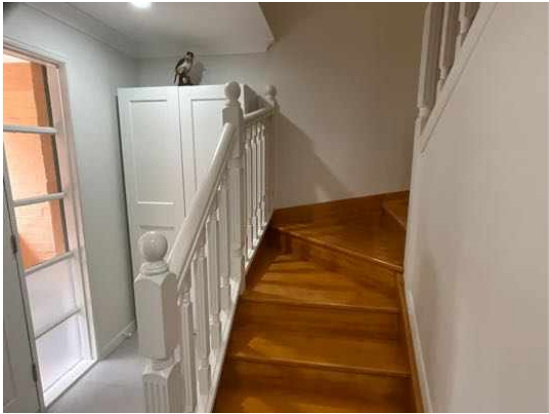
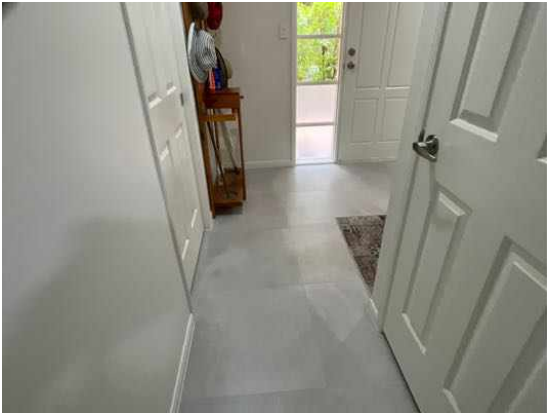
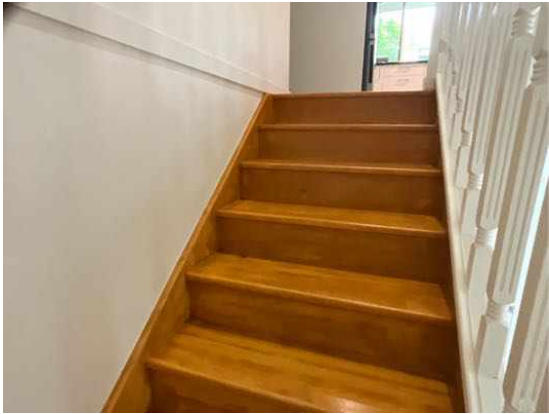
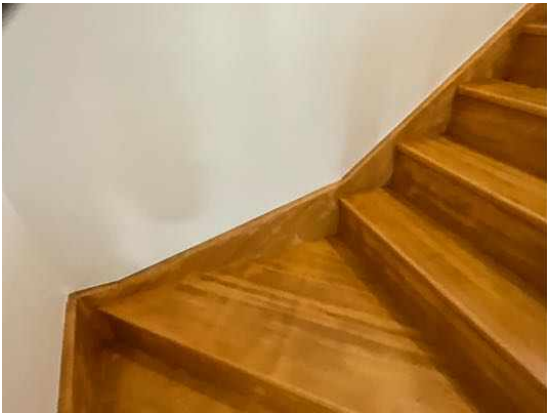
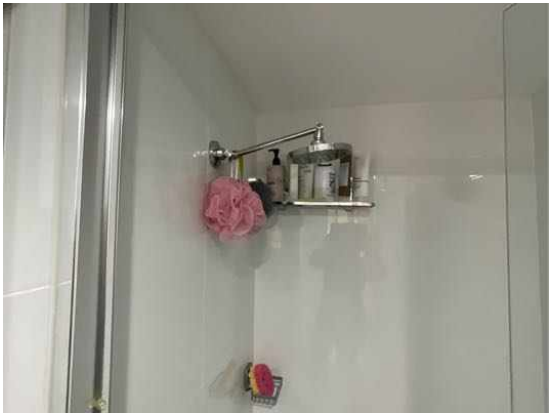
Building: Main Building
Location: All Areas
Finding: Additional Photos - Obstructions and Limitations
Information: These photographs are an indication of the obstructions and limitations which impeded full inspection of the property at the time of inspection. These obstructions can hide an array of defects and should be removed to allow full inspection to be carried out. A re-inspection is recommended once the areas are made accessible.
