Building and Timber Pest Inspection Report VR

Inspection Date: Mon, 9 Feb 2026

Property Address: 34 Barclay St, Bundamba QLD 4304,
Australia

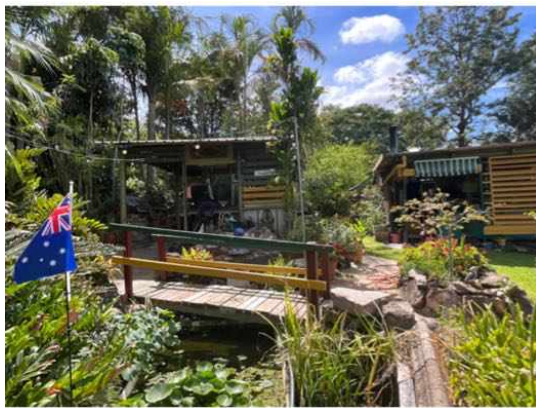
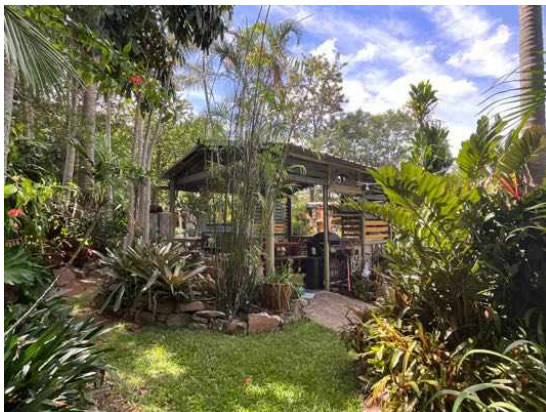
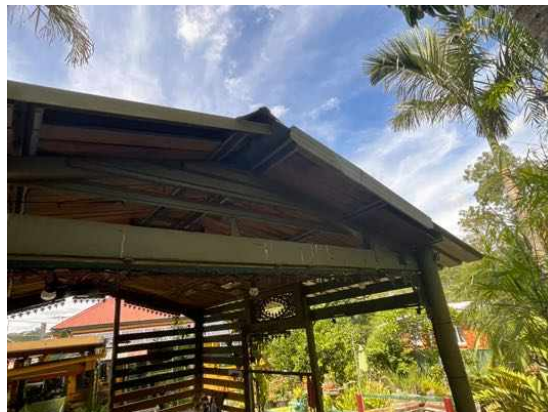
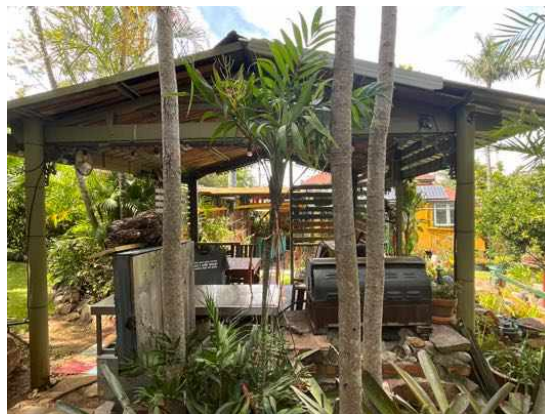
The outdoor awning/pergola structure shows signs of general deterioration and age-related wear. Roof sheeting appears weathered and uneven, with sections showing misalignment and inadequate support. Timber framing members exhibit visible movement and deflection, and fixings appear inconsistent in places. The structure is supported by painted posts with evidence of previous patch repairs and surface degradation. Drainage components (downpipe and gutter connection) appear non-standard and poorly aligned, which may compromise effective stormwater discharge. Overall presentation indicates non-engineered construction with ad-hoc modifications over time.

The current condition increases the risk of water ingress, further structural movement, and potential failure during high winds or heavy rain events. Poor roof alignment and drainage may accelerate timber decay and corrosion of fixings. If left unrectified, this may lead to progressive deterioration and possible safety hazards to occupants using the entertaining area.

Engage a licensed builder or qualified carpenter to carry out a structural assessment of the awning/pergola, including roof sheeting, framing members, posts, and drainage connections. Rectification works may include realignment or replacement of roof sheets, upgrading fixings, improving stormwater discharge, and repairing or replacing deteriorated structural elements. Where required, works should comply with current NCC requirements and relevant Australian Standards.

Repairs are recommended within 3–6 months, or sooner if further movement, leaks, or instability are observed.

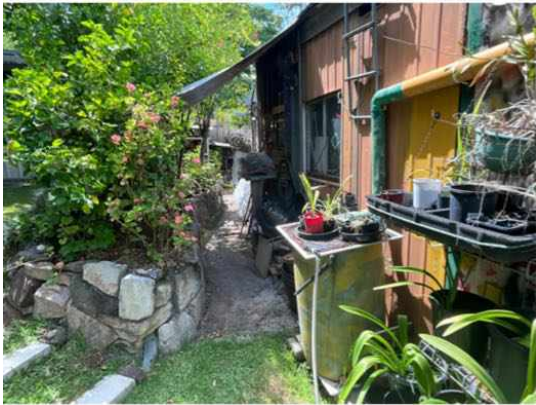
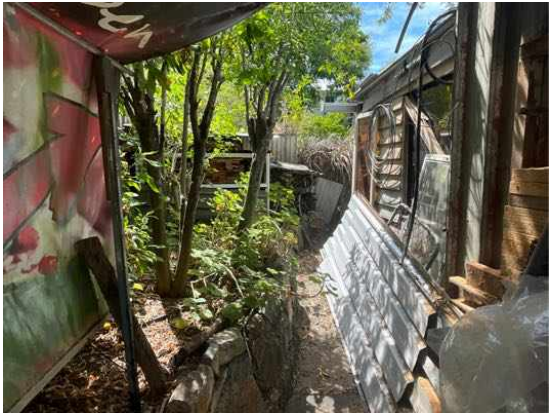
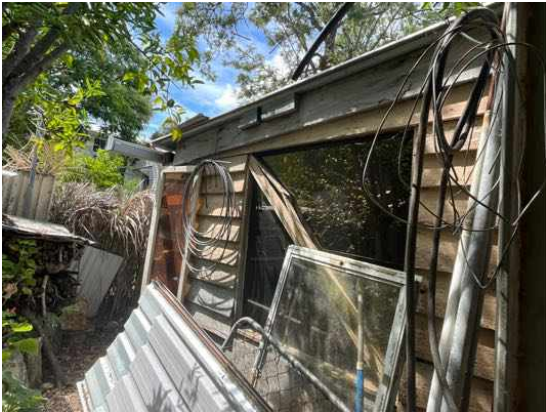
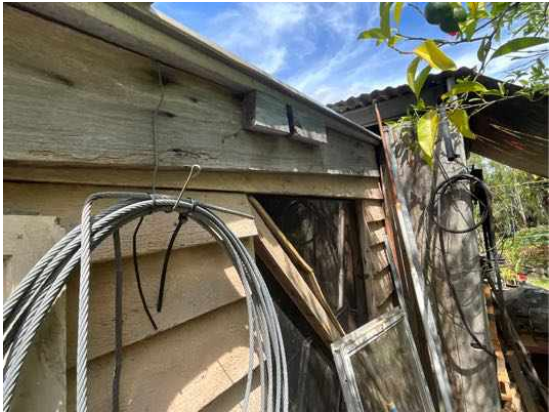
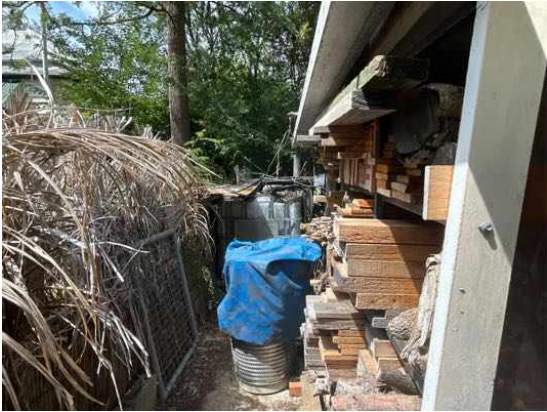
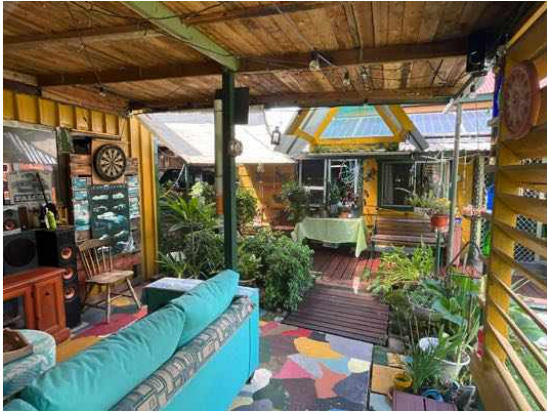
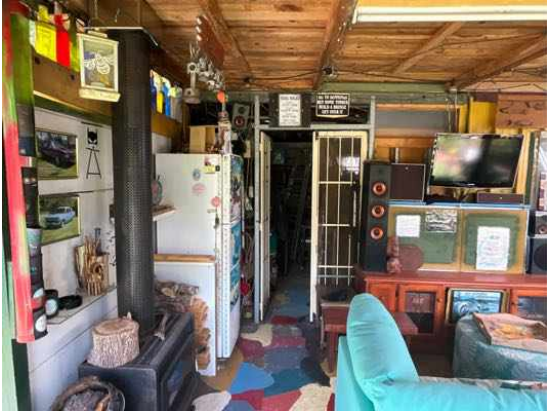
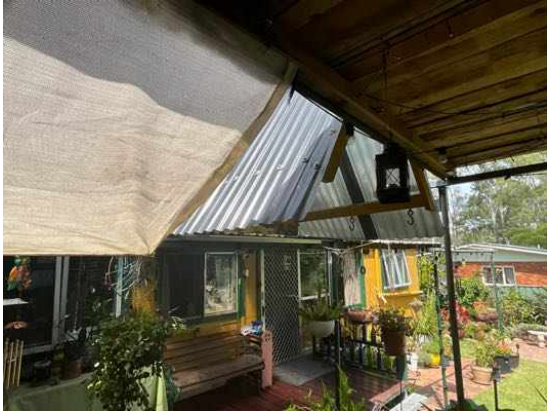
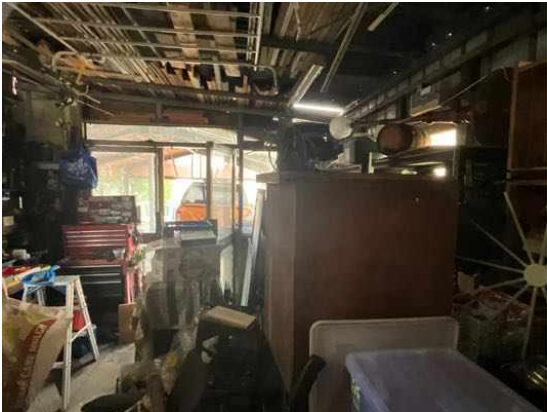
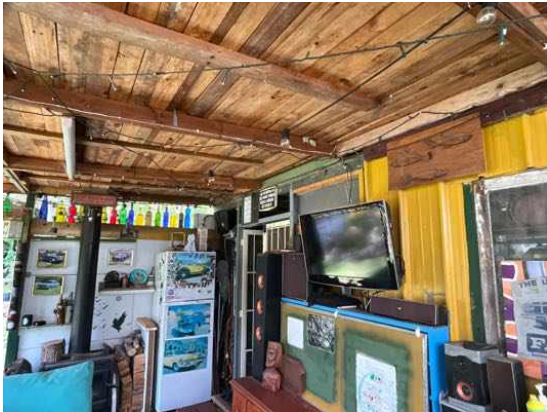
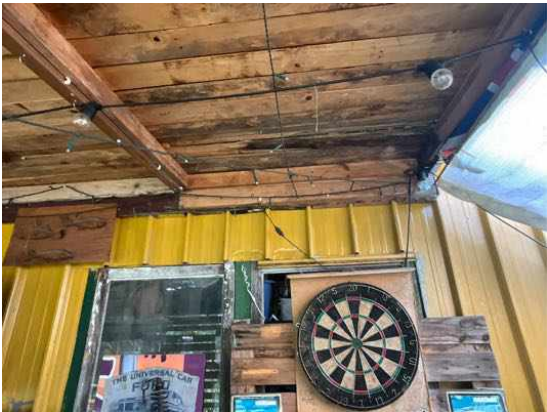
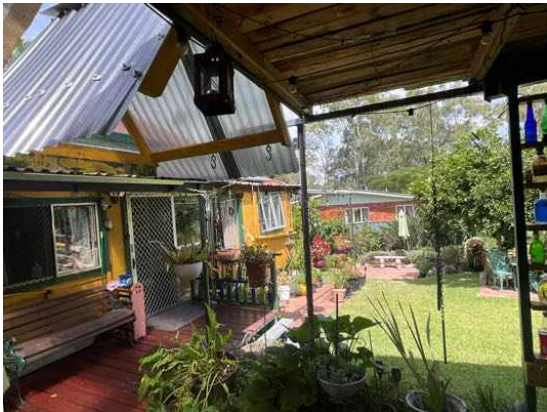
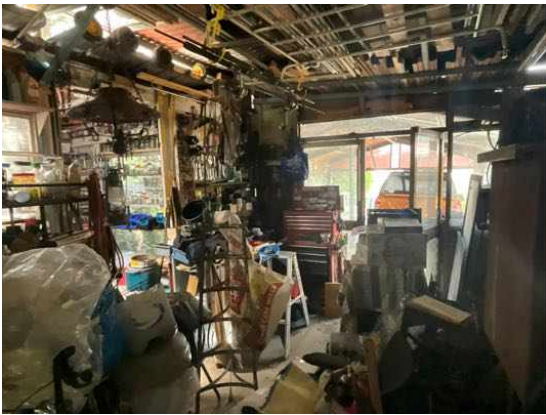
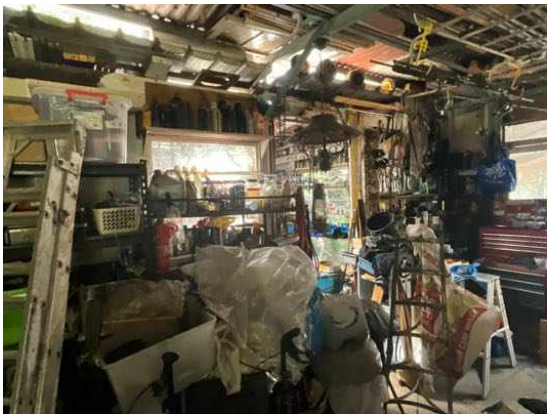
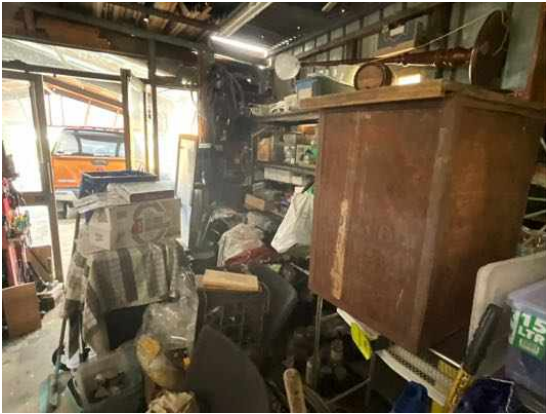
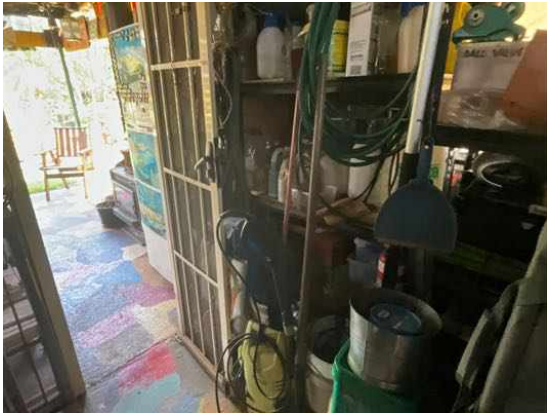
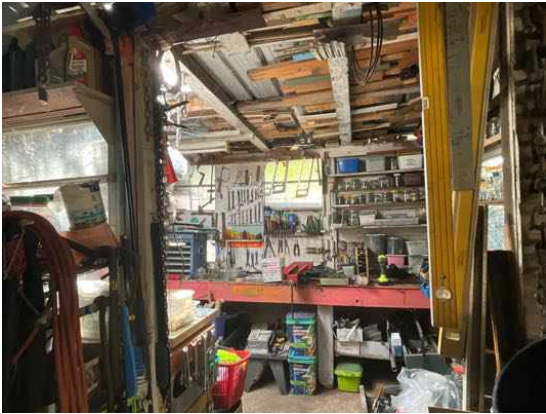
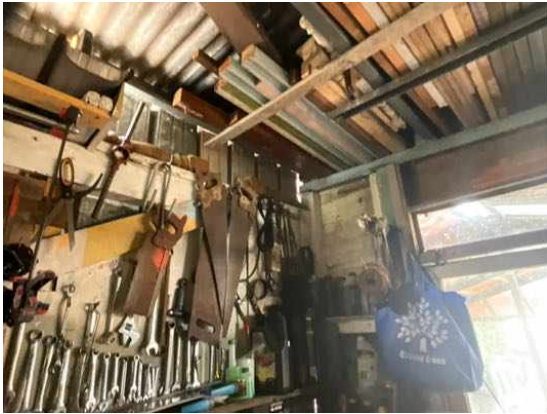
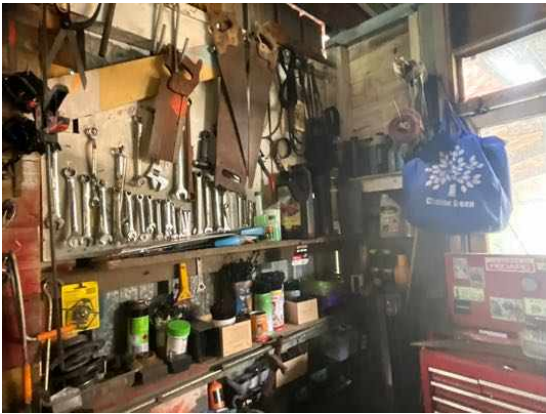
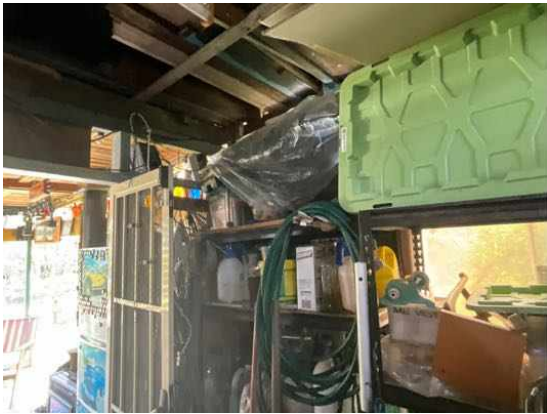
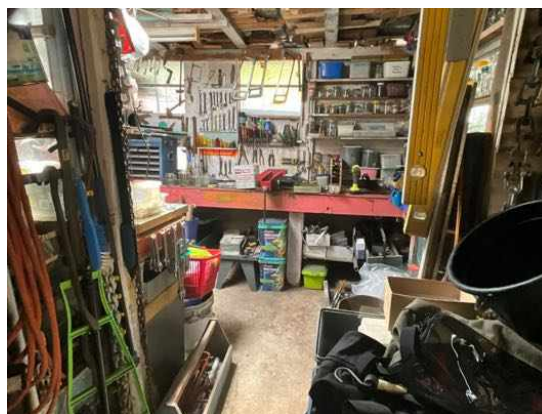
Finding 2.02

Building:	Main Building
Location:	Yard - Back
Finding:	Tool Shed – General Condition and Structural Integrity (Rear Yard)
Information:	Tool Shed – General Condition and Structural Integrity (Rear Yard)

The tool shed is constructed using a combination of aged timber framing, mixed cladding materials, recycled windows, and corrugated metal roofing. Based on visual inspection, the structure presents as non-standard and makeshift in nature. The following conditions were observed:

- Visible timber deterioration, weathering, and uneven framing.
- Roofing materials appear inconsistently installed, with gaps and patchwork sections increasing risk of water ingress.
- Internal framing and ceiling linings show staining and signs consistent with historic moisture exposure.
- Stored materials and equipment obstructed full inspection of wall linings, floor areas,

- Electrical cabling and lighting appear ad-hoc and not installed to a clearly compliant standard.
- External access paths are narrow and uneven, creating trip hazards and restricting safe maintenance access.
- Overall presentation indicates the shed is approaching the end of its serviceable life.

Short term (0–3 months) – Further deterioration and safety risks are likely if not addressed.

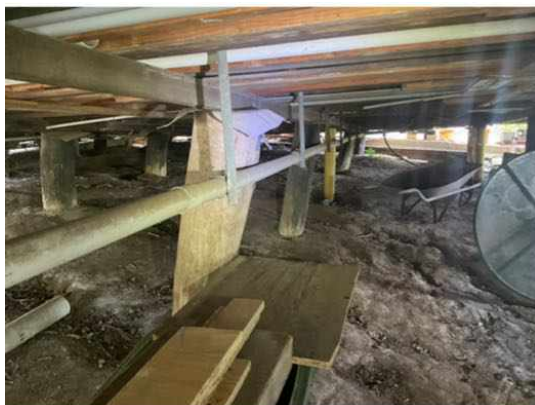
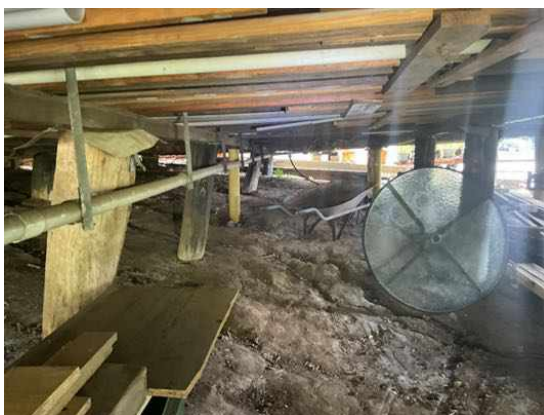
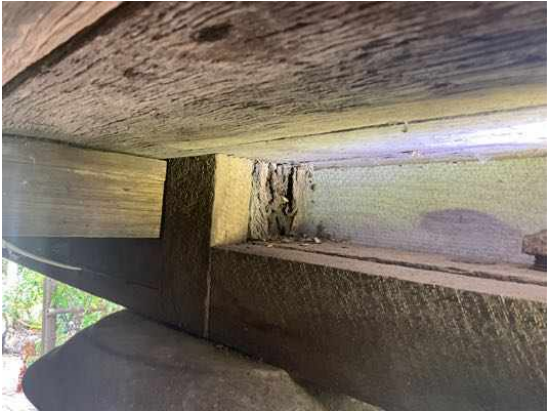
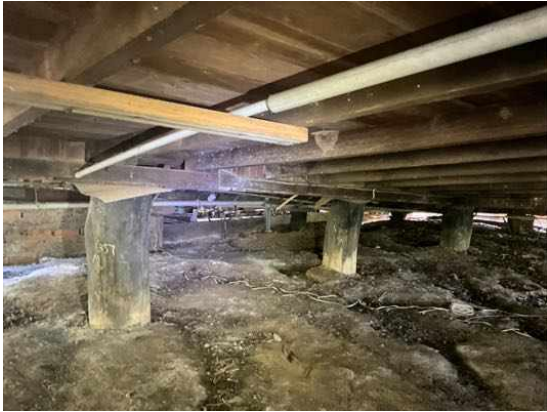
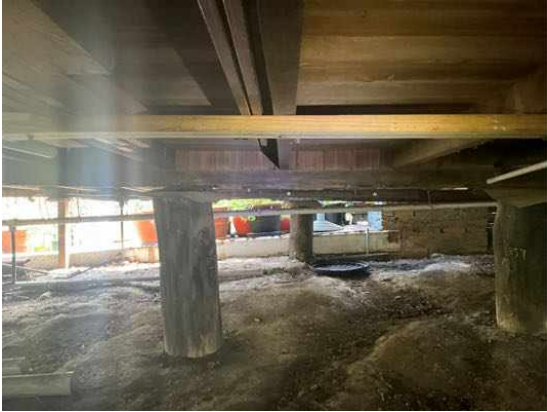
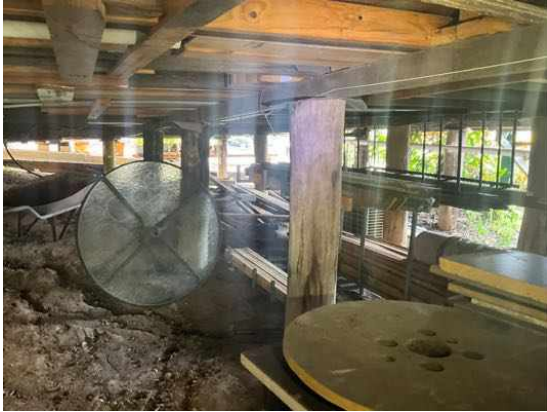
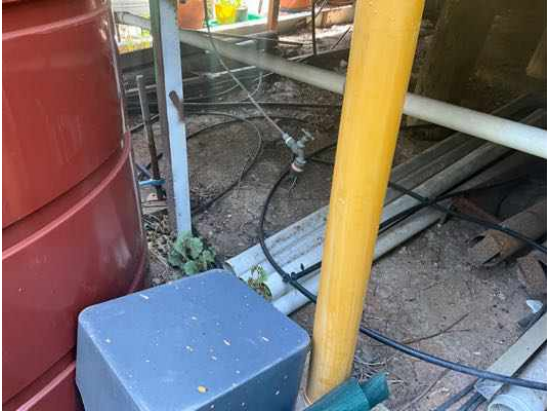
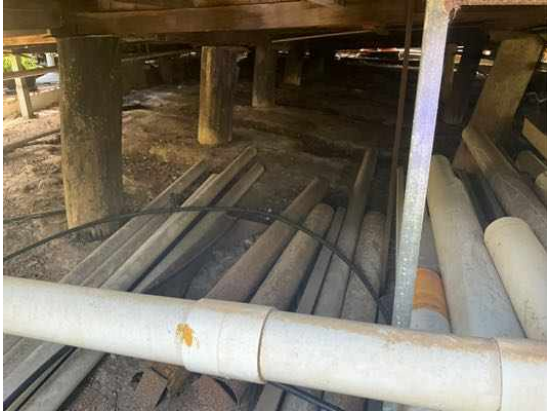
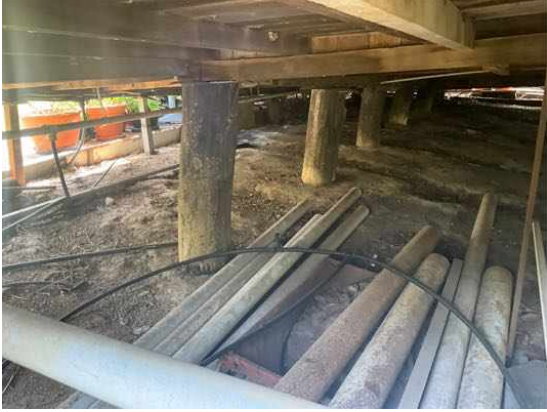
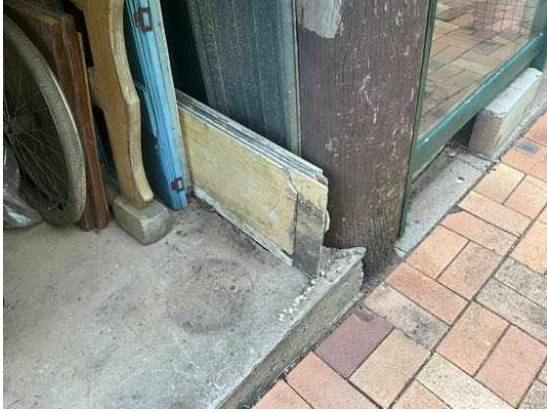
Finding 2.03

Building:	Main Building
Location:	Subfloor
Finding:	Subfloor & Timber Stumps – General Condition and Support (Subfloor Area)
Information:	Subfloor & Timber Stumps – General Condition and Support (Subfloor Area)

Further assessment recommended within 30 days, with rectification works completed as required following professional advice.

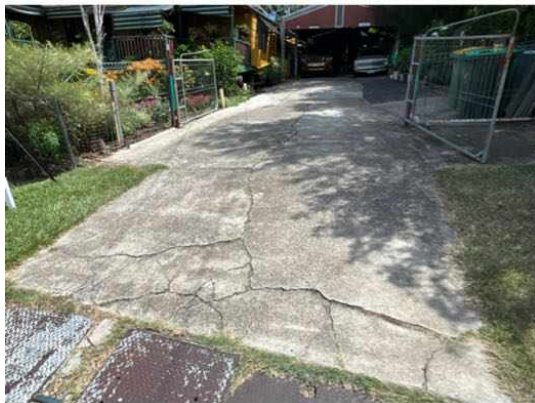
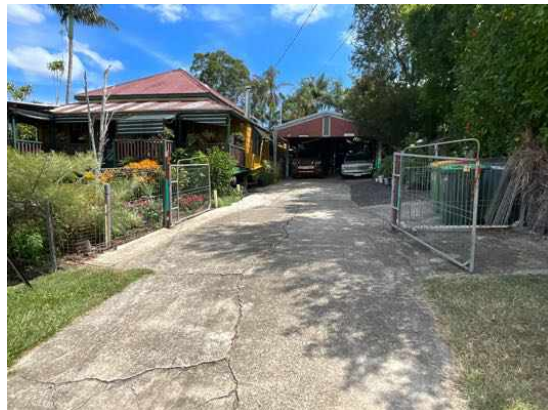
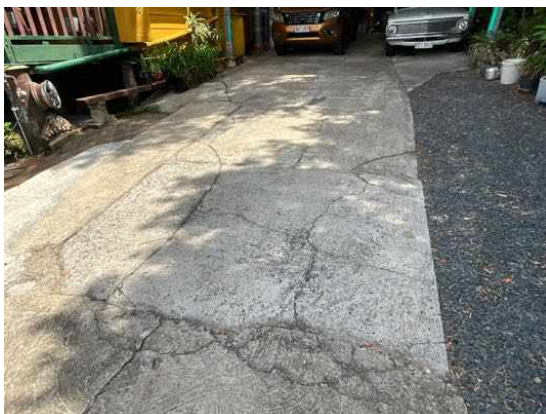
Finding 3.01

The approximate width of the crack to be considered Category 3 is greater than 2.0mm, or a change in offset of 15-25mm when a 3m straight edge is placed over the defect.

Category 3 cracks to slabs exceed allowable Standards and Tolerances, and are considered defects requiring rectification.

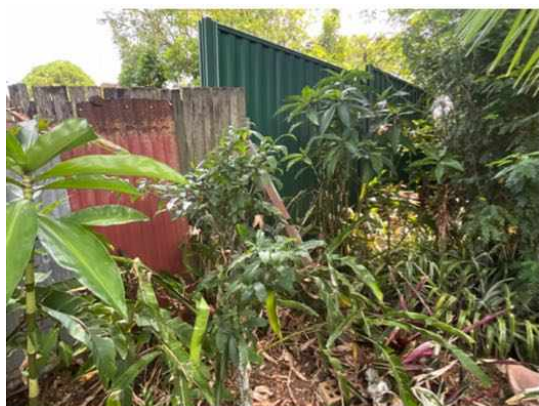
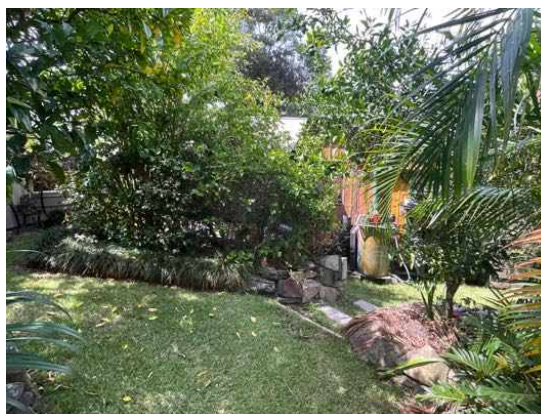
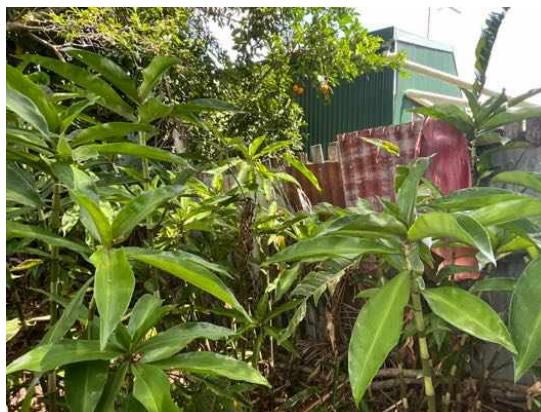
Assessment is visual only and limited by access and site conditions at the time of inspection. No destructive testing was undertaken. Subsurface post conditions and concealed fixings were not visible. Timber decay and pest activity may exist in concealed areas. Further evaluation by a licensed fencing contractor and qualified pest inspector is recommended prior to any works.

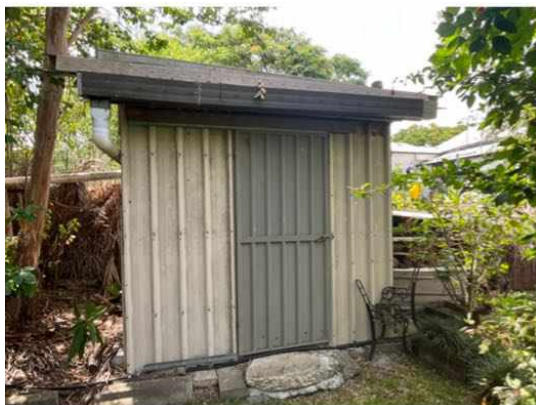
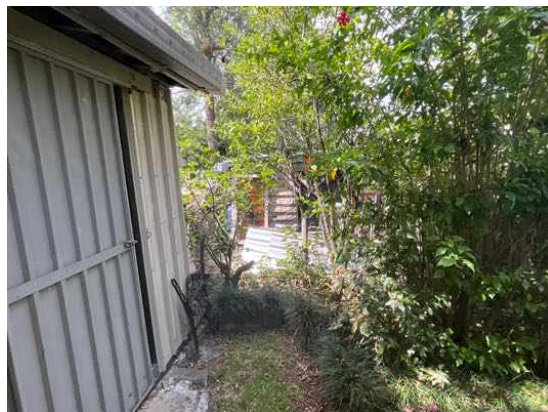
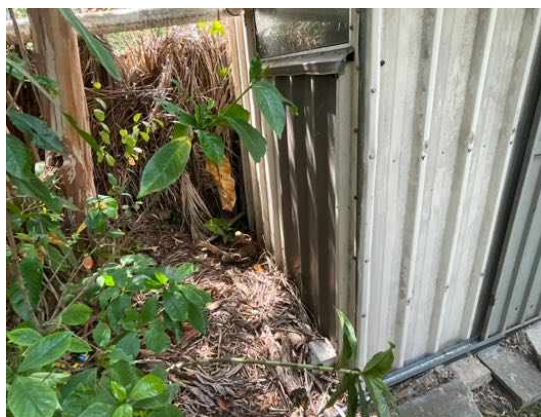
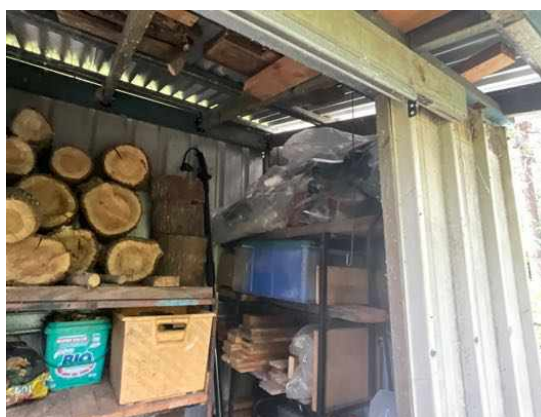
Finding 3.03

Building:	Main Building
Location:	Yard - Back
Finding:	Shed – External Walls, Roof & Overall Condition (Rear Yard)
Information:	Shed – External Walls, Roof & Overall Condition (Rear Yard)

The external shed structure is in poor overall condition. Corrugated wall cladding shows age-related deterioration, weathering and uneven alignment. The roof sheeting appears dated with visible edge distortion and inconsistent fixings. Evidence of vegetation encroachment is present around the perimeter, including organic debris buildup at the base of walls, increasing moisture retention and pest harbourage risk.

The shed is constructed on uneven footings/pavers with signs of settlement and inadequate support. Door alignment appears compromised, and general wear suggests the structure is nearing the end of its serviceable life.

- Increased risk of moisture ingress and further material deterioration
- Potential pest harbourage (including termites and rodents) due to vegetation contact and debris accumulation
- Reduced structural stability due to uneven base support
- Possible health risk if materials are disturbed and later confirmed to contain asbestos
- Reduced usability and security of the shed

Engage a licensed builder or shed installer to assess the structure and provide advice on repair versus full replacement. Vegetation should be cleared away from all shed walls to improve ventilation and reduce moisture/pest risk. If renovation, cutting, or demolition is proposed, asbestos sampling by a NATA-accredited laboratory is strongly recommended prior to any works.

Repairs or replacement should be considered within 3–6 months, or sooner if the shed is actively used or storing valuable items.

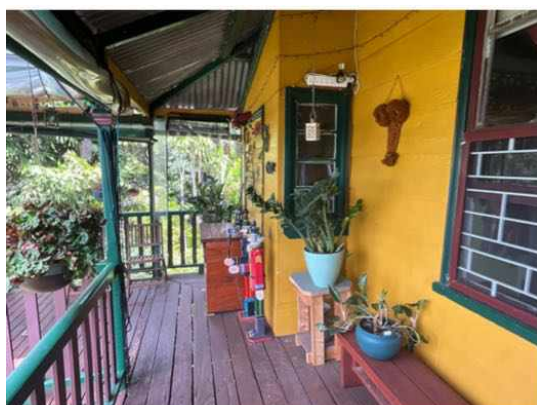
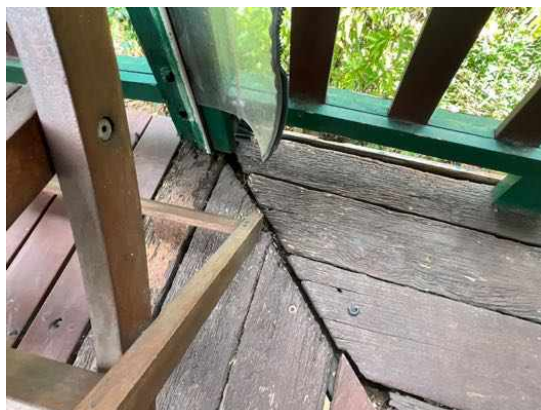
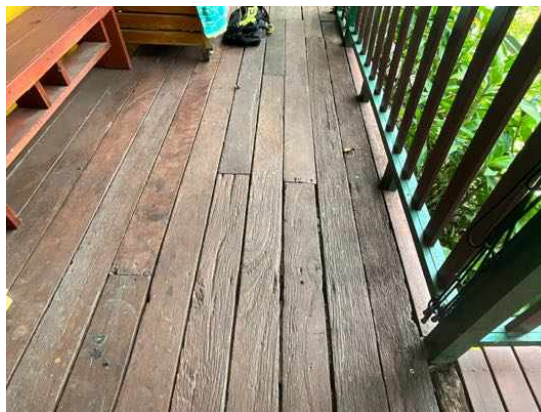
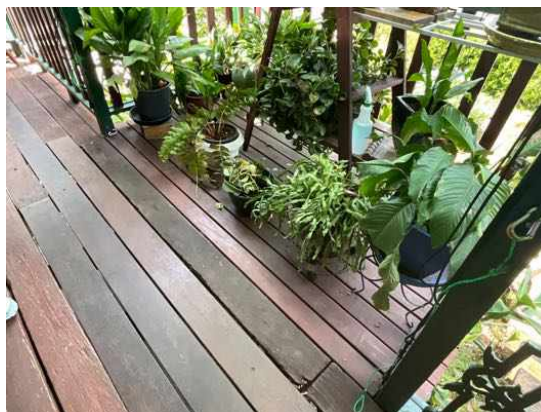
Finding 3.04

Building:	Main Building
Location:	Verandah
Finding:	Deck / Verandah – General Deterioration and Localised Timber Damage
Information:	Deck / Verandah – General Deterioration and Localised Timber Damage

The timber deck and verandah flooring shows widespread age-related deterioration, including uneven and misaligned boards, open gaps at junctions, poorly finished mitred board joints, and areas of surface weathering. Several boards show signs consistent with timber degradation, including splitting, edge breakdown, and loss of section, particularly at corners and high-traffic locations. Fixings appear inconsistent in places, and some boards may not be adequately supported beneath, contributing to movement and unevenness underfoot.

- Increased trip and fall hazard, particularly at uneven board junctions and raised or deteriorated edges
- Progressive timber deterioration if moisture ingress continues
- Potential reduction in the structural serviceability of the deck over time
- Localised timber damage may worsen if not addressed, leading to more extensive repairs

A licensed builder or experienced carpenter should carry out a detailed assessment of the deck structure and flooring. Works may include re-fixing or replacing damaged or deteriorated boards, correcting uneven junctions, improving fixings, and assessing sub-floor support and ventilation. Any replacement timbers should be suitable for external exposure and installed in accordance with relevant standards.

Repairs are recommended in the short to medium term. Trip hazards should be addressed as a priority to reduce safety risks.

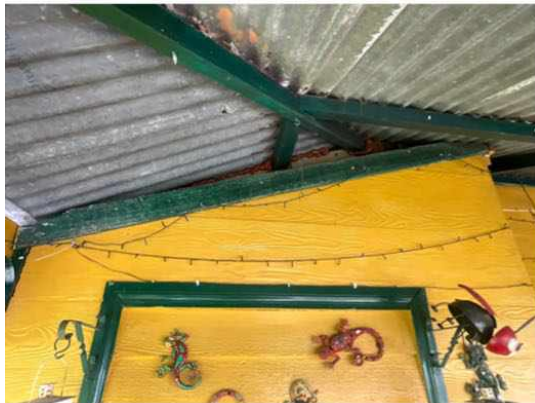
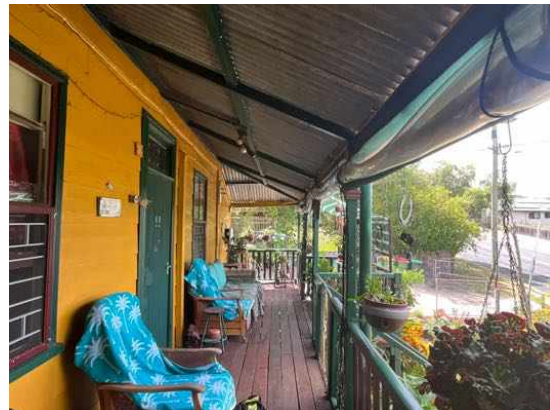
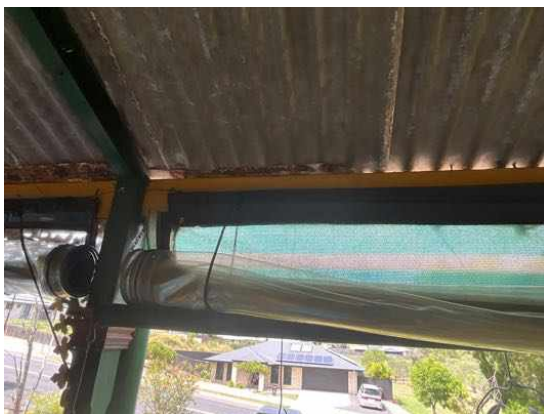
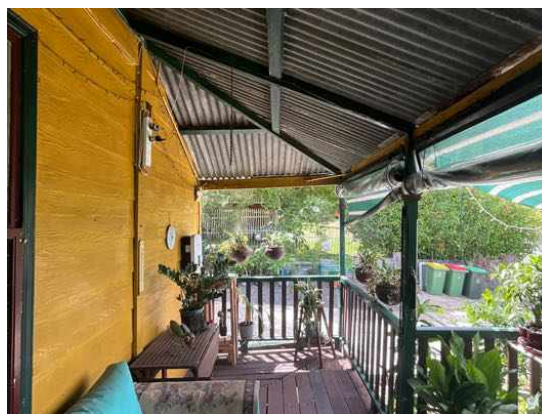
Finding 3.05

Building: Main Building
 Location: Verandah
 Finding: Veranda Roof Sheeting
 Information: Condition Summary – Veranda Roof Sheeting

The veranda roof is clad with older-style corrugated sheeting showing signs of age-related wear, including surface weathering, staining, and general deterioration consistent with prolonged exposure to the elements. Localised corrosion is evident to associated metal framing and fixings. No active leaks were observed at the time of inspection; however, the overall condition indicates the roof covering is aged and approaching the later stage of its serviceable life.

- Continued exposure to weather may result in progressive deterioration.
- Ongoing ageing may increase the likelihood of future leaks or material failure.

- Corrosion to supporting elements may reduce long-term durability if left unaddressed.

Monitor the condition of the veranda roof and associated structural components. Allow for maintenance, repairs, or future replacement as part of ongoing property upkeep. Any works should be carried out by a suitably qualified and licensed contractor.

Medium term, or sooner should signs of active leakage, further corrosion, or deterioration become evident.

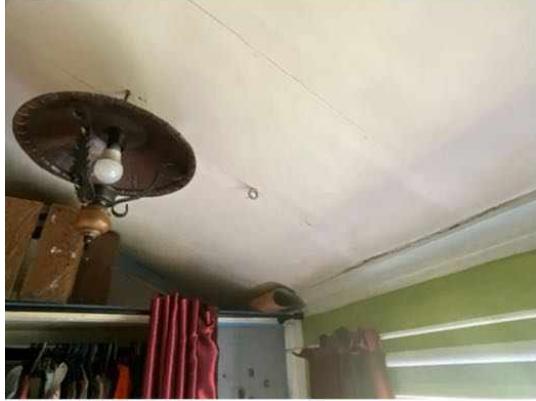
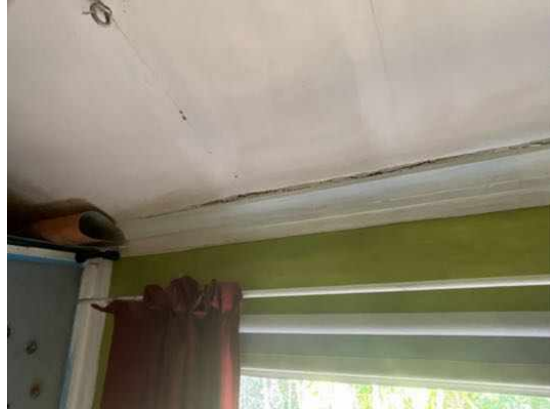
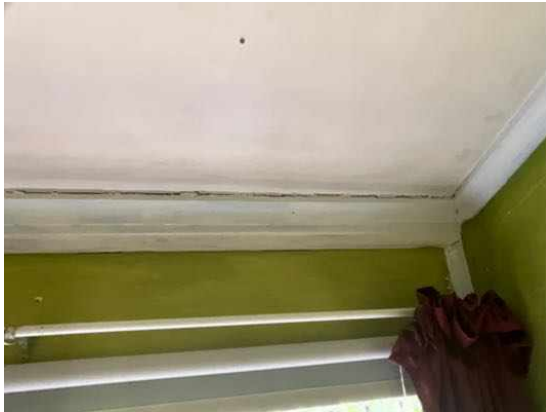
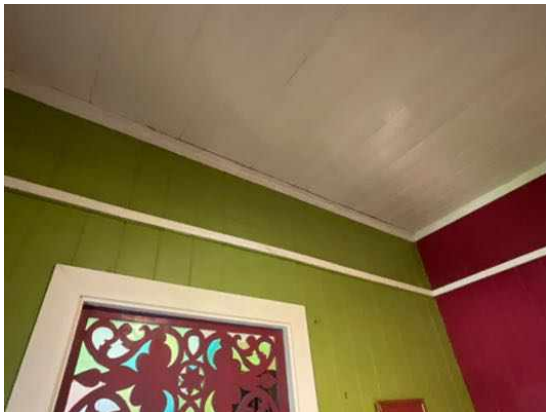
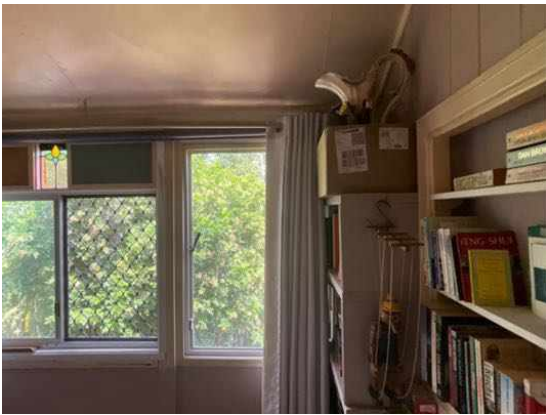
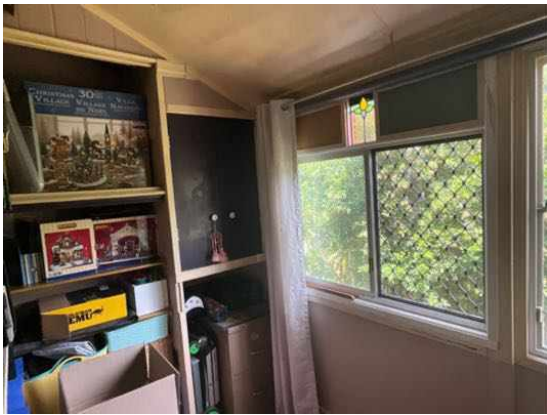
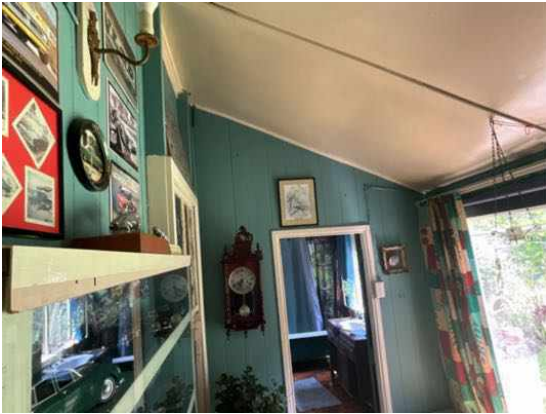
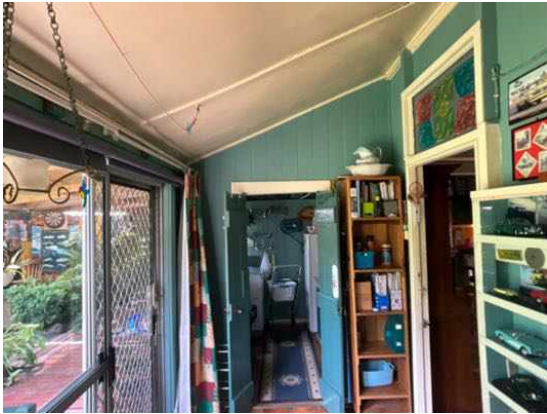
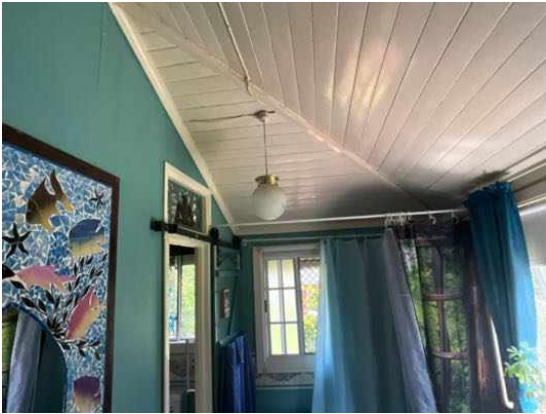
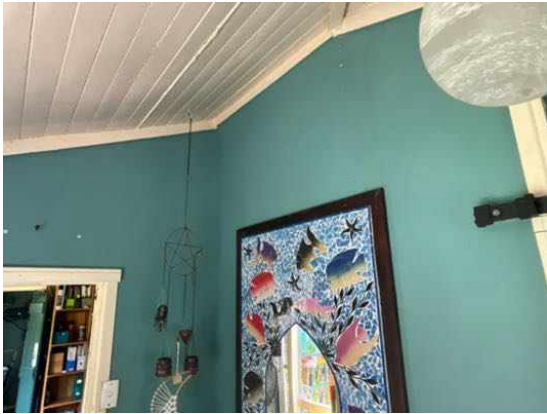
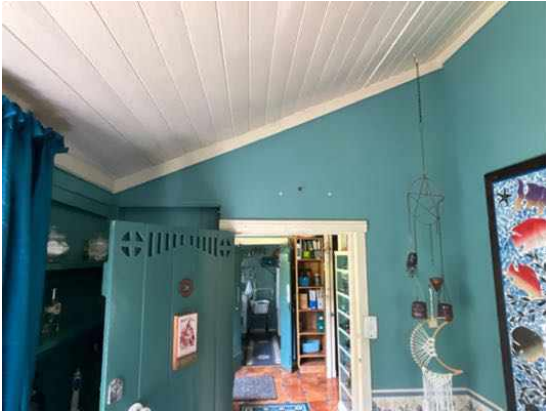
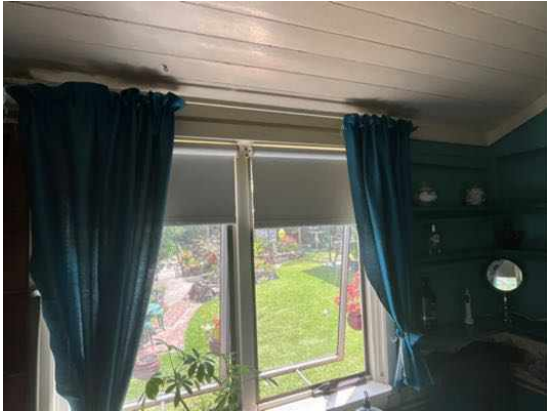
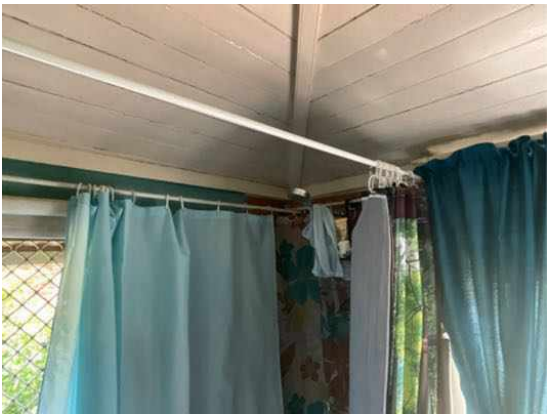
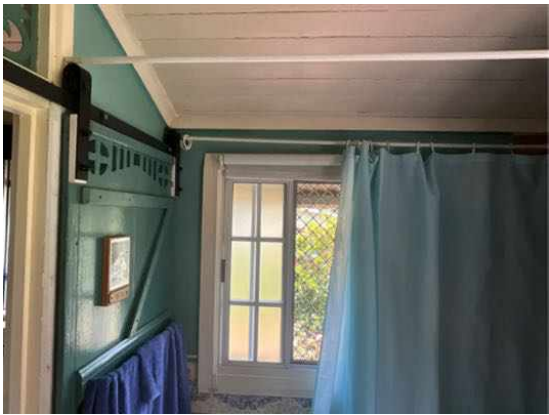
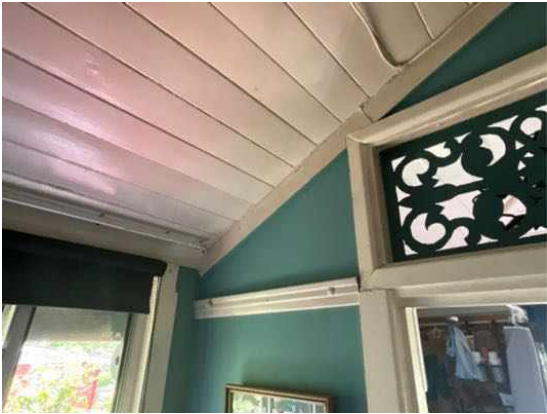
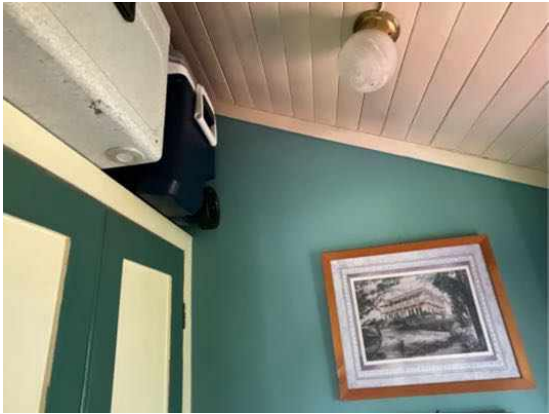
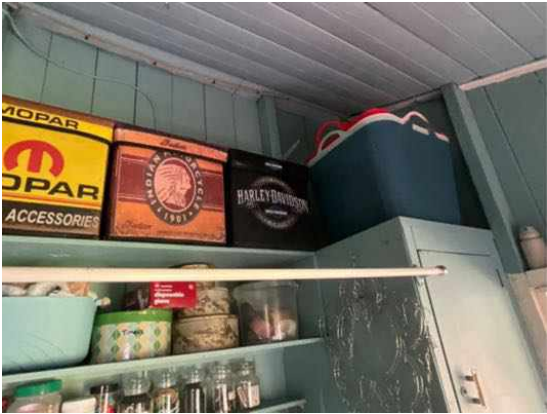
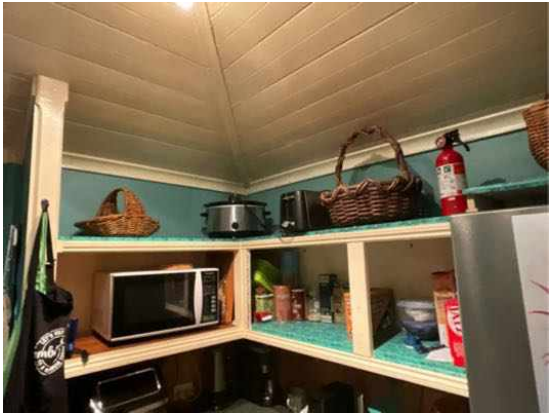
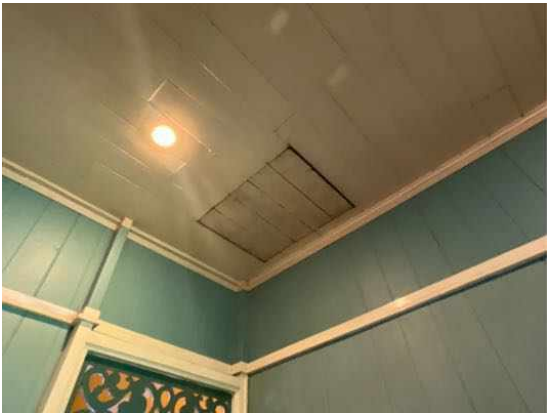
Finding 3.06

Building:	Main Building
Location:	All Areas
Finding:	Ceiling Linings – Cracking, Joint Separation & General Wear
Information:	Ceiling Linings – Cracking, Joint Separation & General Wear

The ceiling linings exhibit visible cracking along sheet joints and cornice junctions, minor separation at trim interfaces, and general ageing-related deterioration. Hairline cracking is evident across several areas, with localized joint movement and minor surface irregularities. These conditions are consistent with building movement, age-related settlement, and historical moisture exposure.

While no immediate structural failure was observed at the time of inspection, continued movement may lead to further cracking and deterioration of finishes. Open joints may also allow moisture ingress or pest entry if left unattended. Aesthetic presentation is reduced, and ongoing degradation may increase future repair costs.

A qualified plasterer or builder should assess the affected areas and carry out appropriate repairs, including re-fixing where required, re-taping joints, patching cracks, and repainting to restore condition and prevent further deterioration.

Repairs are recommended within the short to medium term (within 3–6 months), or sooner if cracking worsens.

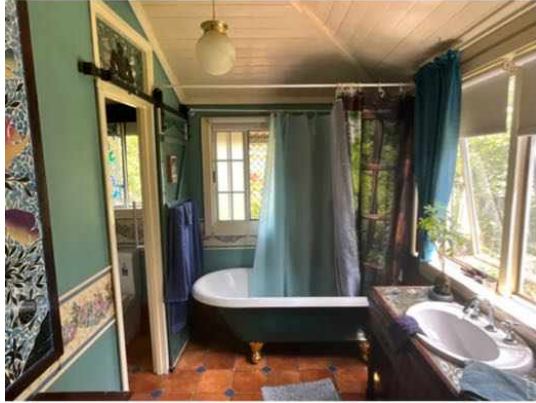
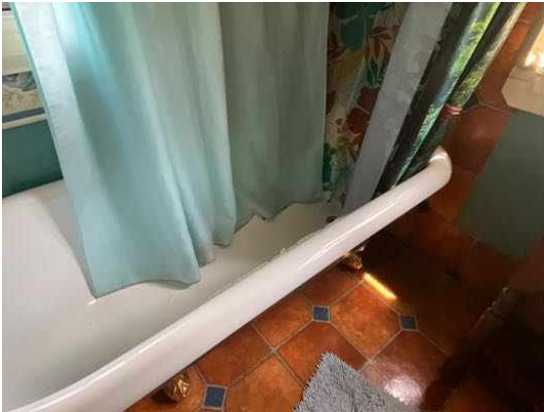
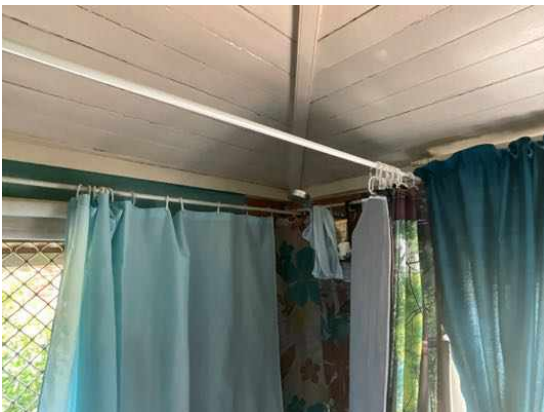
Finding 3.07

Building: Main Building
Location: Bathroom
Finding: Inadequate Wet Area Waterproofing – Shower/Bath Area
Information: Inadequate Wet Area Waterproofing – Shower/Bath Area

At the time of inspection, the shower/bath area was observed to have no fixed tiled wet-area linings or waterproof wall finishes installed. Water containment is currently reliant on a plastic shower curtain only, with painted wall surfaces directly exposed to moisture splash zones. No compliant waterproof membrane, splashback tiling, or water-resistant wall linings were evident within the shower/bath area.

This configuration does not provide adequate protection against ongoing moisture ingress and is inconsistent with typical wet-area construction standards.

Repairs are recommended in the short term to reduce the risk of moisture-related damage.

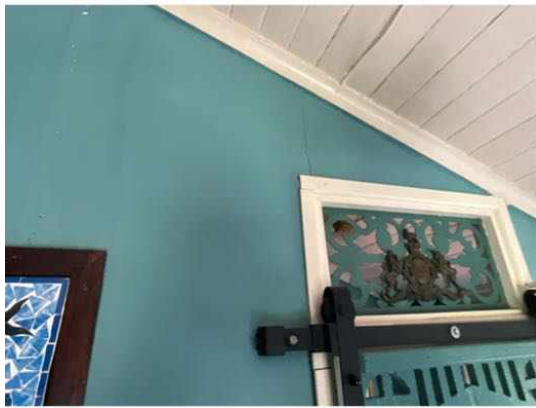
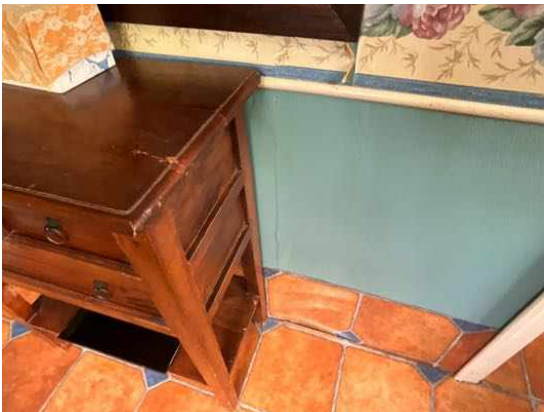
Finding 3.08

This assessment is visual only and limited to accessible areas at the time of inspection. No invasive investigation was undertaken. The cause of cracking cannot be definitively determined without further specialist assessment. This report does not constitute a structural engineering opinion. Building movement can be progressive, and concealed defects may exist. Ongoing monitoring is advised.

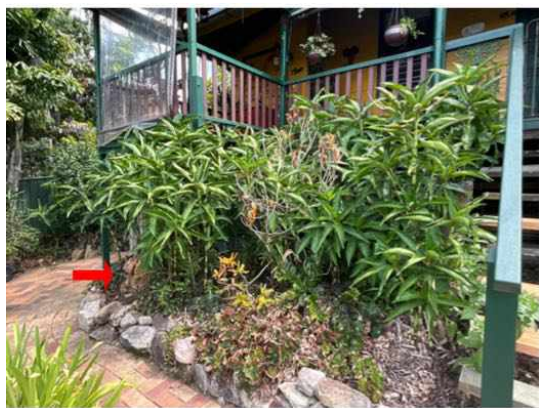
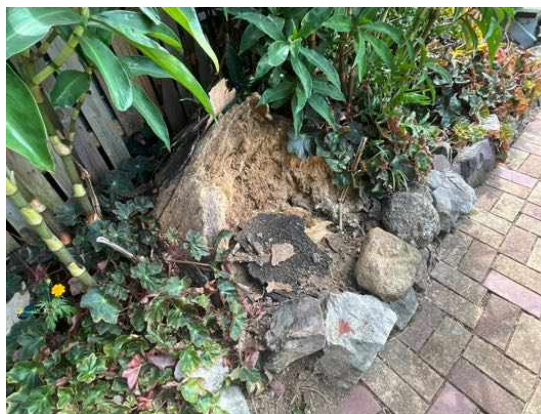
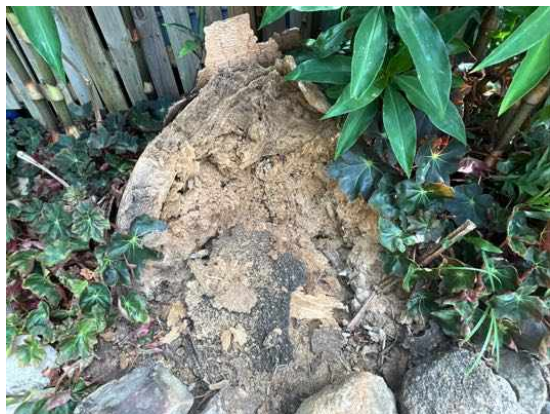
Information: Defect: Tree Stump and Root Remnants – Increased Termite and Pest Risk

A decaying tree stump and root remnants were observed in close proximity to the dwelling and adjoining paved surfaces. The stump is in a decomposing state, with organic material and disturbed soil present. This condition provides a favourable environment for termite activity, wood-destroying insects, fungal decay, and moisture retention. The proximity of timber material to the structure increases the risk of concealed termite entry pathways and pest harbourage.

Decomposing timber in contact with soil is a known termite attractant and may increase the likelihood of concealed termite infestation to the dwelling. Additionally, root decay may contribute to soil subsidence, moisture retention, drainage issues, and movement affecting nearby paving or footings. Failure to address this condition may elevate the risk of structural timber damage and hidden pest activity.

A licensed stump removal contractor or arborist should remove the stump and associated root system in full. The affected area should then be backfilled, compacted, and reinstated to ensure stable ground conditions. A qualified pest inspector is recommended to assess the area and determine whether termite management or preventative treatment is required.

Short term (within 1 month) — sooner if termite activity or moisture issues are suspected.
