Building and Timber Pest Inspection Report VR

Inspection Date: Mon, 9 Feb 2026

Property Address: 34 Barclay St, Bundamba QLD 4304,
Australia

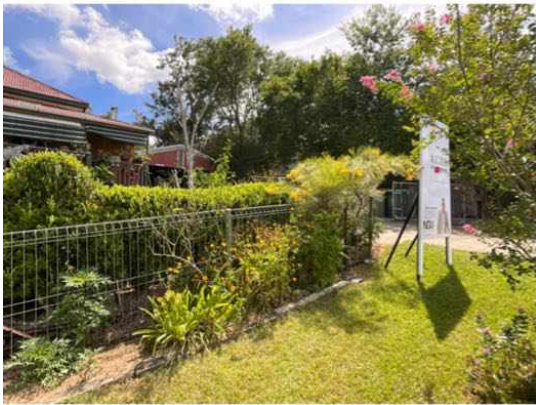
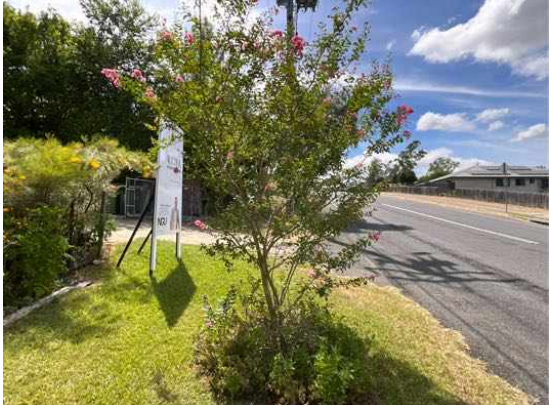
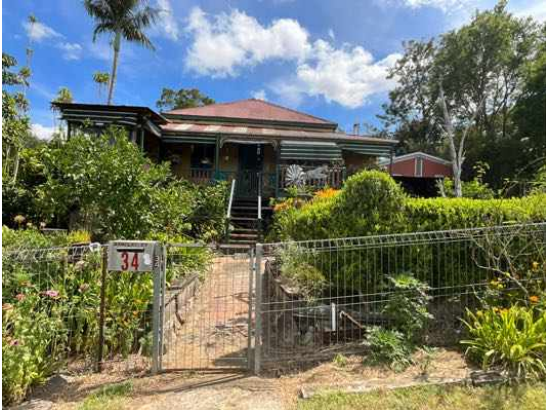
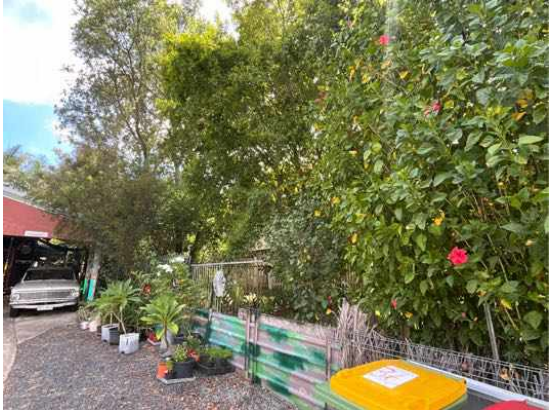
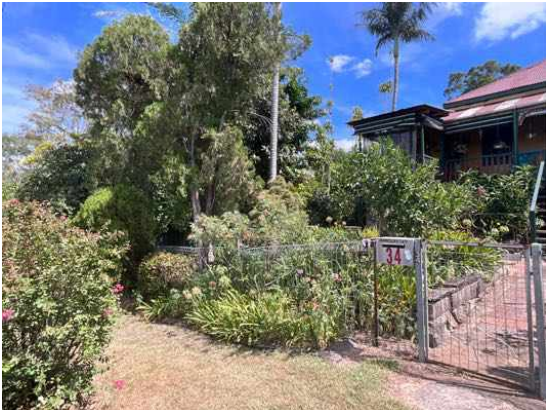
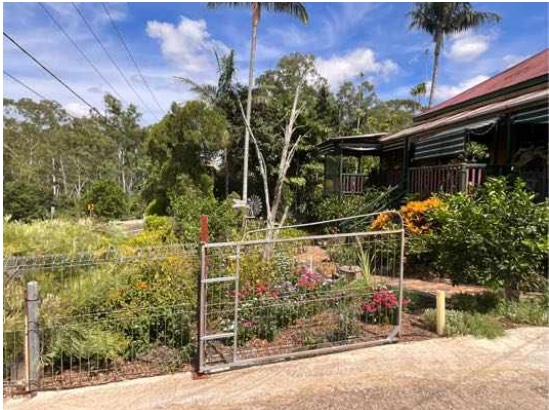
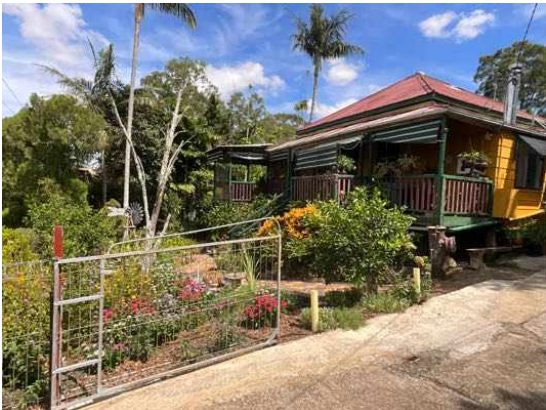
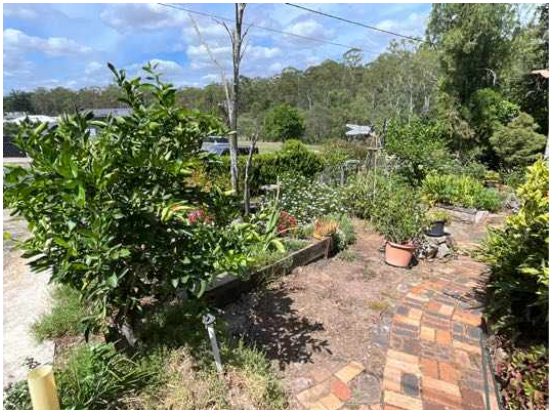
Finding 6.01

Conditions Conducive to Timber Pest Activity

To address this, consider maintaining a clear space between the vegetation and your home.

If you suspect a termite issue, it's advisable to consult with a licensed pest control professional for inspection and treatment.

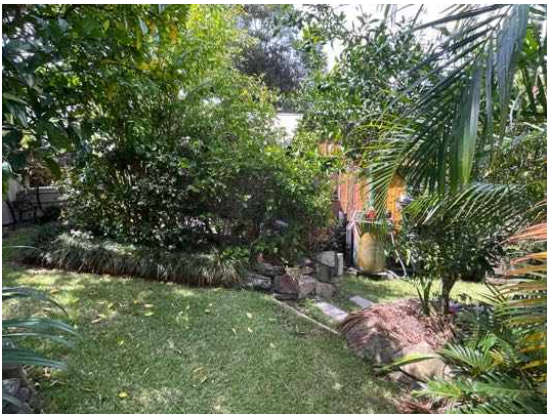
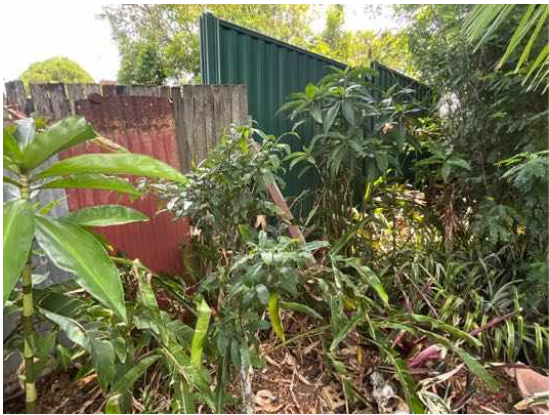
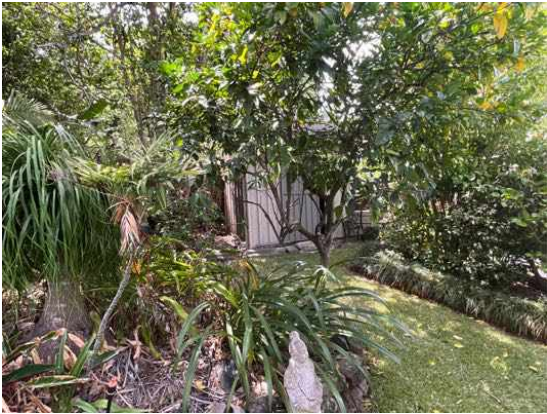
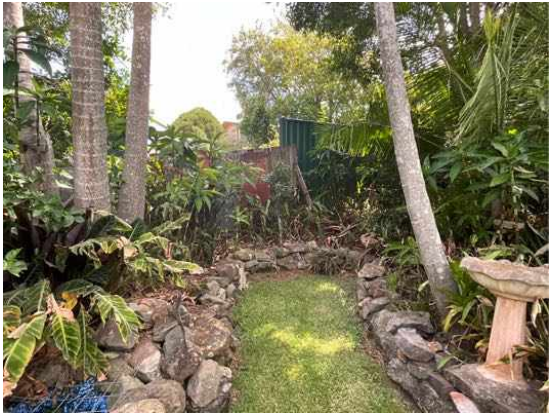
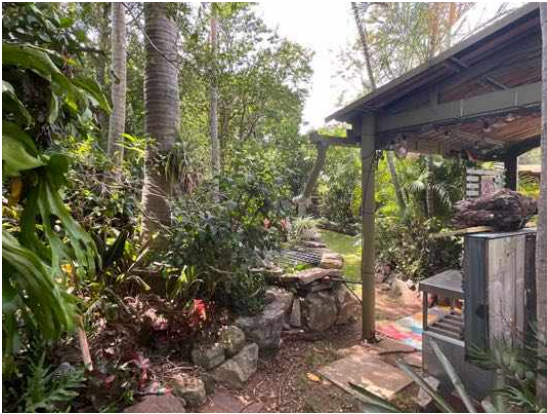
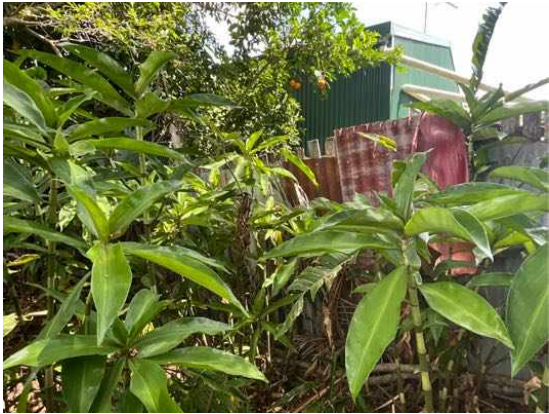
Finding 6.02

Building:	Main Building
Location:	All Areas
Finding:	Timber on ground / conducive conditions to termite damage.
Information:	Timber on the ground is indeed conducive to termite damage.

Termites are known to thrive in moist environments, and wood in contact with soil or moisture is more susceptible to infestation.

To prevent this, it's important to keep timber elevated and away from direct ground contact.

Regular inspections and proper termite control measures are also essential to protect your wooden structures from termite damage.

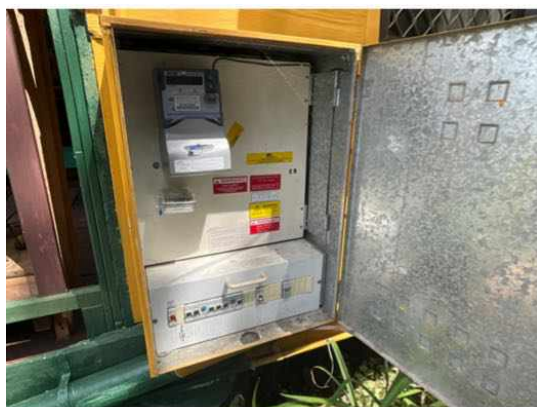
A durable notice should be placed in the switchboard unit to indicate current termite barriers. At the time of inspection, it appeared as though no termite management system has been installed, with no evidence to suggest preventative works taking place.

The client may consider gaining further advice from a pest controller as to the costs and procedures involved with this application. It is recommended that obtaining such advice be a short-term priority.

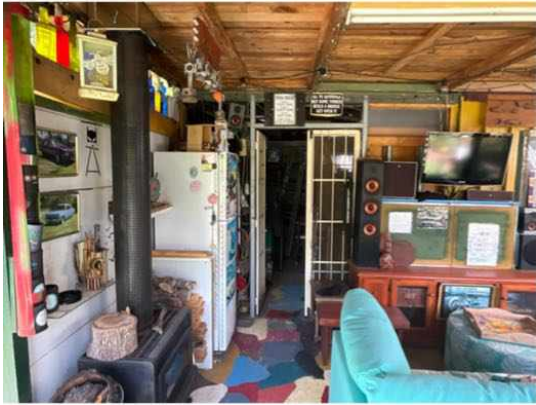
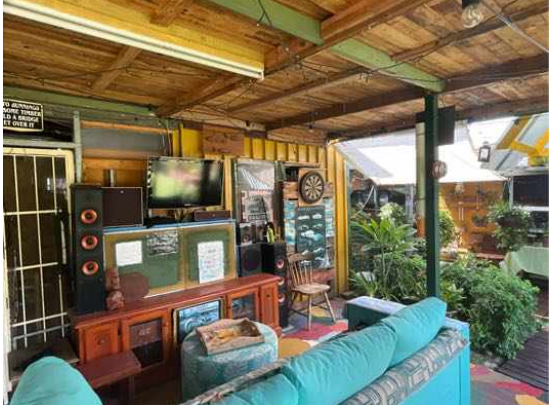
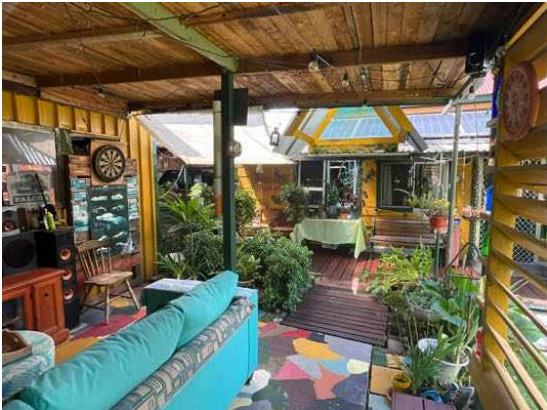
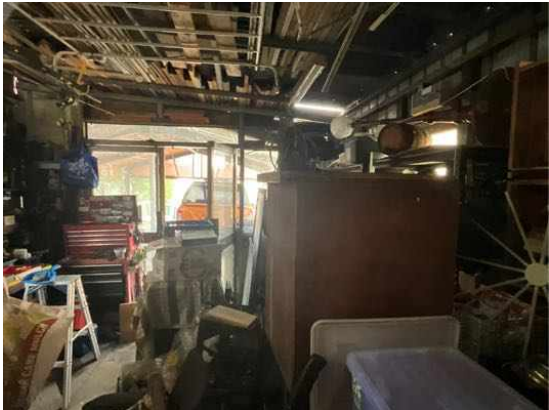
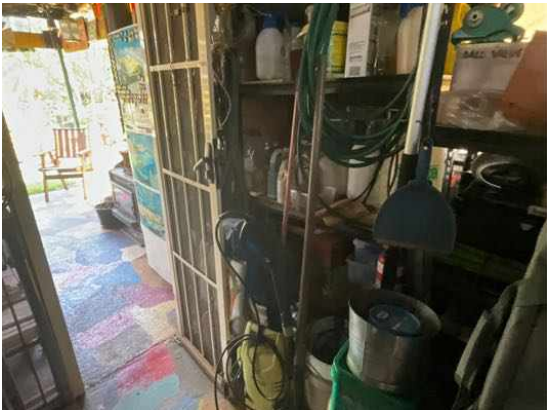
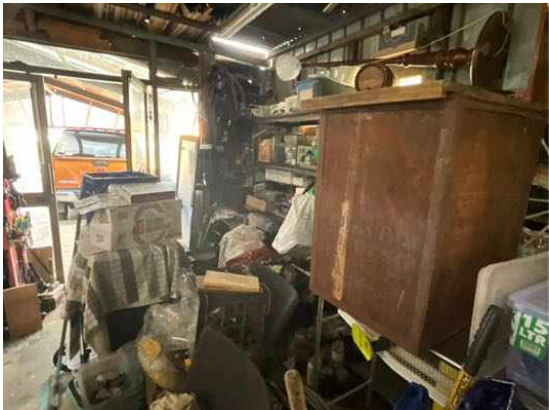
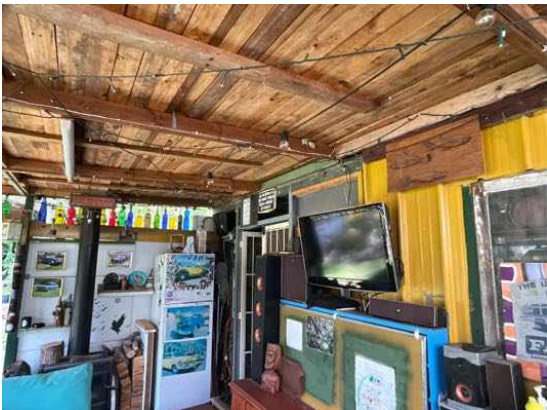
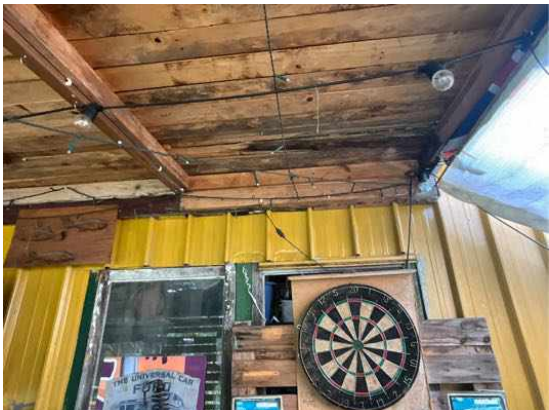
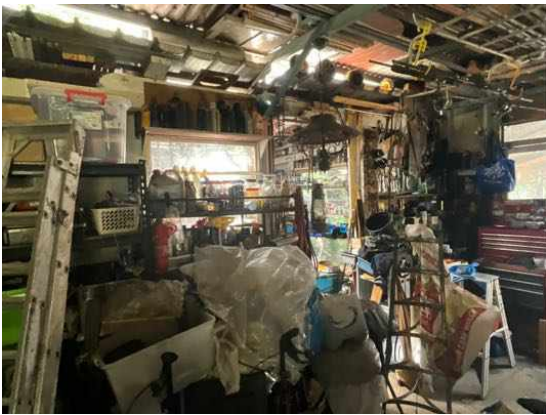
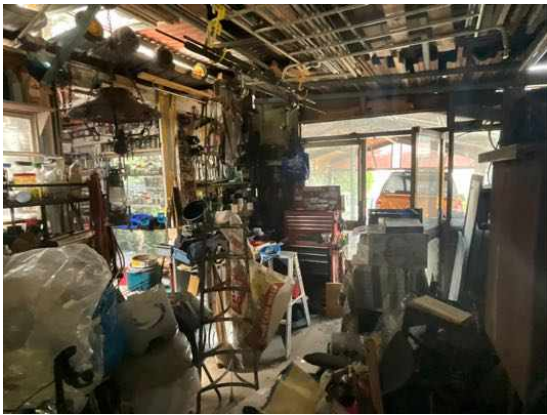
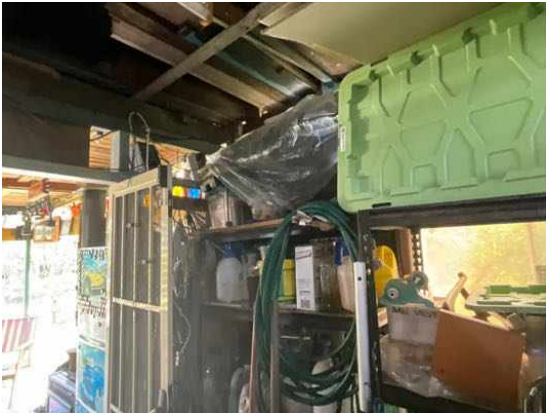
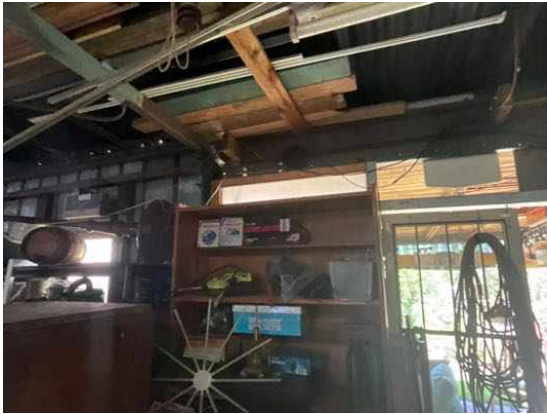
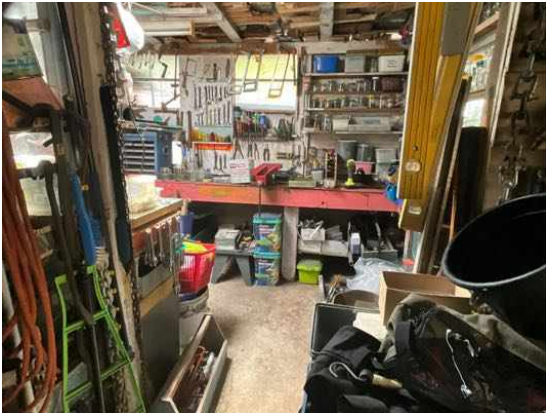
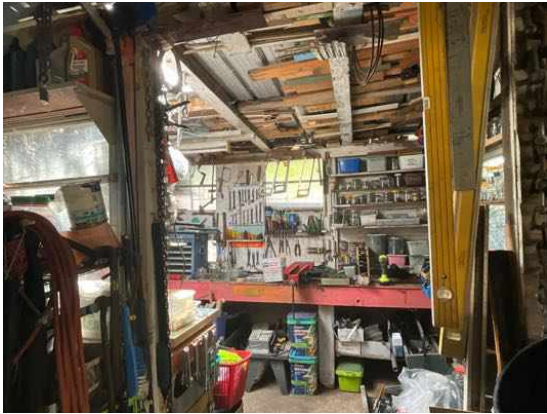
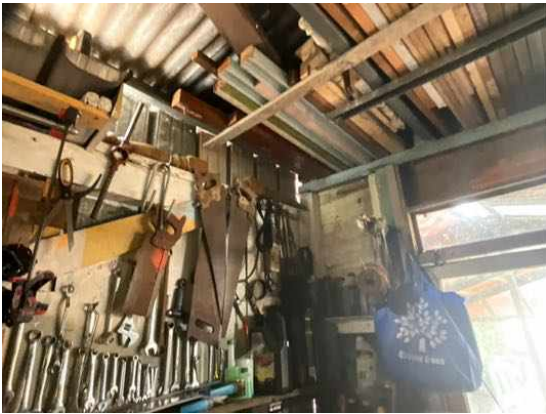
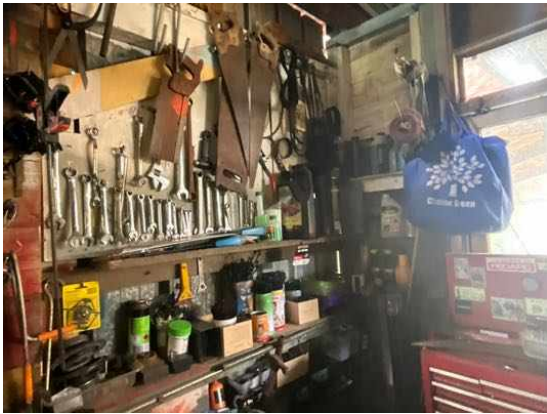
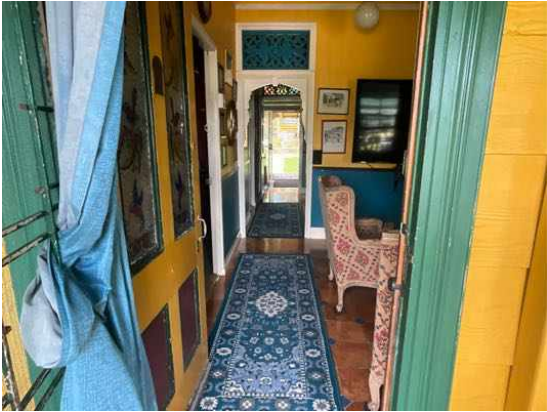
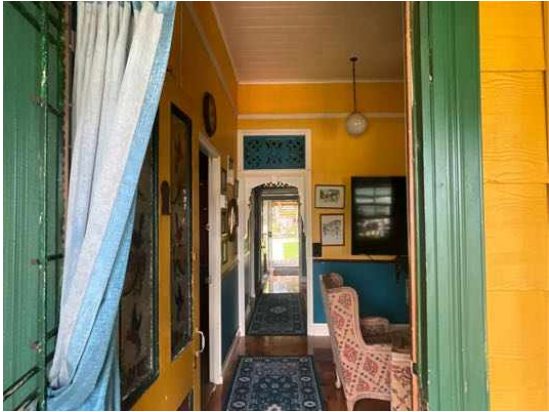
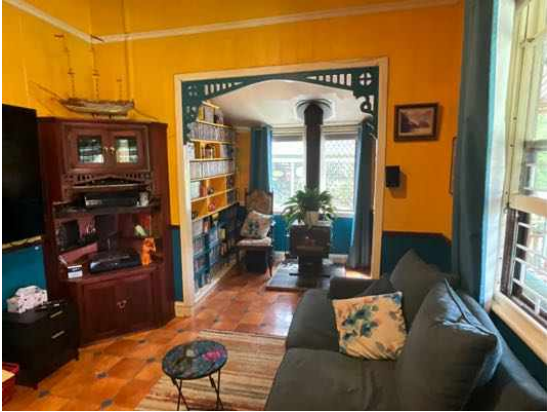
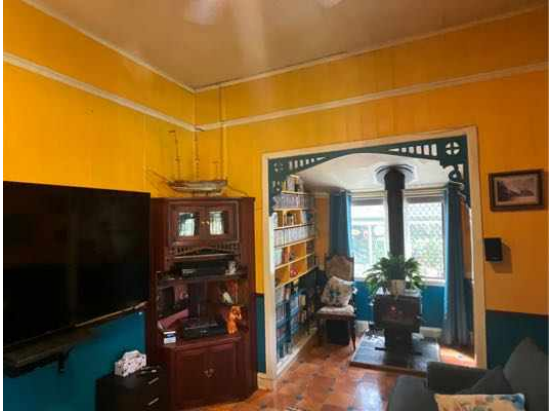
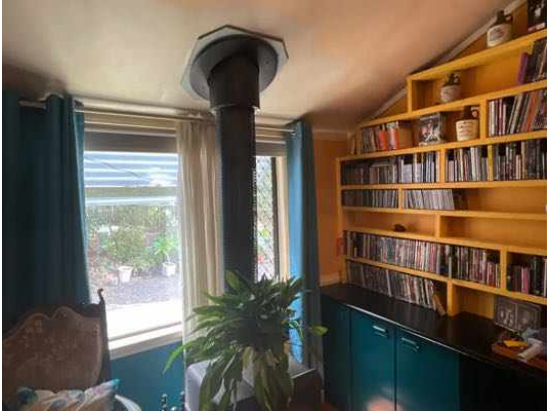
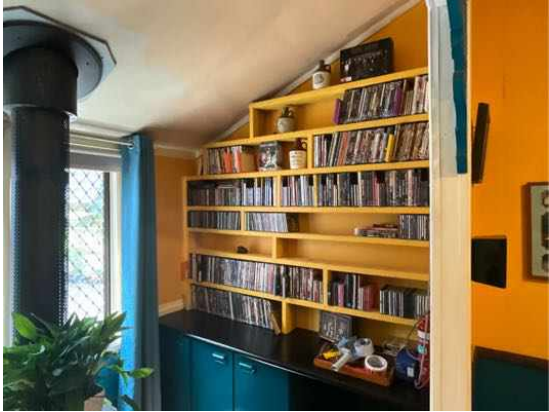
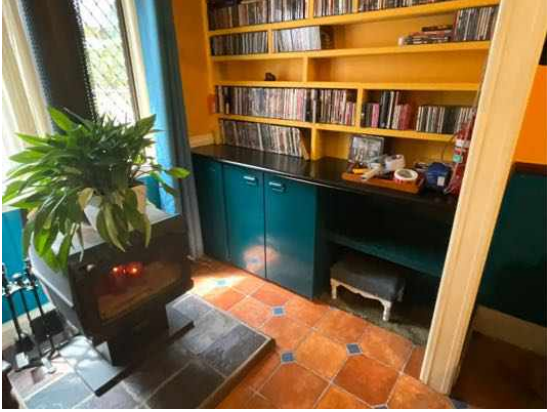
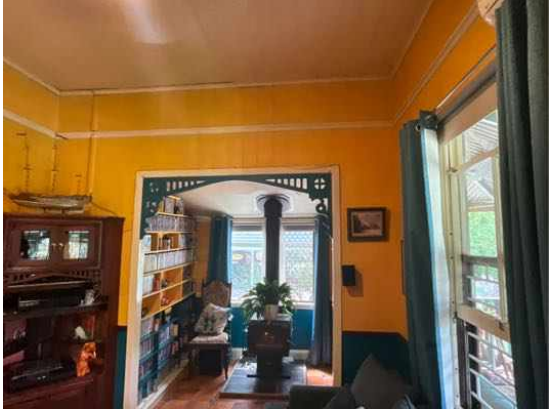
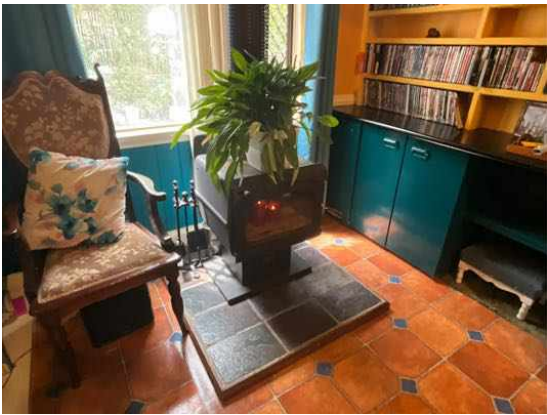
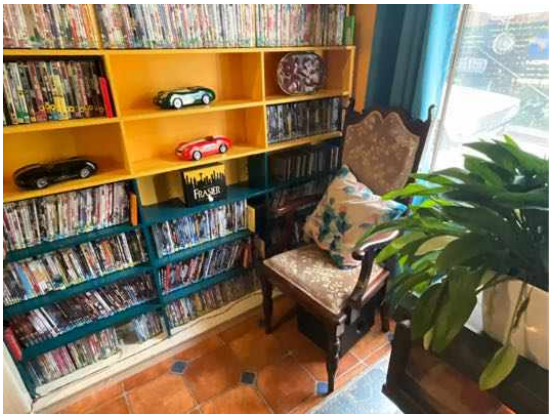
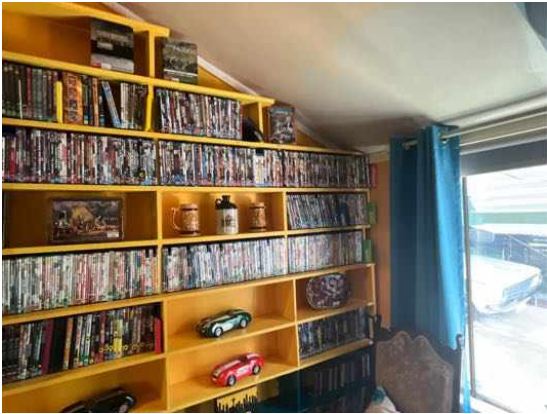
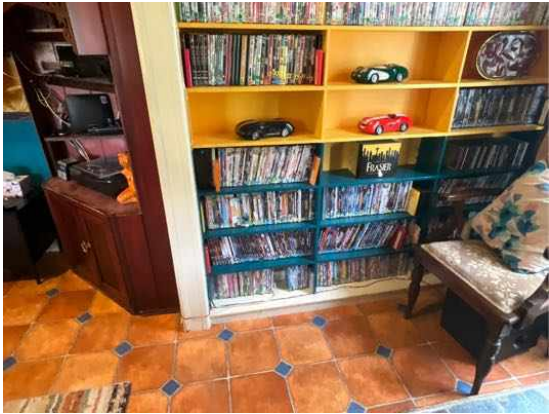
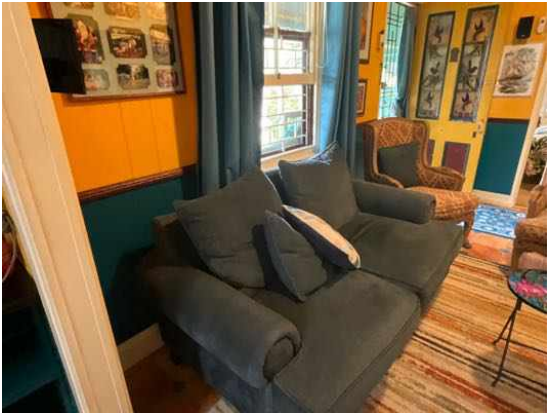
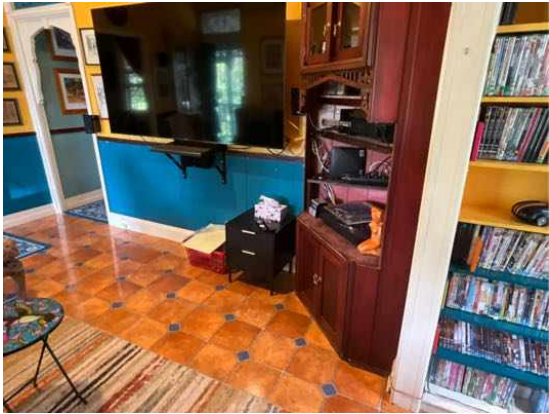
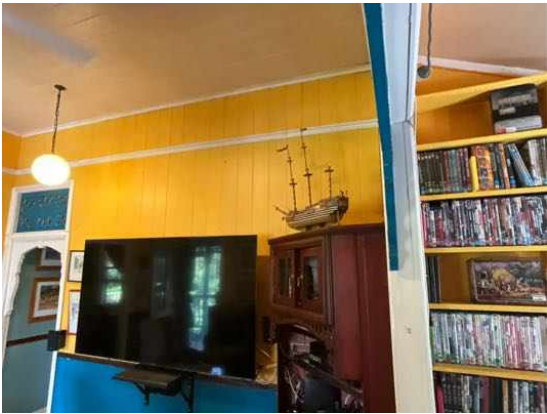
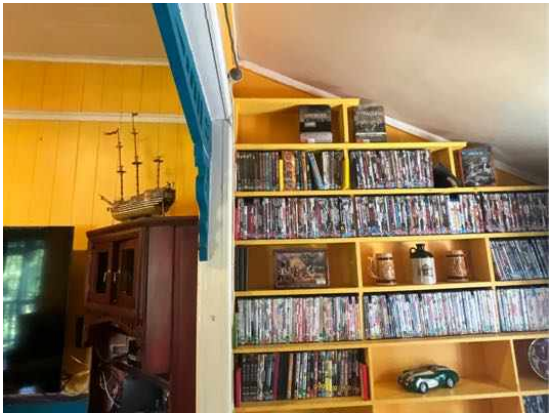
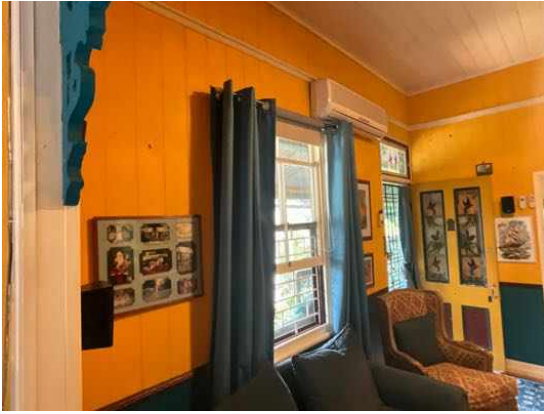
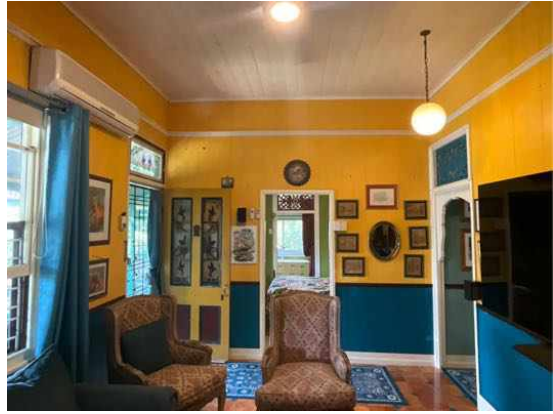
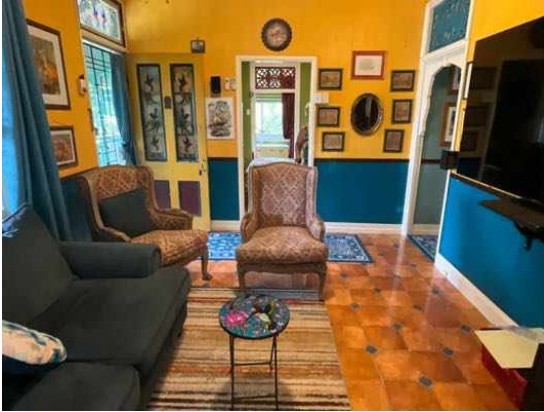
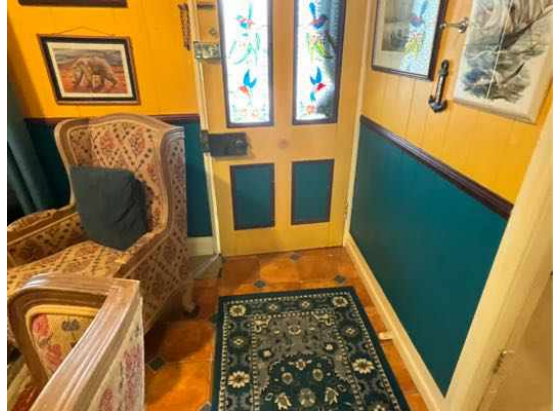
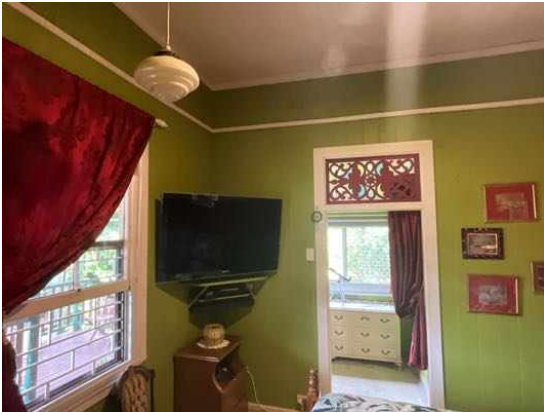
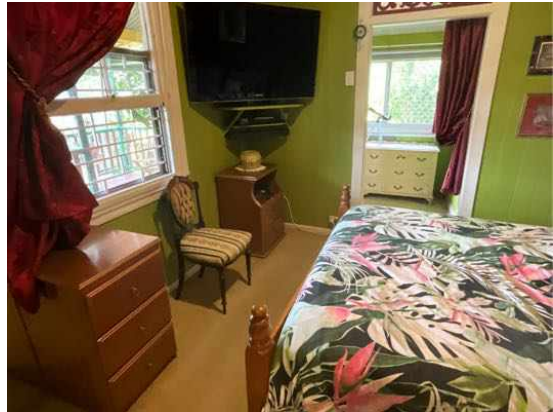
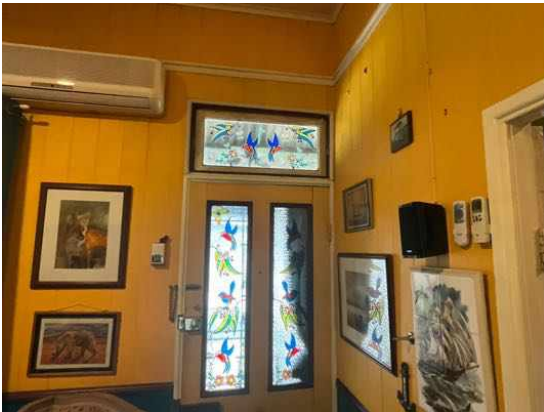
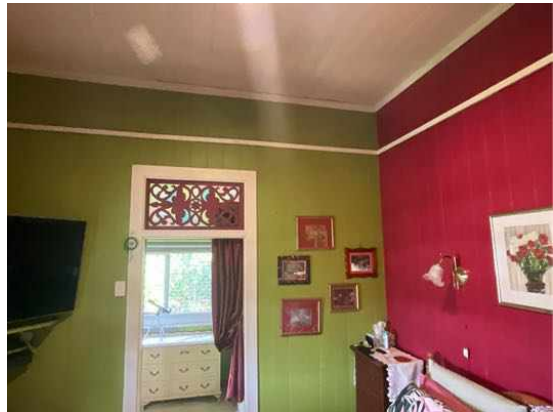
Building: Main Building
 Location: All Areas
 Finding: Additional Photos - Obstructions and Limitations
 Information: These photographs are an indication of the obstructions and limitations which impeded full inspection of the property at the time of inspection. These obstructions can hide an array of defects and should be removed to allow full inspection to be carried out. A re-inspection is recommended once the areas are made accessible.

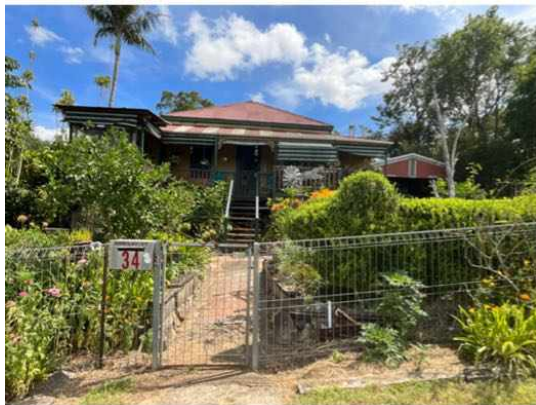
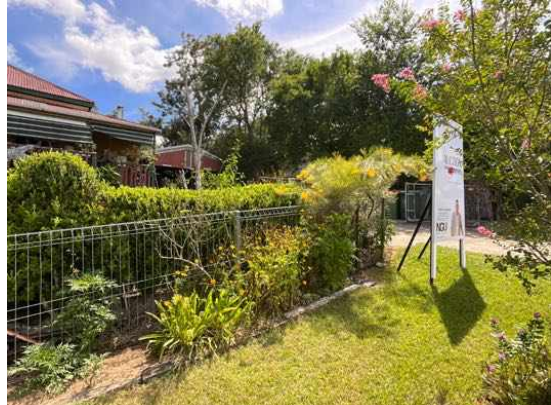
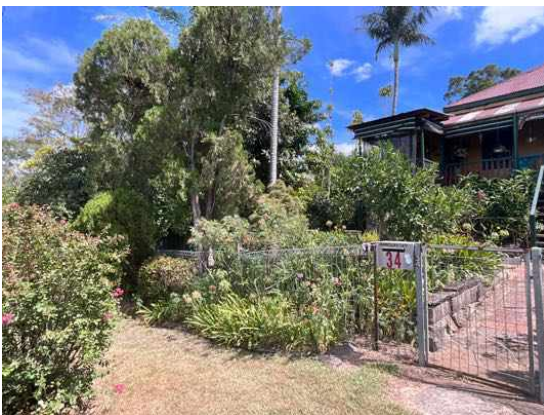
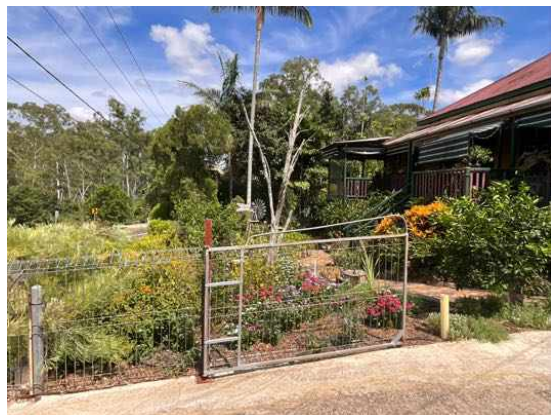
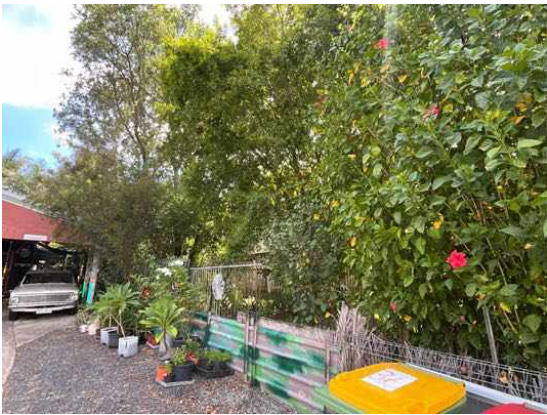
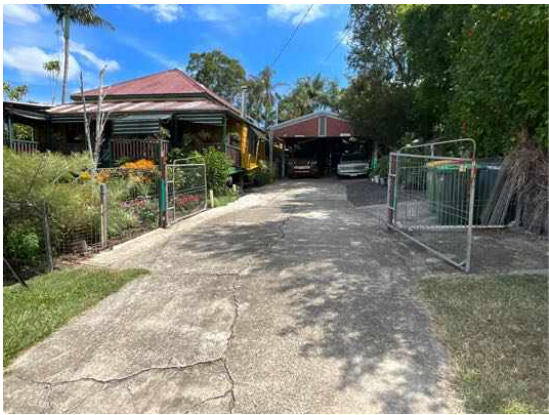
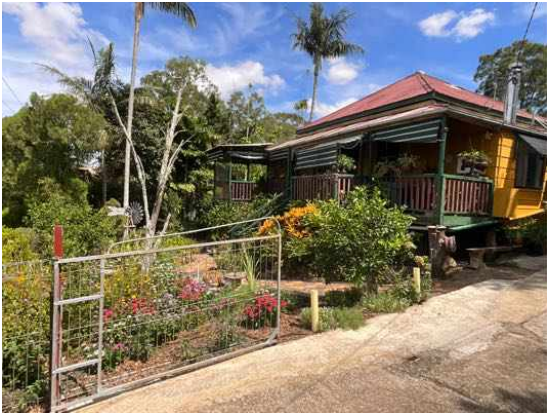
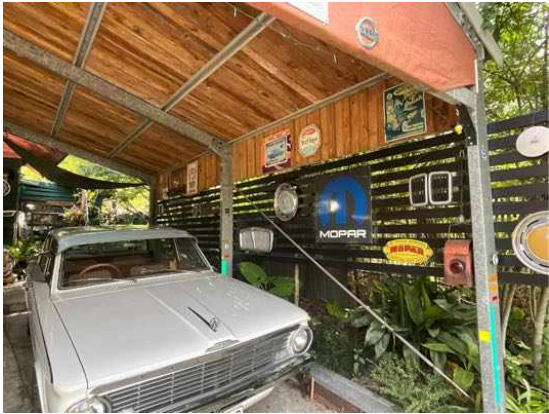
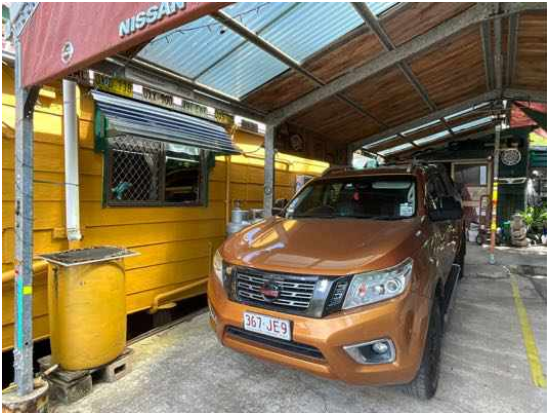
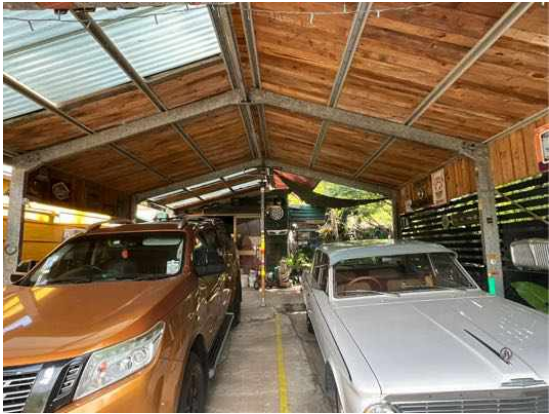
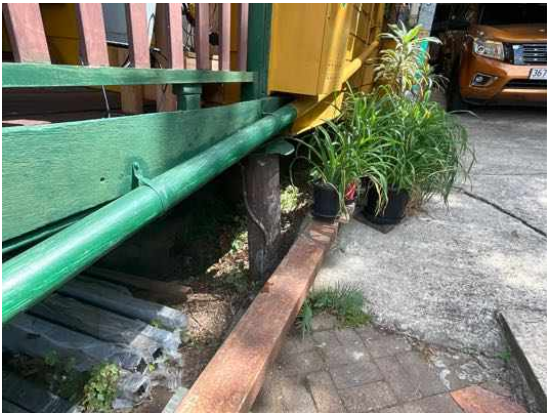
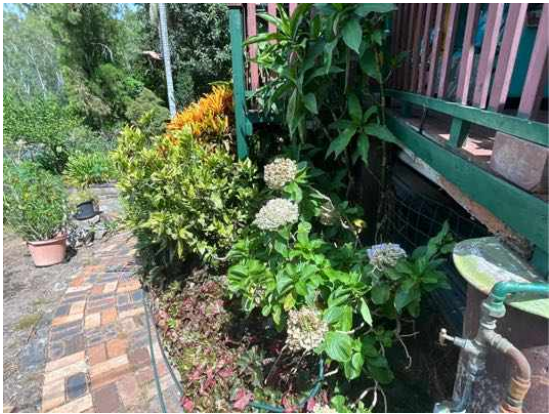
Finding: Additional Photos - Obstructions and Limitations

Information: These photographs are an indication of the obstructions and limitations which impeded full inspection of the property at the time of inspection. These obstructions can hide an array of defects and should be removed to allow full inspection to be carried out. A re-inspection is recommended once the areas are made accessible.
