Building Inspection Report

Inspection Date: Mon, 23 Mar 2026

Property Address: 180/38 Shoreline Dr, Rhodes NSW 2138,
Australia

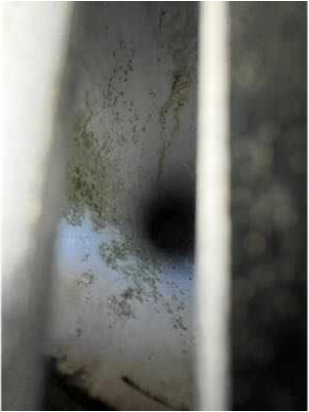
Defects 2.02

Several points of the bathroom floor tiles have been identified for silicon crack.
